## **Green CCR Landfill**

### **Disposal of Coal Combustion Residuals (CCR) from Electric Utilities Final Rule CCR Landfill 2017 Annual Inspection Report**

**January 11, 2018**

**Project ID: 170138B**

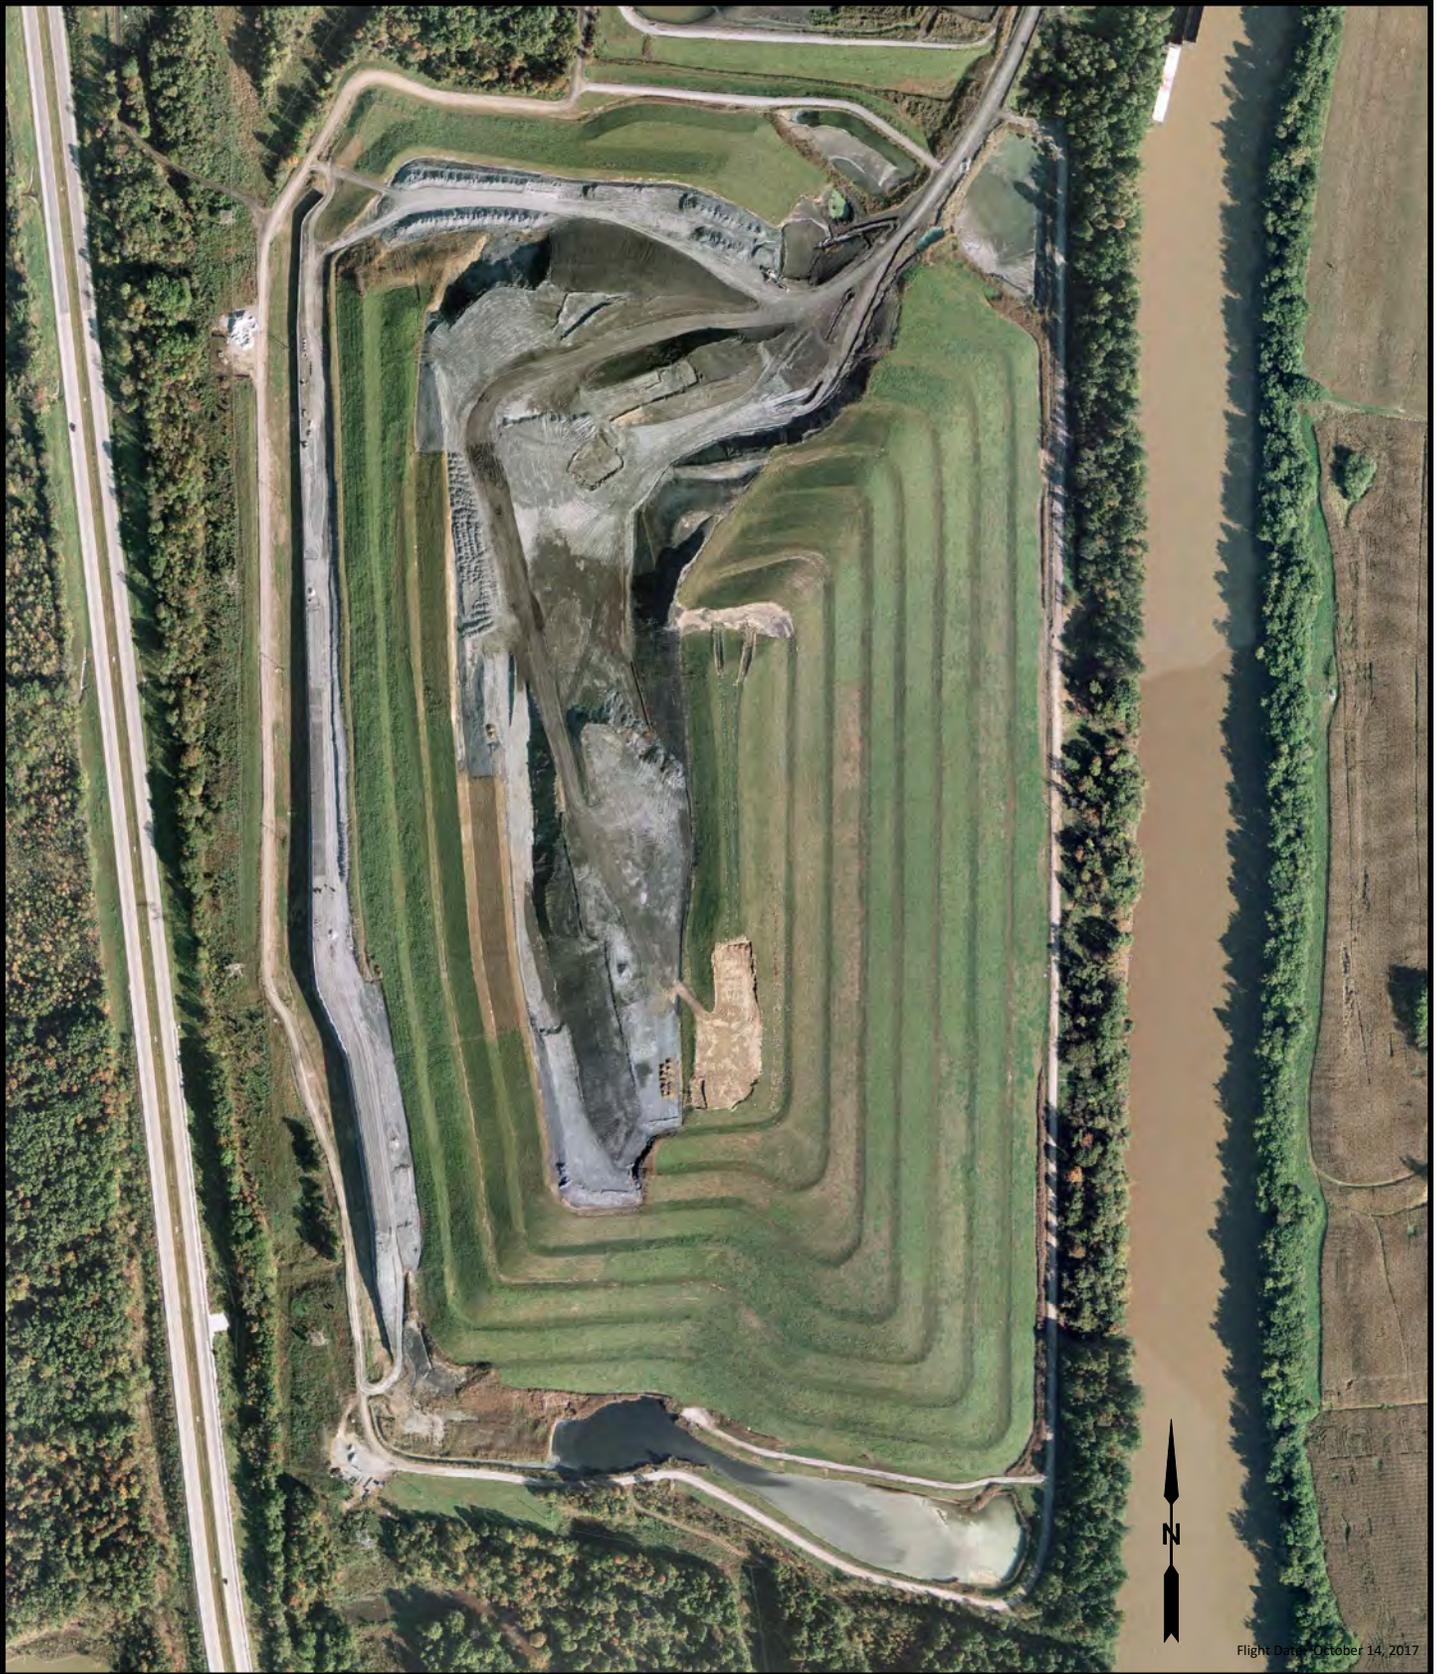
Green CCR Landfill  
2017 Annual Inspection Aerial Photo

Changes to the landfill geometry since the previous (2016) annual inspection include continued placement of CCR material behind the constructed vertical expansion wall on the west exterior slope; and the placement of additional CCR and cover material on the landfill.

The total volume of CCR material contained in the Green CCR Landfill was estimated to be 21.3 million cubic yards. This volume was calculated from available baseline topography compared to October 2017 flight derived topographic contours.

A change to the Green CCR Landfill since the previous (2016) annual inspection that may have the potential to affect the stability or operation of the CCR unit is placement of CCR material behind the constructed vertical expansion wall on the west exterior slope. The expansion wall was designed per accepted engineering standards and if constructed as designed, should achieve required factors of safety. Additional CCR material and soil cover have been placed since the 2016 CCR Rule Annual Landfill Inspection Report.
