## **Green CCR Surface Impoundment**

### **Disposal of Coal Combustion Residuals (CCR) from Electric Utilities Final Rule CCR Impoundment 2017 Annual Inspection Report**

**January 11, 2018**

## **Reid/HMP&L CCR Surface Impoundment**

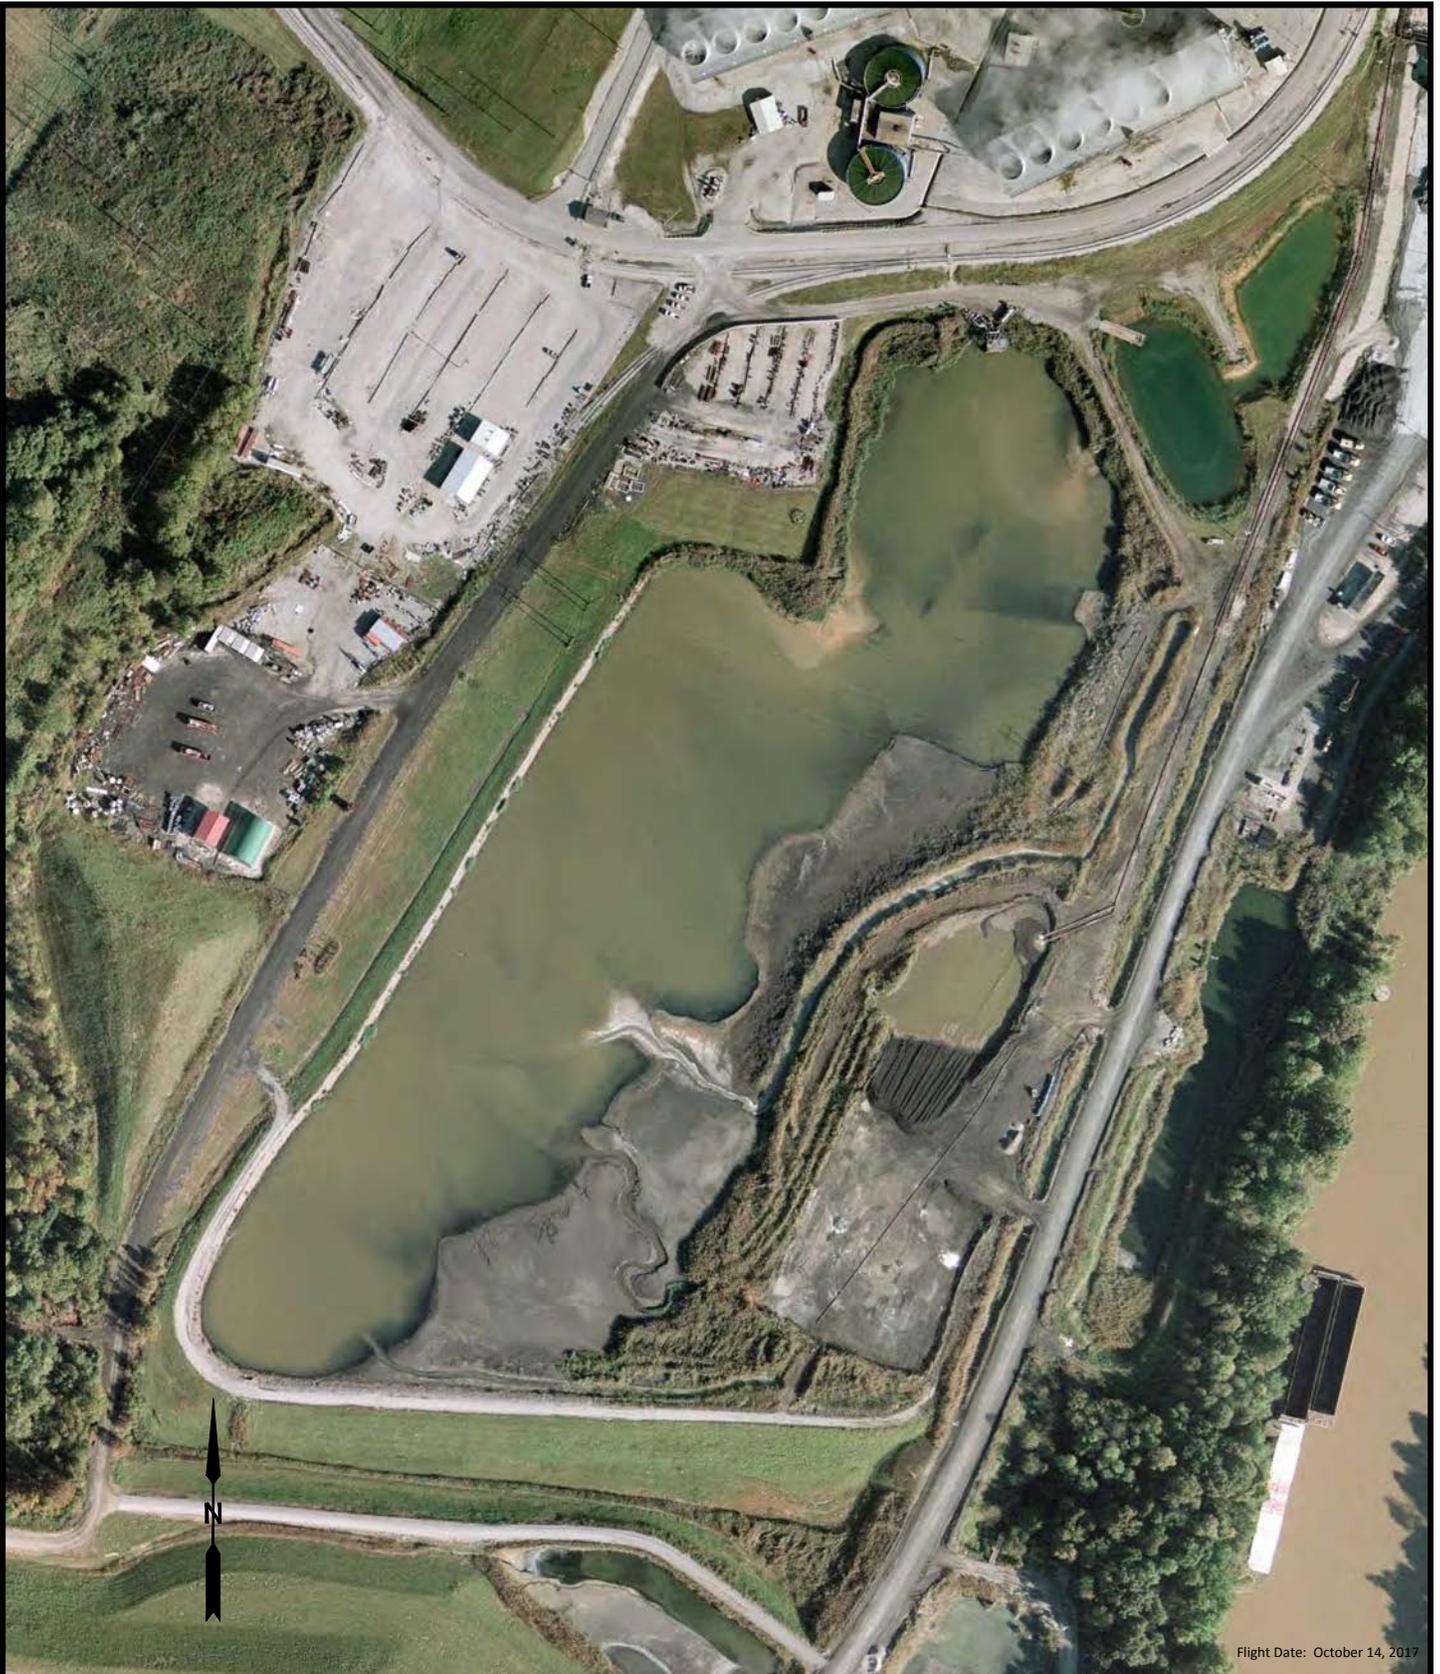
Green CCR Surface Impoundment  
2017 Annual Inspection Aerial Photo

The inspection consisted of a visual assessment of the surface impoundment, embankments and discharge; and began at the southwest corner of the impoundment on the embankment crest access road. The crest access road and the upstream embankment slope were adequately rocked and maintained. A small isolated low area was observed on the crest access road. The downstream slope at the southwest corner of the impoundment was sparsely vegetated except for areas of thick vegetation adjacent to the discharge pipe outlets (no discharge observed at the time of inspection). The south embankment downstream slope was generally well vegetated and mowed. Small animal burrows and disturbed ground were observed on the mid-slope and lower downstream slope of the central portion and east end of the south embankment. Damage from mowers was observed on the east end of the south embankment downstream slope. Moderate erosion was observed on the south east groin of the downstream embankment slope. Standing water and thick stands of vegetation were observed in the ditch located adjacent to the south embankment toe that directs drainage east towards the Green River.

The east side of the impoundment interior contains CCR material at or above the current pool elevation. Active management of CCR material was observed where stored above the pool elevation and previously placed dewatering bags were observed on adjacent area. A dredge was actively working in the north end of the impoundment. The east crest access road is not well separated from interior CCR storage areas, and drainage control for these areas was observed not to be effective. Drainage control ditches are absent or poorly drained and contain excess vegetation. Areas of exposed CCR material and erosion were observed on the east embankment downstream slope.

The northeast, north and northwest portions of the impoundment are incised and the upstream slopes were observed to be thickly vegetated with stands of phragmites that extend approximately 30 feet into the impoundment and obstructing view. An inflow pipe that is located at the north end of the impoundment was observed to be in poor condition and contains debris.

The northern portion of the west embankment crest and upstream slope was generally observed to be adequately rocked and the downstream slope adequately vegetated. Minor small animal burrows and areas of sparse vegetation were observed on the embankment crest adjacent to the rocked upstream slope and vegetated downstream slope. A very flat ditch runs along the majority of the west downstream slope toe where vegetation is sparse to absent because of ponded water. A minor slump was observed on the upstream slope approximately 300 feet north of the west access road to the crest. The southern portion of the west embankment upstream slope and the south embankment upstream slope were observed to be adequately rocked and clear of vegetation.

The south embankment contains the discharge structure (two corrugated steel discharge pipes; each 30 inches in diameter). The upstream end of the discharge structure has a concrete common headwall with variable height steel debris deflectors that should be removed. Thick vegetation was present around the spillway pipe outlets. The pipe conveyances were inspected on October 27, 2017 by Envision Contractors, LLC using a remote camera and found to be in acceptable operating condition.

- When weather permits, areas of rutting identified in the report from mowing will be repaired.

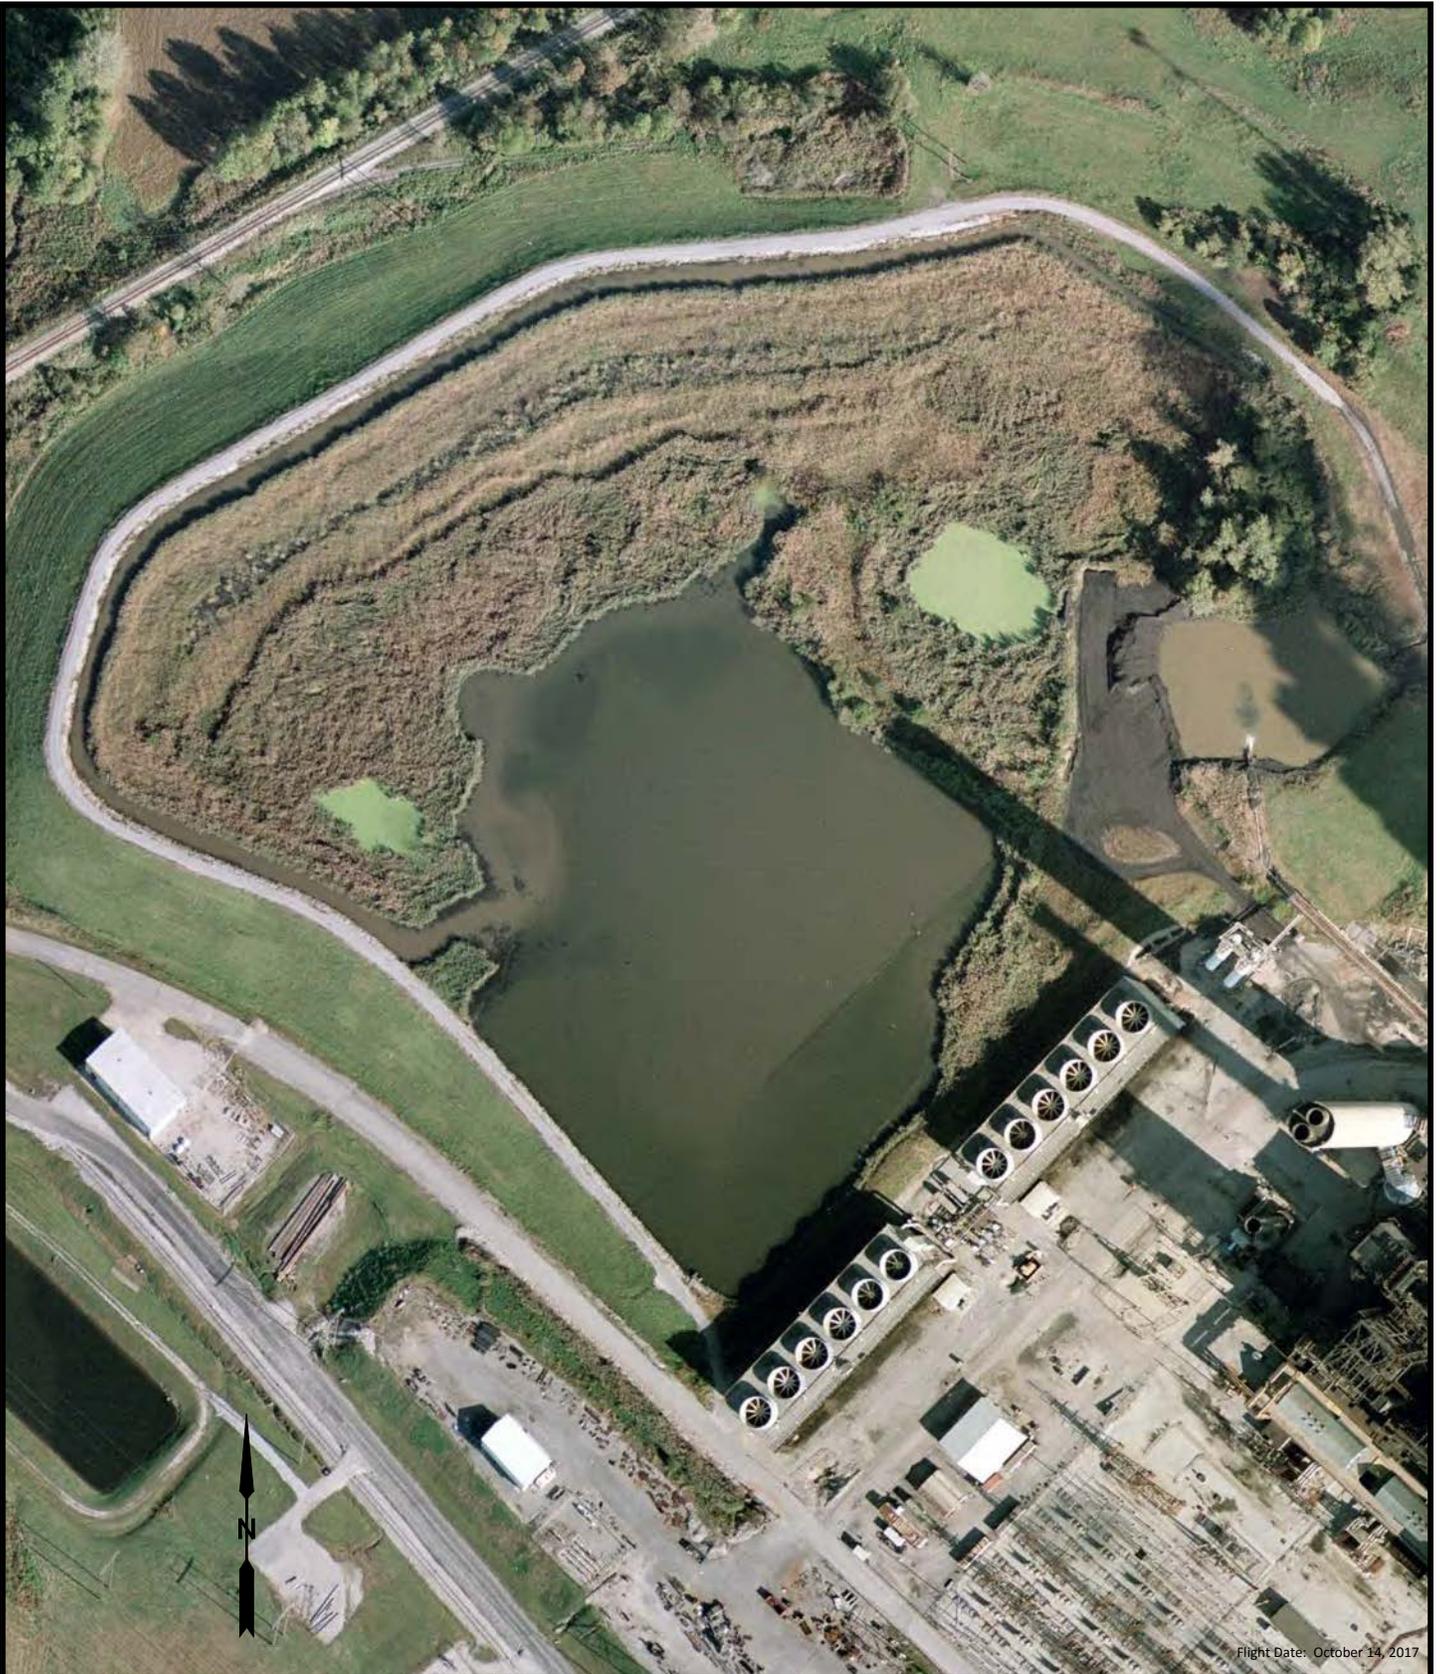
**BIG RIVERS ELECTRIC CORPORATION**  
 Reid/HMP&L CCR Surface Impoundment  
 2017 Annual Inspection Aerial Photo

The inspection consisted of a visual assessment of the surface impoundment, embankments and discharge; and began at the northeast corner of the impoundment adjacent to the access road located on the north embankment crest. The inspection noted thick vegetation in the interior of the impoundment and on the upstream slope of the embankment. A channel of open water is maintained adjacent to the upstream slope of the embankment. The upstream slope is steep where the channel has been dredged and heavily vegetated. The inspection proceeded west along the north embankment crest where a minor slip was observed on the upstream slope adjacent to the dredged channel. The access road continues around the impoundment on the crest of the west and south embankments and is adequately rocked and maintained. Several small areas of exposed soil (no rock or vegetation) were observed at the southeast corner of the impoundment adjacent to the catwalk to the discharge structure.

The inspection continued to the downstream slope of the south embankment where damage to vegetation from mowing equipment was noted at the southeast corner. The south downstream slope was vegetated and generally in good condition with a small depression located mid-slope approximately mid-length of the embankment. Areas of older vegetated erosion were also observed at this approximate location along the downstream slope toe. As the inspection progressed west, areas along the slope were very wet and supported thick vegetation. Areas of saturated ground and deep mower ruts were observed on the lower slope adjacent to the toe. Very wet conditions, saturated ground and mower ruts continued along the toe of the southwest and west embankments. Wet areas include a depression on the embankment slope and a heavily vegetated saturated strip of ground extending from the embankment toe to the adjacent ditch. Minor mower damage was observed along the upper downstream slope at the north end of the west embankment. The crest of the west embankment was well maintained.

The inspection of the downstream slope of the north embankment noted an area of approximately one-quarter acre of standing water and very thick vegetation at the east end of the embankment. The crest of the north embankment was in good condition and areas of moderate to deep erosion were observed on the upstream slope of the northeast corner of the

impoundment. Active management of CCR material was observed in an area of approximately three-quarters acre in the interior of the northeast corner of the impoundment. The majority of the northern area of the impoundment interior was observed to be thickly vegetated with stands of phragmites.

The south embankment which parallels adjacent cooling towers to the east is the smallest embankment and occurs primarily on the southwest corner of the impoundment. The upstream side is steep-sided, thinly covered with rip-rap and covered with phragmites. The crest and downstream embankment slope were mowed. The sand filter backwash pipe runs along the crest (south end) and exits at the discharge structure located in the southeast corner of the impoundment. The impoundment embankment crest supports an access road around the south, west and north perimeters and has adequate gravel cover over the entire length.

The impoundment discharge structure consists a rectangular concrete drop structure with a variable height steel debris skimmer and the pool elevation can be controlled by adding or removing stop logs. The discharge structure connects to a 24-inch diameter smooth walled metal pipe underground conveyance. The pipe conveyance was inspected on October 27, 2017 by Envision Contractors, LLC using a remote camera and found to be in acceptable operating condition.

- When the weather warms, the upstream slope areas that need additional rip rap will be repaired.
- When the weather warms, the downstream slope areas that are sporadically bare will be either seeded or covered by rip rap.
