## **Green CCR Landfill**

### **Disposal of Coal Combustion Residuals (CCR) from Electric Utilities Final Rule CCR Landfill 2016 Annual Inspection Report**

**January 10, 2017**

**Project ID: 160122B**

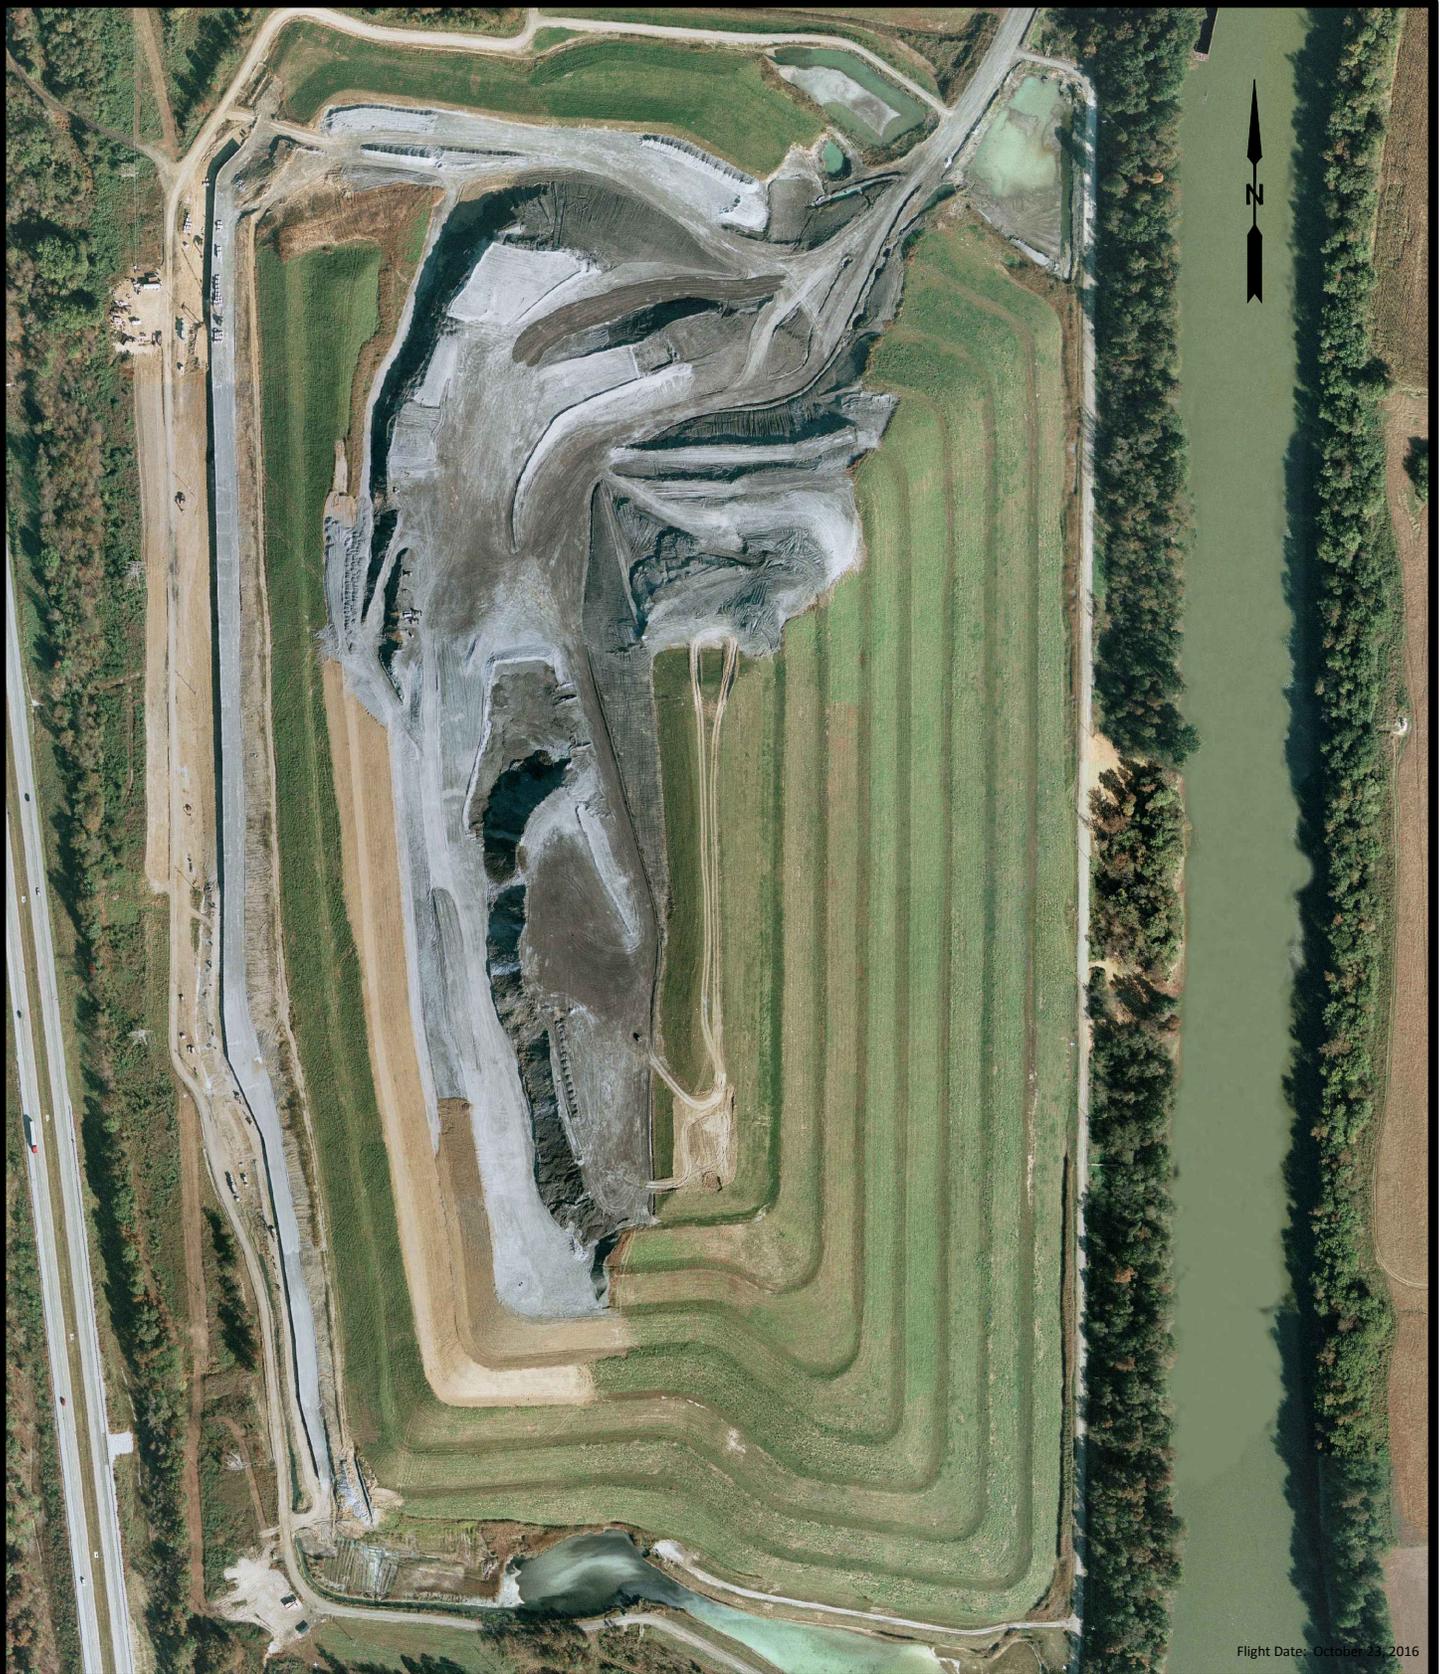
Green CCR Landfill  
2016 Annual Inspection Aerial Photo

Flight Date: October 23, 2016
