Reid/HMPL CCR Surface Impoundment

Disposal of Coal Combustion Residuals (CCR) from Electric
Utilities Final Rule
CCR Surface Impoundment 2018 Annual Inspection Report

Big Rivers Electric Corporation

January 11, 2019

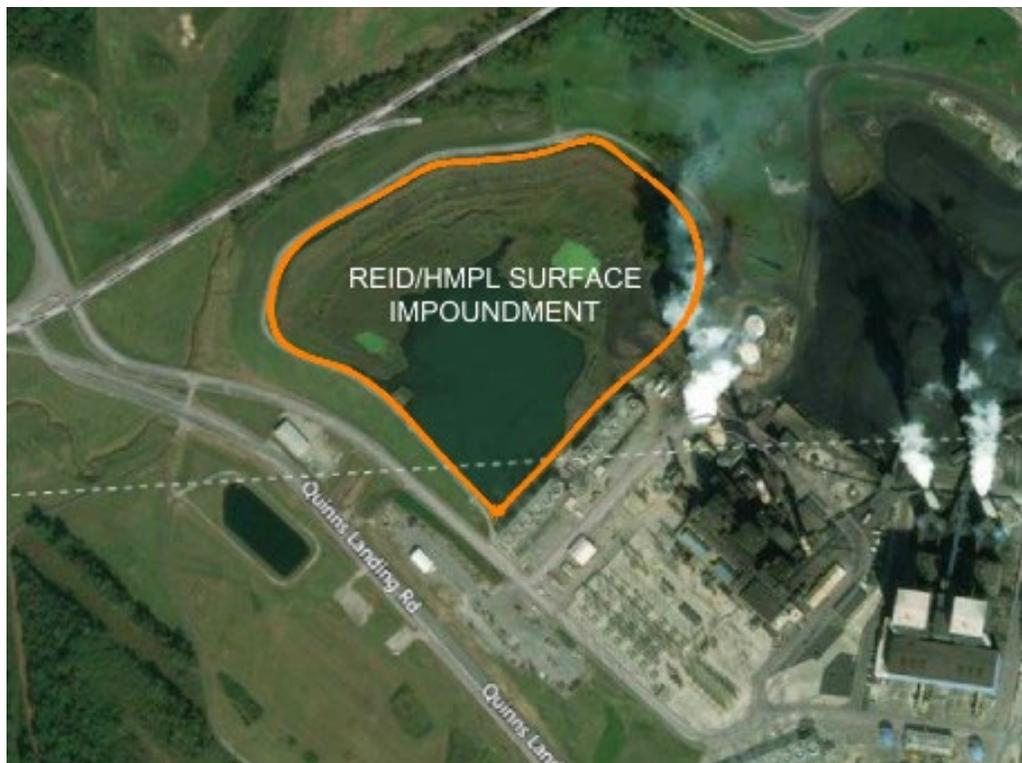
Figure 1: Big Rivers Reid/HMPL CCR Surface Impoundment Overview

The Reid/HMPL CCR Surface Impoundment consists of an earthen embankment on the south, west and north sides and incised to the east as shown in Figure 1. The impoundment is approximately 2,500 feet to the east of the Green River and the maximum height of the embankment is 42 feet on the west dike. The impoundment currently receives only sluiced bottom ash however, previously received both sluiced fly ash and bottom ash until 1985 when the Boothe system was put into operation.

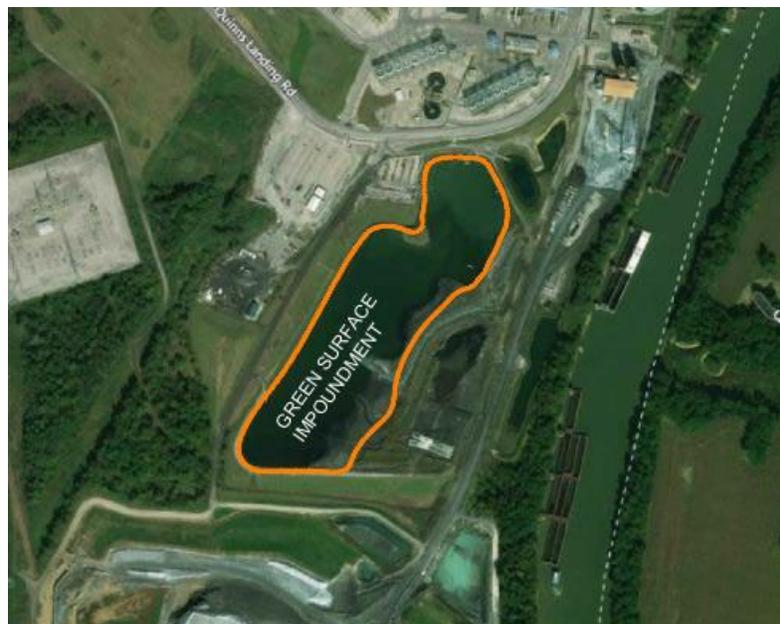
Figure 1: Green CCR Surface Impoundment Aerial Photograph

The Green CCR Surface Impoundment consists of an earthen embankment to the south, and incised on the remaining sides. The south embankment has a maximum height of 19.5 feet. The middle of the south embankment was constructed on a ridge and the toe of the embankment was previously a drainage area.
