D.B. Wilson Phase II CCR Landfill

Disposal of Coal Combustion Residuals (CCR) from Electric
Utilities Final Rule
CCR Phase II Landfill 2018 Annual Inspection Report

Big Rivers Electric Corporation

January 11, 2019

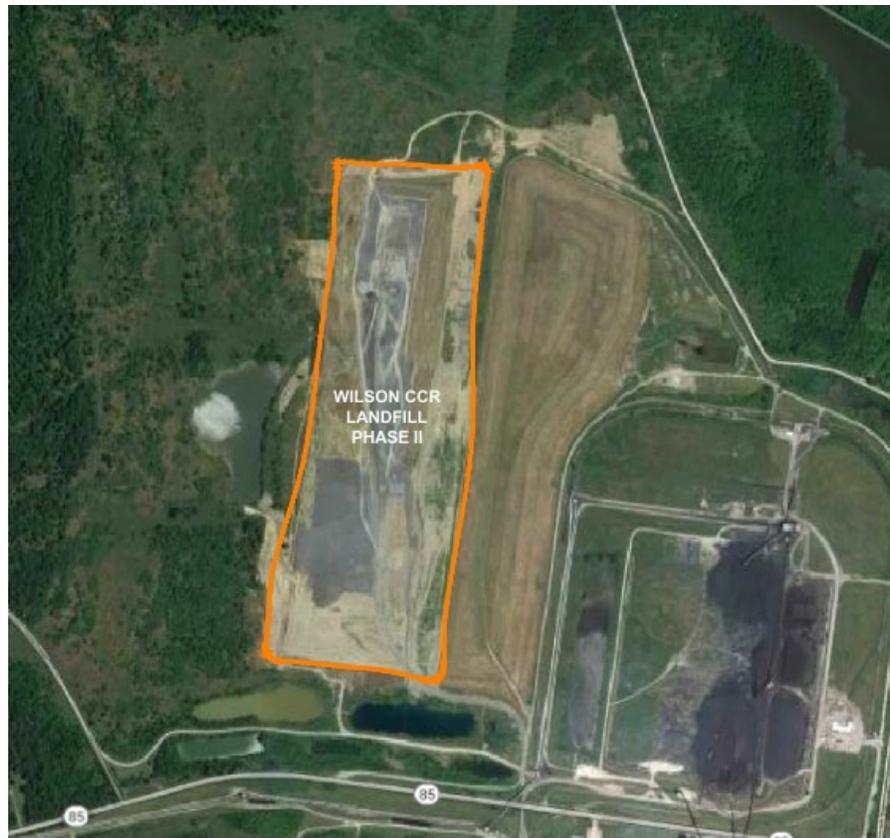
Figure 1: D.B. Wilson Phase II CCR Landfill Aerial Photograph

Changes to the landfill geometry since the previous 2017 annual inspection includes placement of additional CCR, protective cover soils and establishing vegetation on the landfill.
