Green CCR Landfill

Disposal of Coal Combustion Residuals (CCR) from Electric
Utilities Final Rule
CCR Landfill 2018 Annual Inspection Report

Big Rivers Electric Corporation

January 11, 2019

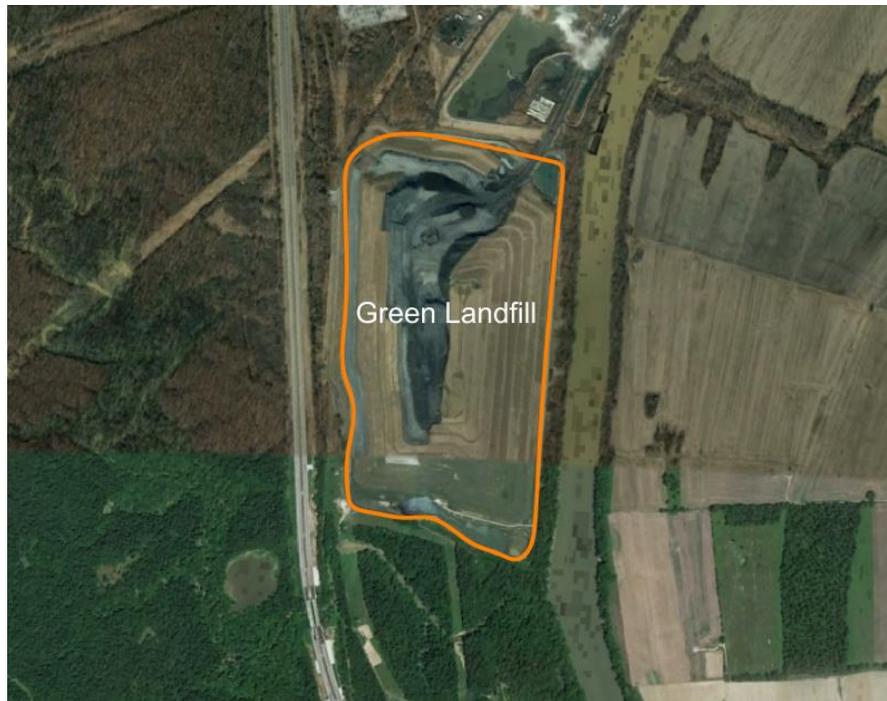
Figure 1: Big Rivers Green Landfill Overview

The Green CCR Landfill is used for the placement of coal combustion residual (CCR) material including primarily Poz-O-Tec and related materials. The landfill has a maximum elevation of approximately 608 feet above mean sea level (MSL). The Green river lies to the east of the landfill and Groves Creek lies to the south of the landfill. The landfill has approximately 7 continuous benches on the south and east side, each higher in elevation until the top of landfill is reached. The north and west sides of the landfill are receiving CCR placement as part of BREC operations. An aerial photograph of the Green CCR Landfill is presented on the next page in Figure 1.

Changes to the landfill geometry since the previous 2017 annual inspection includes placement of additional CCR, protective cover soils and establishing vegetation on the landfill.
