# D.B. Wilson Phase II CCR Landfill

Disposal of Coal Combustion Residuals (CCR) from Electric  
Utilities Final Rule  
CCR Phase II Landfill 2019 Annual Inspection Report

Project number: 60613510

January 10, 2020

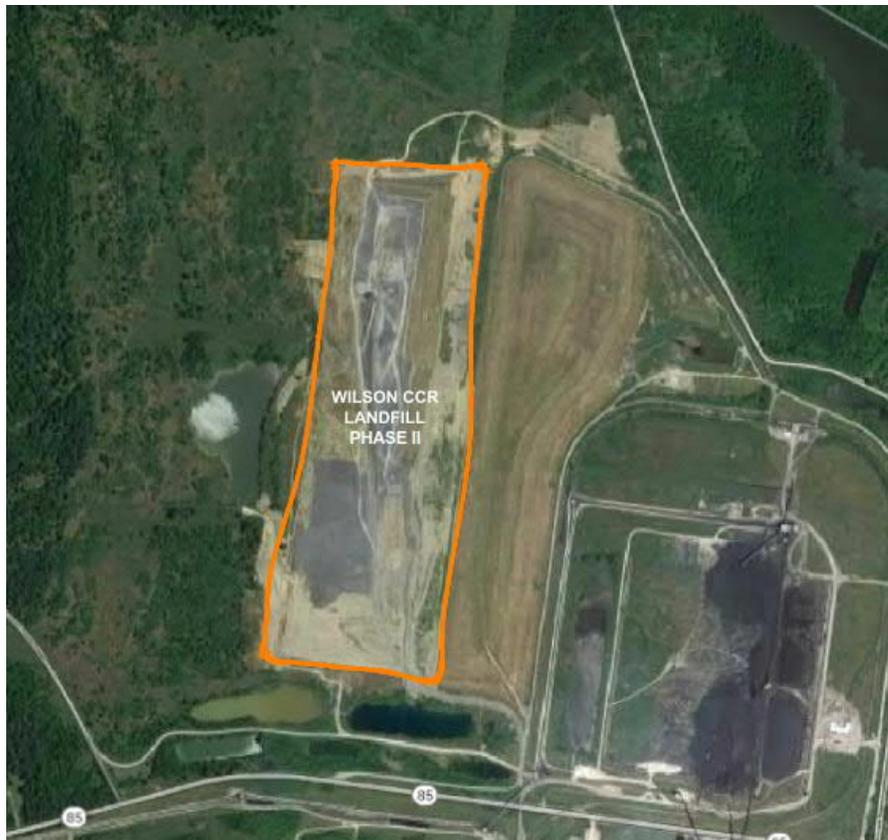
**Figure 1: D.B. Wilson Phase II CCR Landfill Aerial Photograph**

Changes to the landfill geometry since the 2018 annual inspection includes placement of additional CCR, protective cover soils and establishing vegetation on the landfill.
