## Green CCR Landfill

Disposal of Coal Combustion Residuals (CCR) from Electric  
Utilities Final Rule  
CCR Landfill 2019 Annual Inspection Report

**Big Rivers Electric Corporation**

January 10, 2020

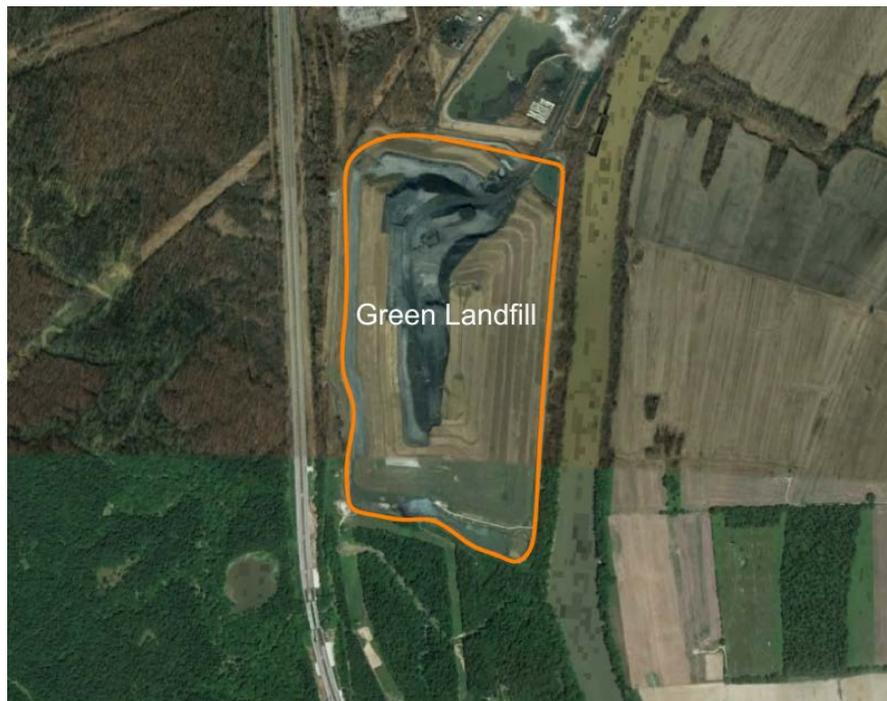
**Figure 1: Big Rivers Green Landfill Overview**

The Green CCR Landfill is used for the placement of coal combustion residual (CCR) material including primarily Poz-O-Tec and related materials. The landfill has a maximum elevation of approximately 606 feet above mean sea level (MSL), based on a topographic survey conducted by Associated Engineers in September 2019. The Green River lies to the east of the landfill and Groves Creek lies to the south of the landfill. The landfill has approximately 7 continuous benches on the south and east side, each higher in elevation until the top of landfill is reached. The north and west sides of the landfill are receiving CCR placement as part of BREC operations. An aerial photograph of the Green CCR Landfill is presented on the next page in Figure 1.

Changes to the landfill geometry since the previous 2018 annual inspection includes placement of additional CCR, protective cover soils and establishing vegetation on the landfill.
