D.B. Wilson Phase II CCR Landfill

January 05, 2022

Project ID: 22-0233

Big Rivers Electric Corporation
Disposal of Coal Combustion Residuals (CCR) from Electric Utilities Final Rule
CCR Landfill 2022 Annual Inspection Report

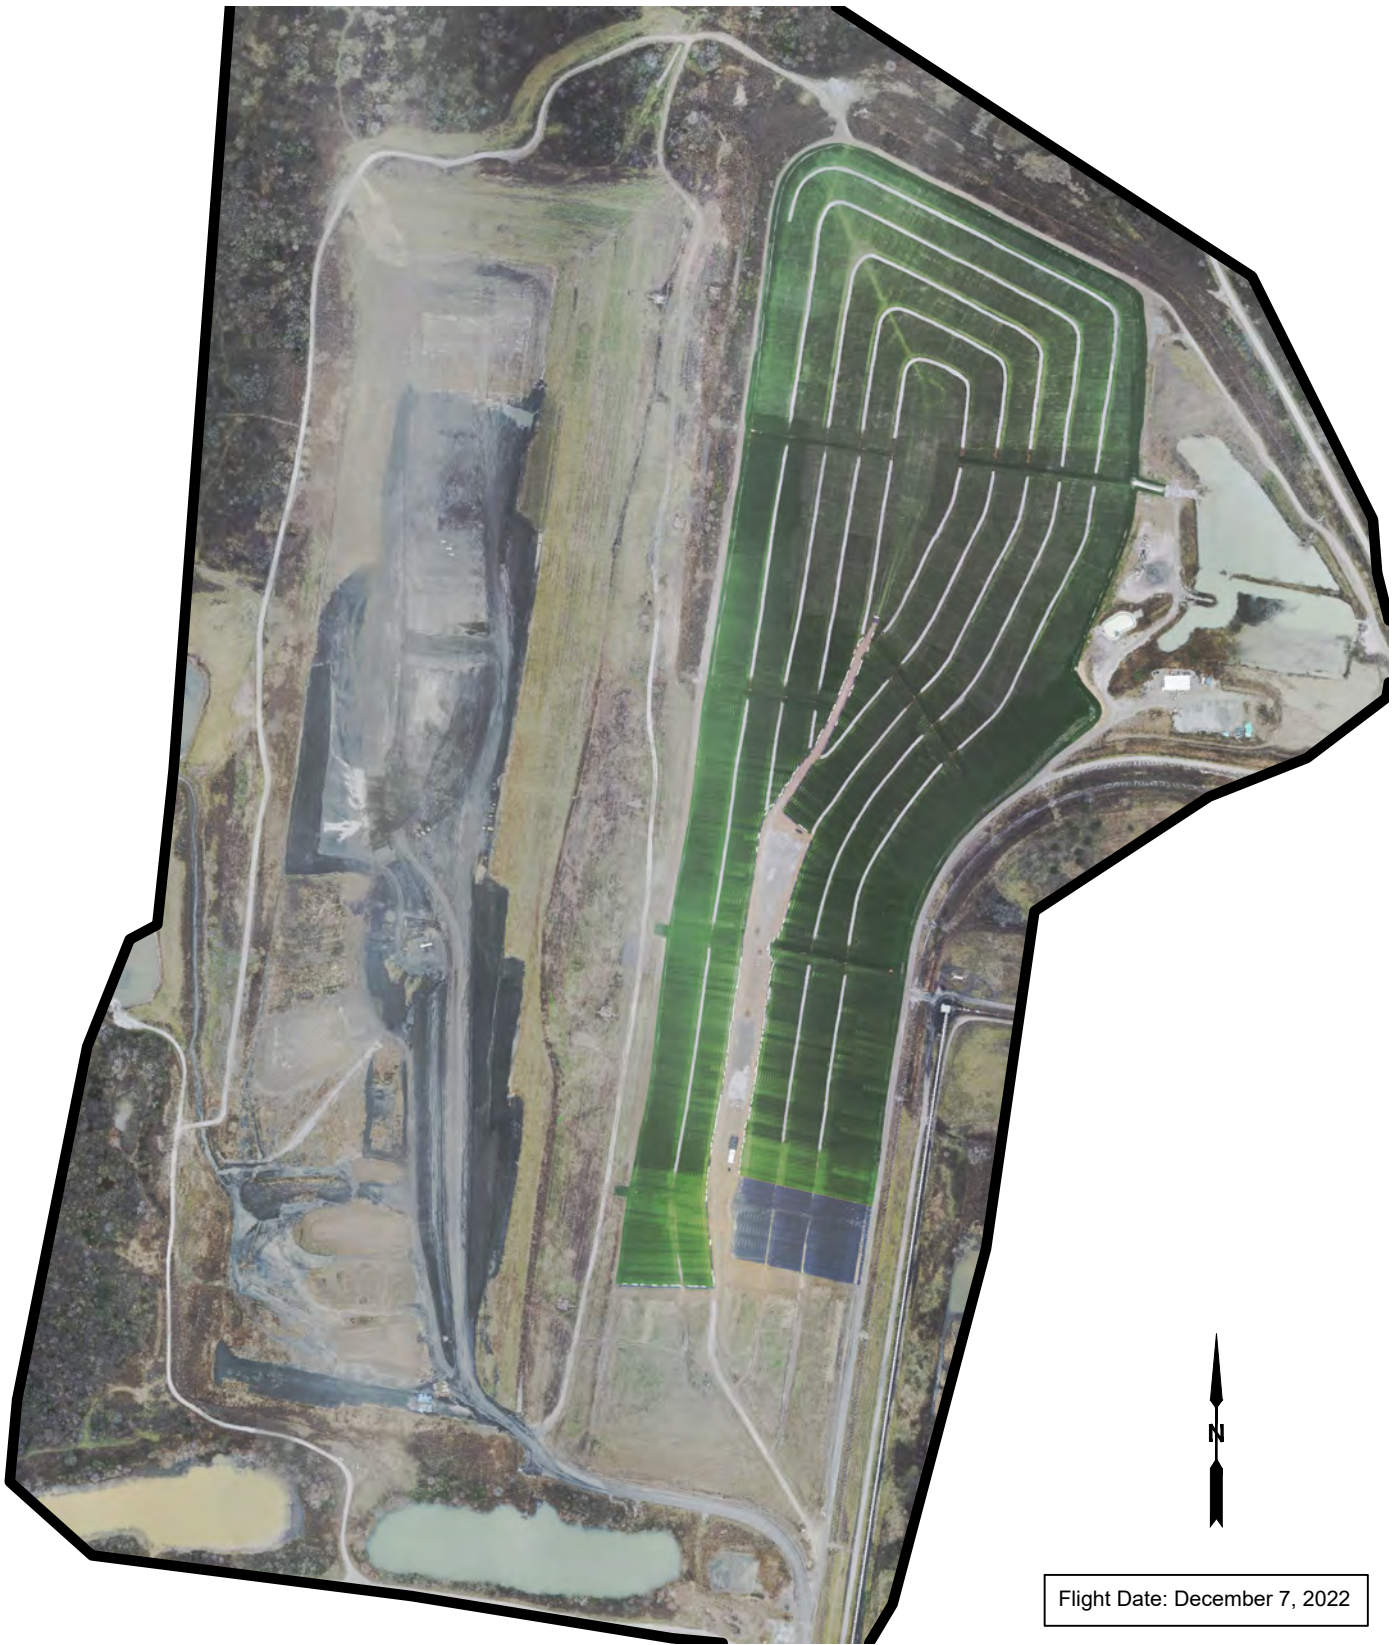
DB Wilson CCR Landfill
 2022 Annual Inspection Aerial Photo

The total volume of CCR material contained in the D.B. Wilson CCR Landfill was estimated to be 3.957 million cubic yards. This volume was calculated from available baseline topography compared to December 7, 2022 aerial Lidar surveyed topographic contours.
