## **D.B. Wilson Phase II CCR Landfill**

### **Disposal of Coal Combustion Residuals (CCR) from Electric Utilities Final Rule CCR Landfill 2023 Annual Inspection Report**

**December 29, 2023**

**Project ID: 23-0163**

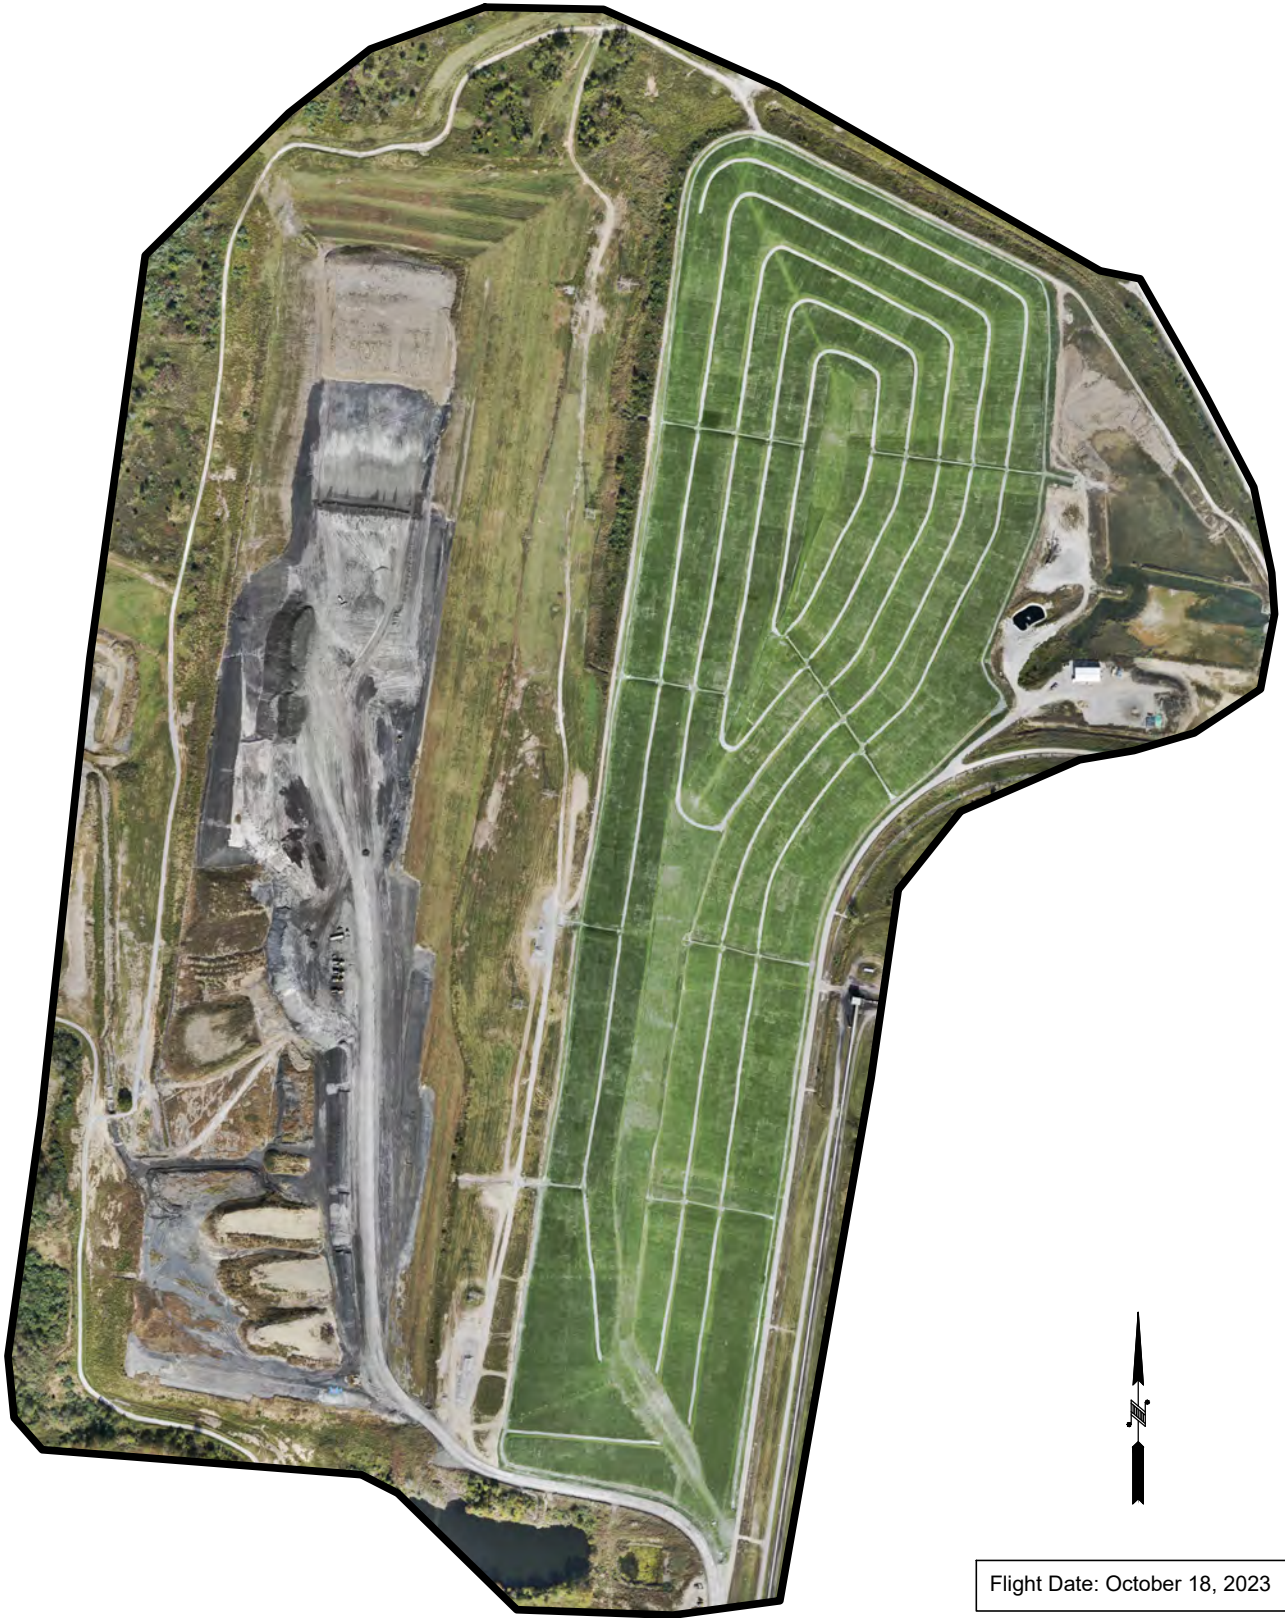
DB Wilson CCR Landfill  
2023 Annual Inspection Aerial Photo

Flight Date: October 18, 2023
