## **Green CCR Landfill**

### **Disposal of Coal Combustion Residuals (CCR) from Electric Utilities Final Rule CCR Landfill 2023 Annual Inspection Report**

**December 29, 2023**

**Project ID: 23-0164**

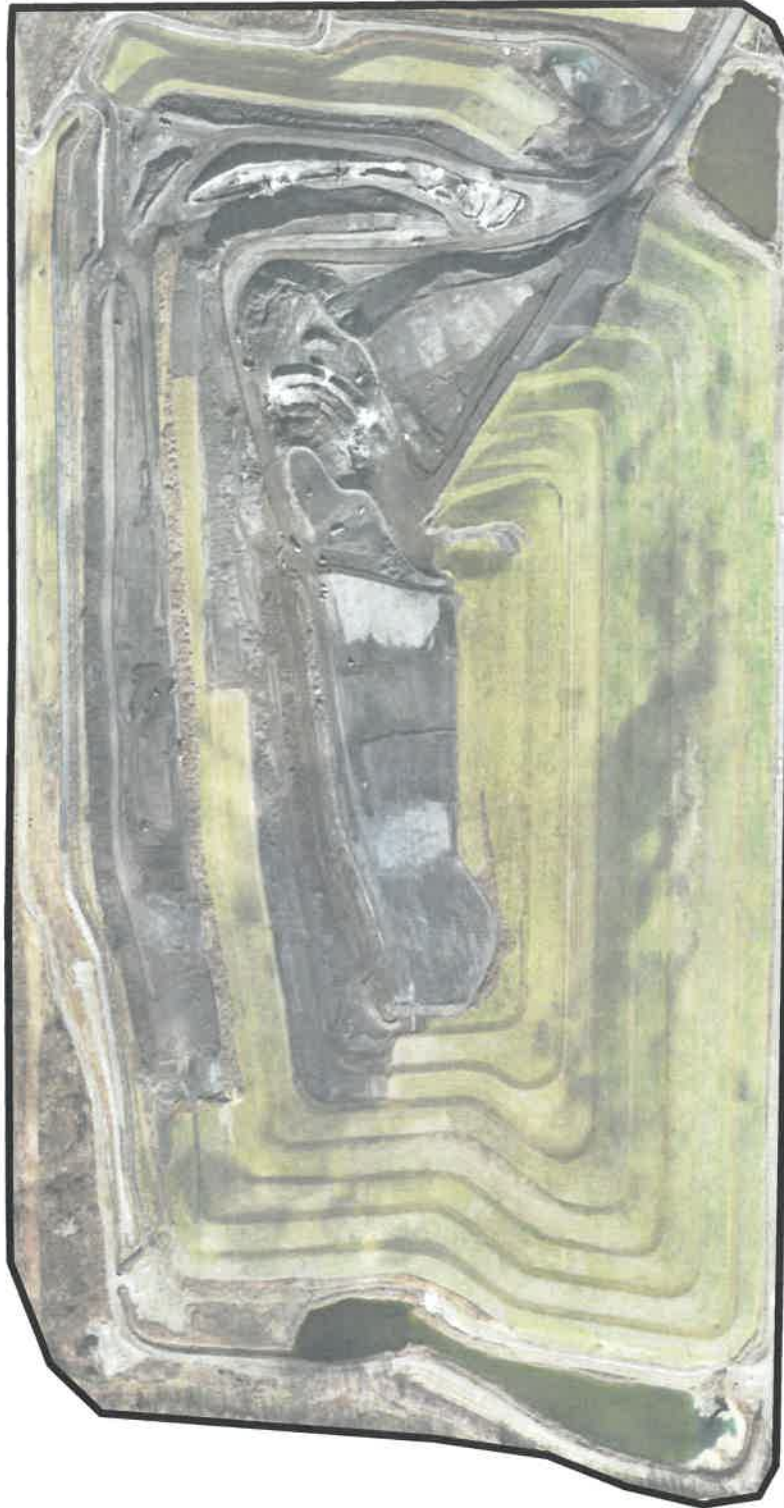
Green CCR Landfill  
2023 Annual Inspection Aerial Photo

The total volume of CCR material contained in the Green CCR Landfill was estimated to be 23.94 million cubic yards. This volume was calculated from available baseline topography compared to December 5, 2023 flight derived topographic contours.
