Ash Pond A Legacy CCR Impoundment

Disposal of Coal Combustion Residuals (CCR) from Electric Utilities Final Rule Legacy CCR Impoundment 2026 Annual Inspection Report

February 6, 2026

Big Rivers Electric Corporation
Disposal of Coal Combustion Residuals (CCR) from Electric Utilities Final Rule
Legacy CCR Impoundment 2026 Annual Inspection Report

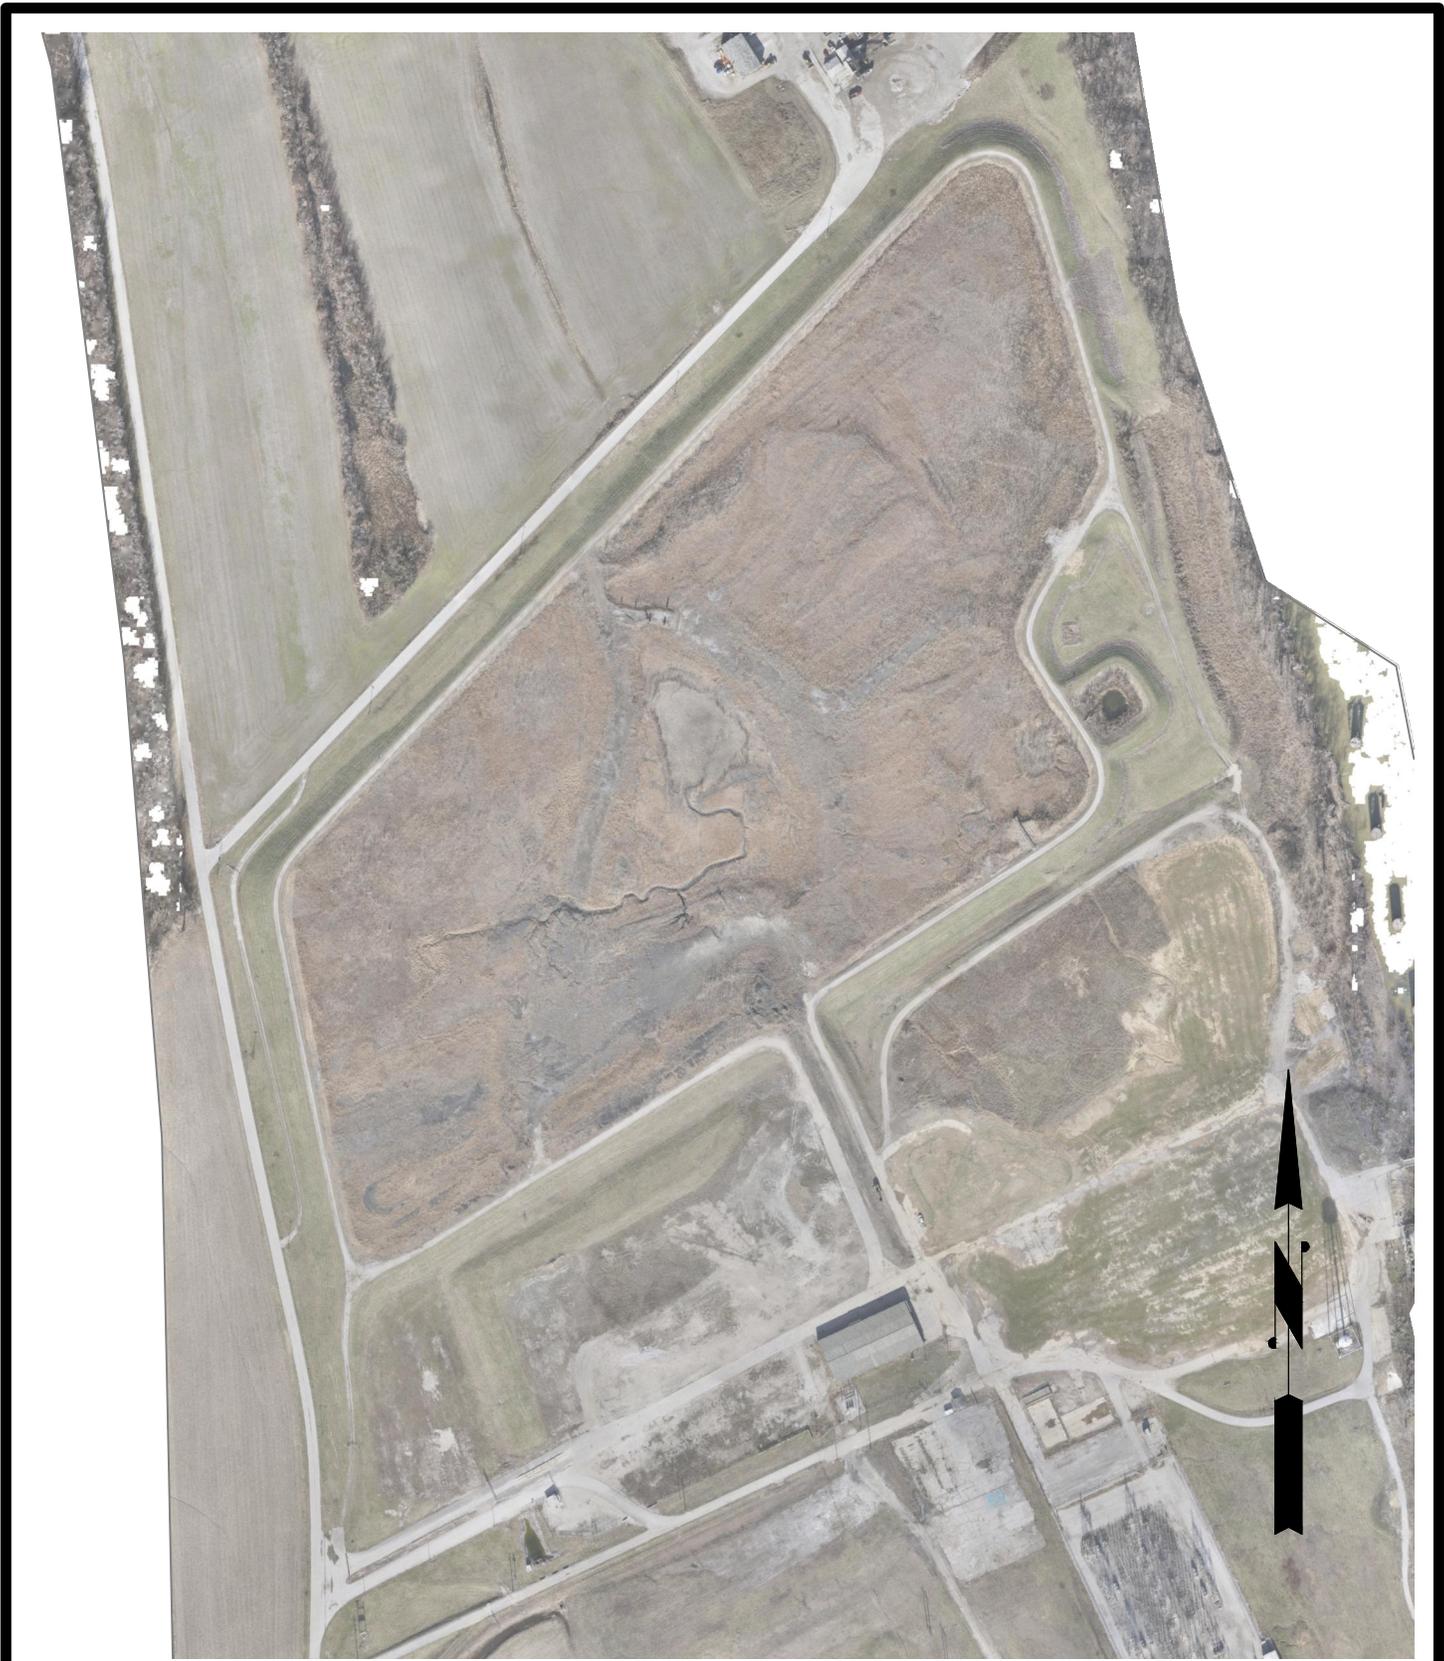
Coleman Facility, Hawesville, Kentucky
Pond A Inspection Map

The pond has been dewatered and graded to the extent that the dam no longer impounds water. The inspection consisted of a visual assessment of the surface impoundment, embankments and out of service discharge; and began along the east embankment on the access road. The access road is adequately rocked and maintained. The upstream slope had adequate stone cover. The downstream slope was well vegetated with only minor mower wheel tracking present. The open channel spillway was well rocked and clean of overgrown vegetation.

The north embankment crest was well maintained. The downstream slope was well vegetated and well maintained with only minor mower wheel tracking present. The upstream slope had adequate stone cover.

The west embankment crest was well maintained. The downstream slope was well vegetated and well maintained with a few areas of minor mower wheel tracking present. The upstream slope had adequate stone and vegetative cover.

The south embankment crest was well maintained. The downstream slope was well vegetated and well maintained. The upstream slope had adequate stone and vegetative cover.

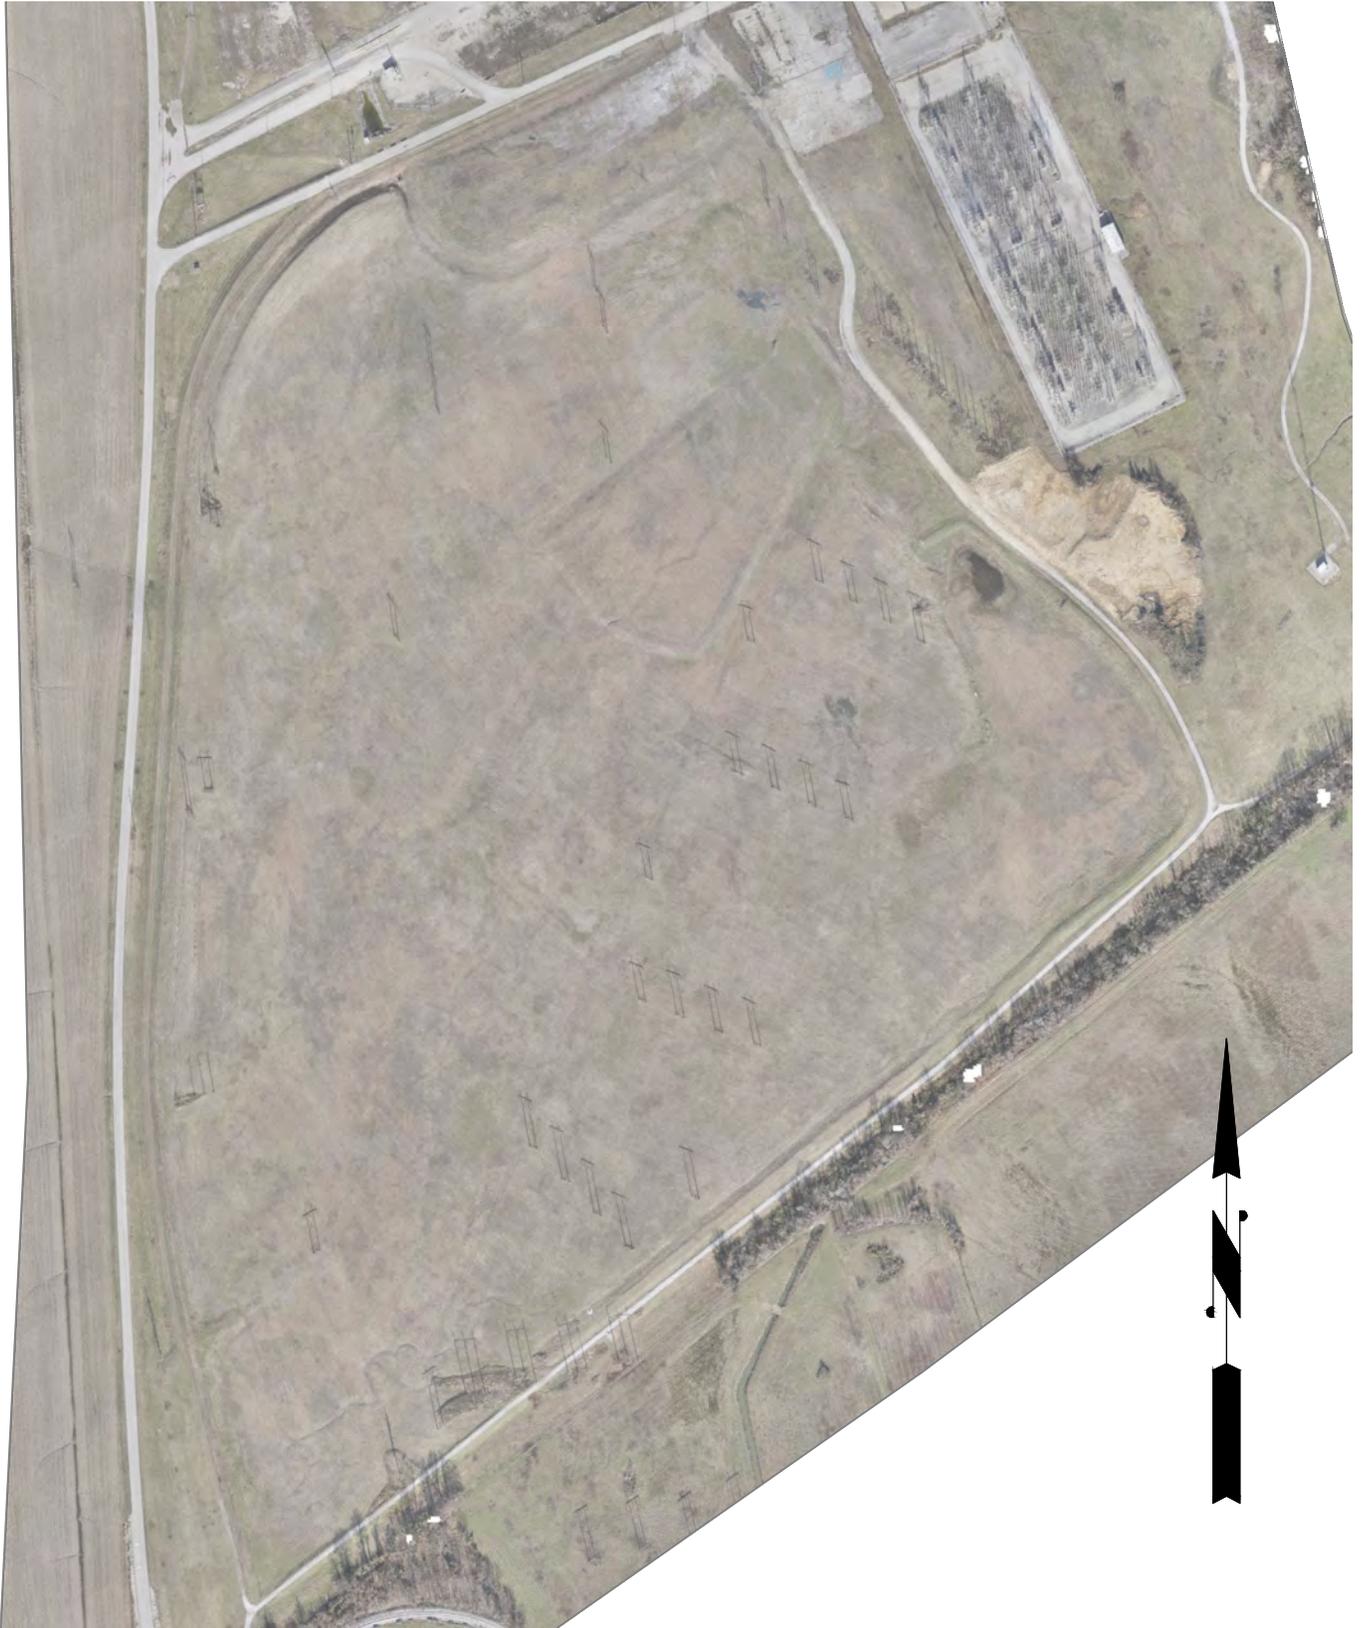
Coleman Facility, Hawesville, Kentucky
Pond C Inspection Map

The pond has been dewatered, graded, and capped; the dam no longer impounds water. The inspection consisted of a visual assessment of the surface impoundment, embankments and out of service discharge; and began along the south embankment on the access road. The access road is adequately rocked and maintained. The upstream embankment slope was well vegetated and maintained. The downstream slope was well vegetated and maintained. The decant pipe inlet was clear of vegetation with no observable damage. The decant pipe valve has been closed, the T handle is missing from the valve mechanism.

The west embankment crest was well maintained. The downstream slope was well vegetated and well maintained with only minor mower wheel tracking present. The upstream slope was well vegetated and maintained.

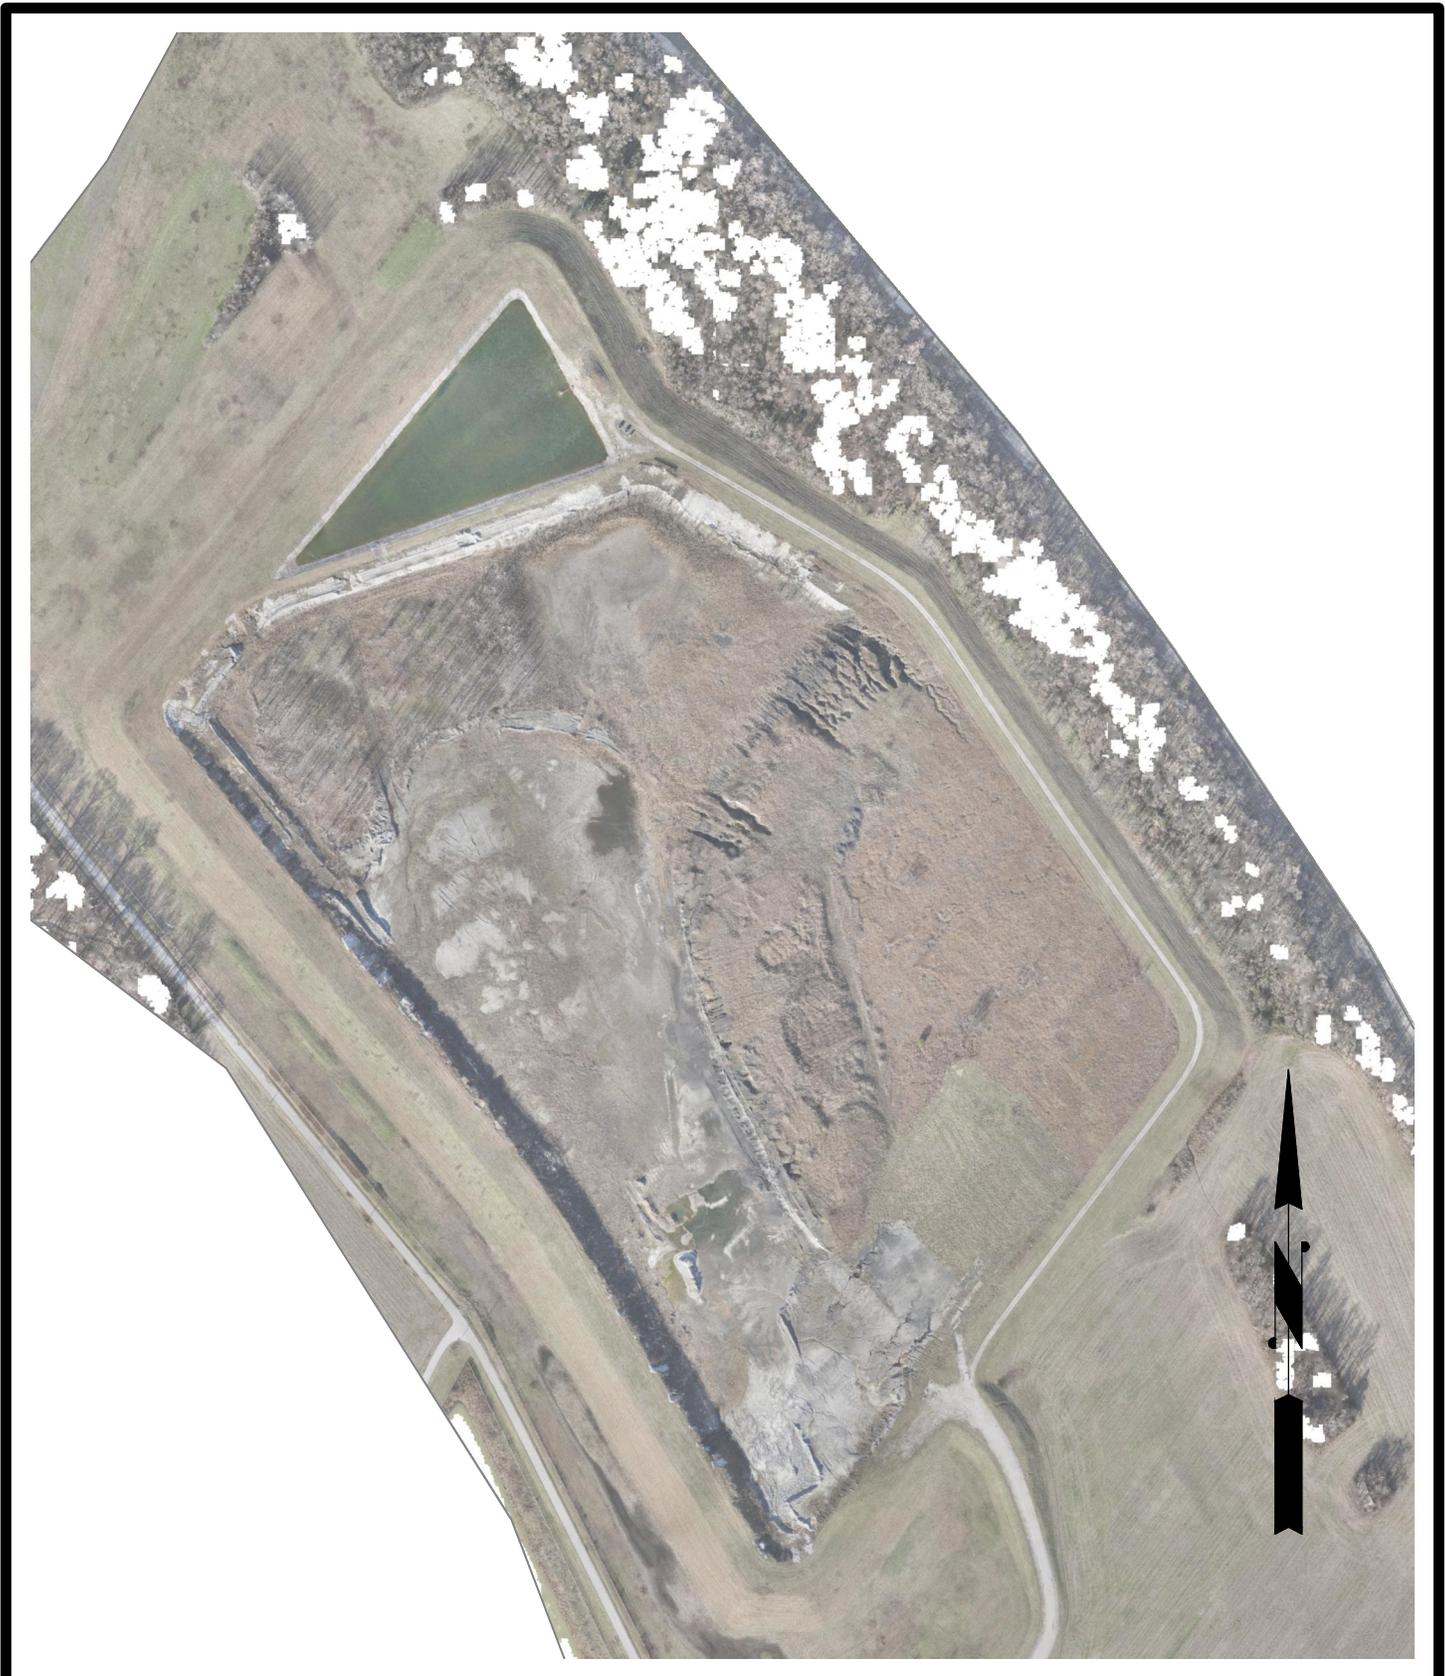
Coleman Facility, Hawesville, Kentucky
Pond D Inspection Map

The inspection found that there were no appearances of an actual or potential structural weakness of the CCR unit, and no existing conditions that would result in the degradation of safety of the CCR unit and appurtenant structures.
