Green CCR Landfill

Disposal of Coal Combustion Residuals (CCR) from Electric Utilities Final Rule CCR Landfill 2024 Annual Inspection Report

December 30, 2024

Project ID: 24-0197

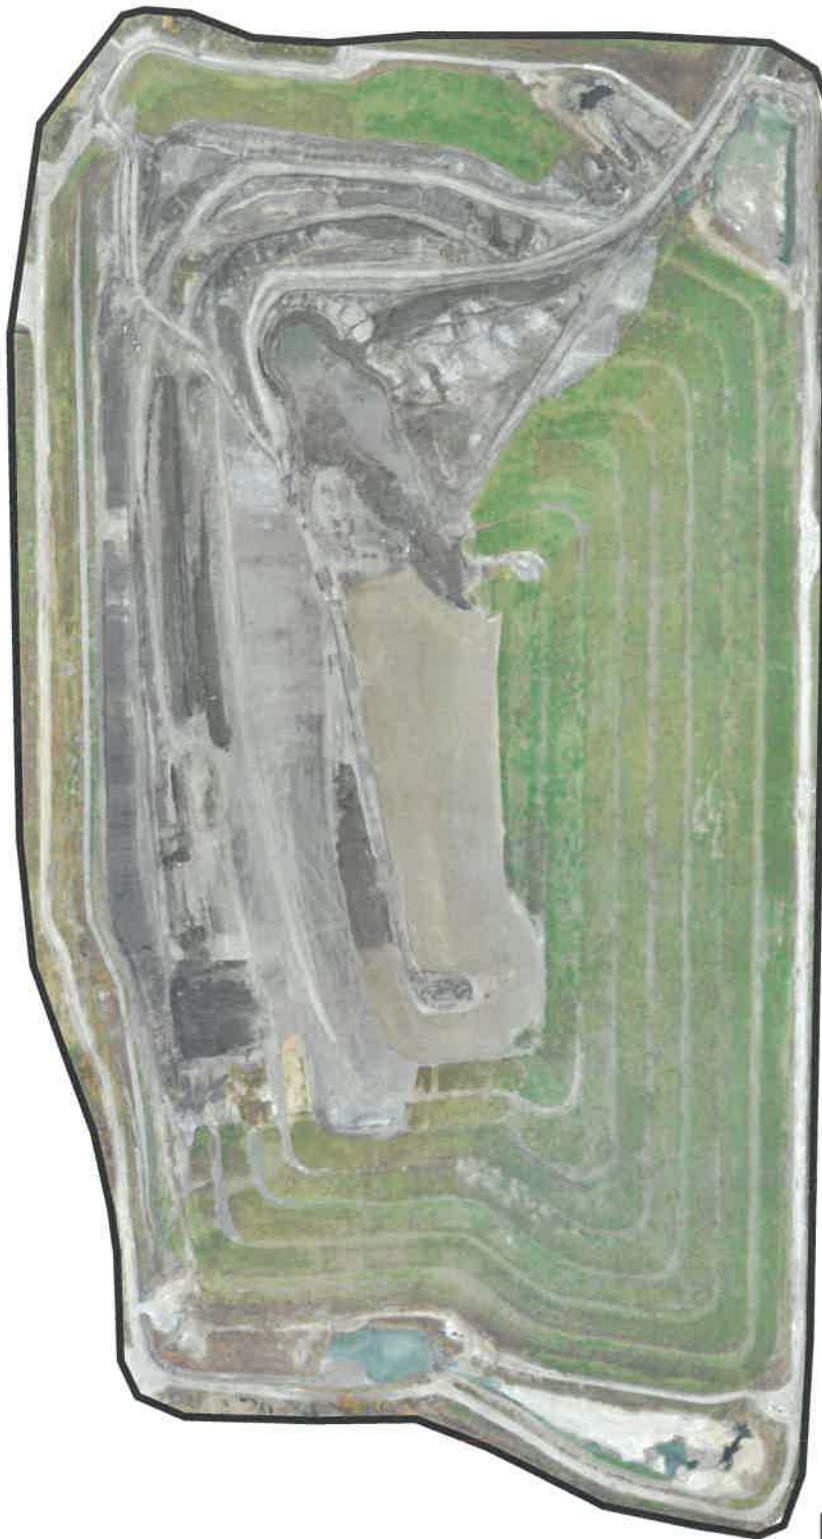
Green CCR Landfill
2024 Annual Inspection Aerial Photo

The total volume of CCR material contained in the Green CCR Landfill was estimated to be 24.69 million cubic yards. This volume was calculated from available baseline topography compared to November 4, 2024 flight derived topographic contours.
