Ash Pond A Legacy CCR Impoundment

Disposal of Coal Combustion Residuals (CCR) from Electric Utilities Final Rule Legacy CCR Impoundment 2025 Annual Inspection Report

February 6, 2025

Project ID: 25-0007

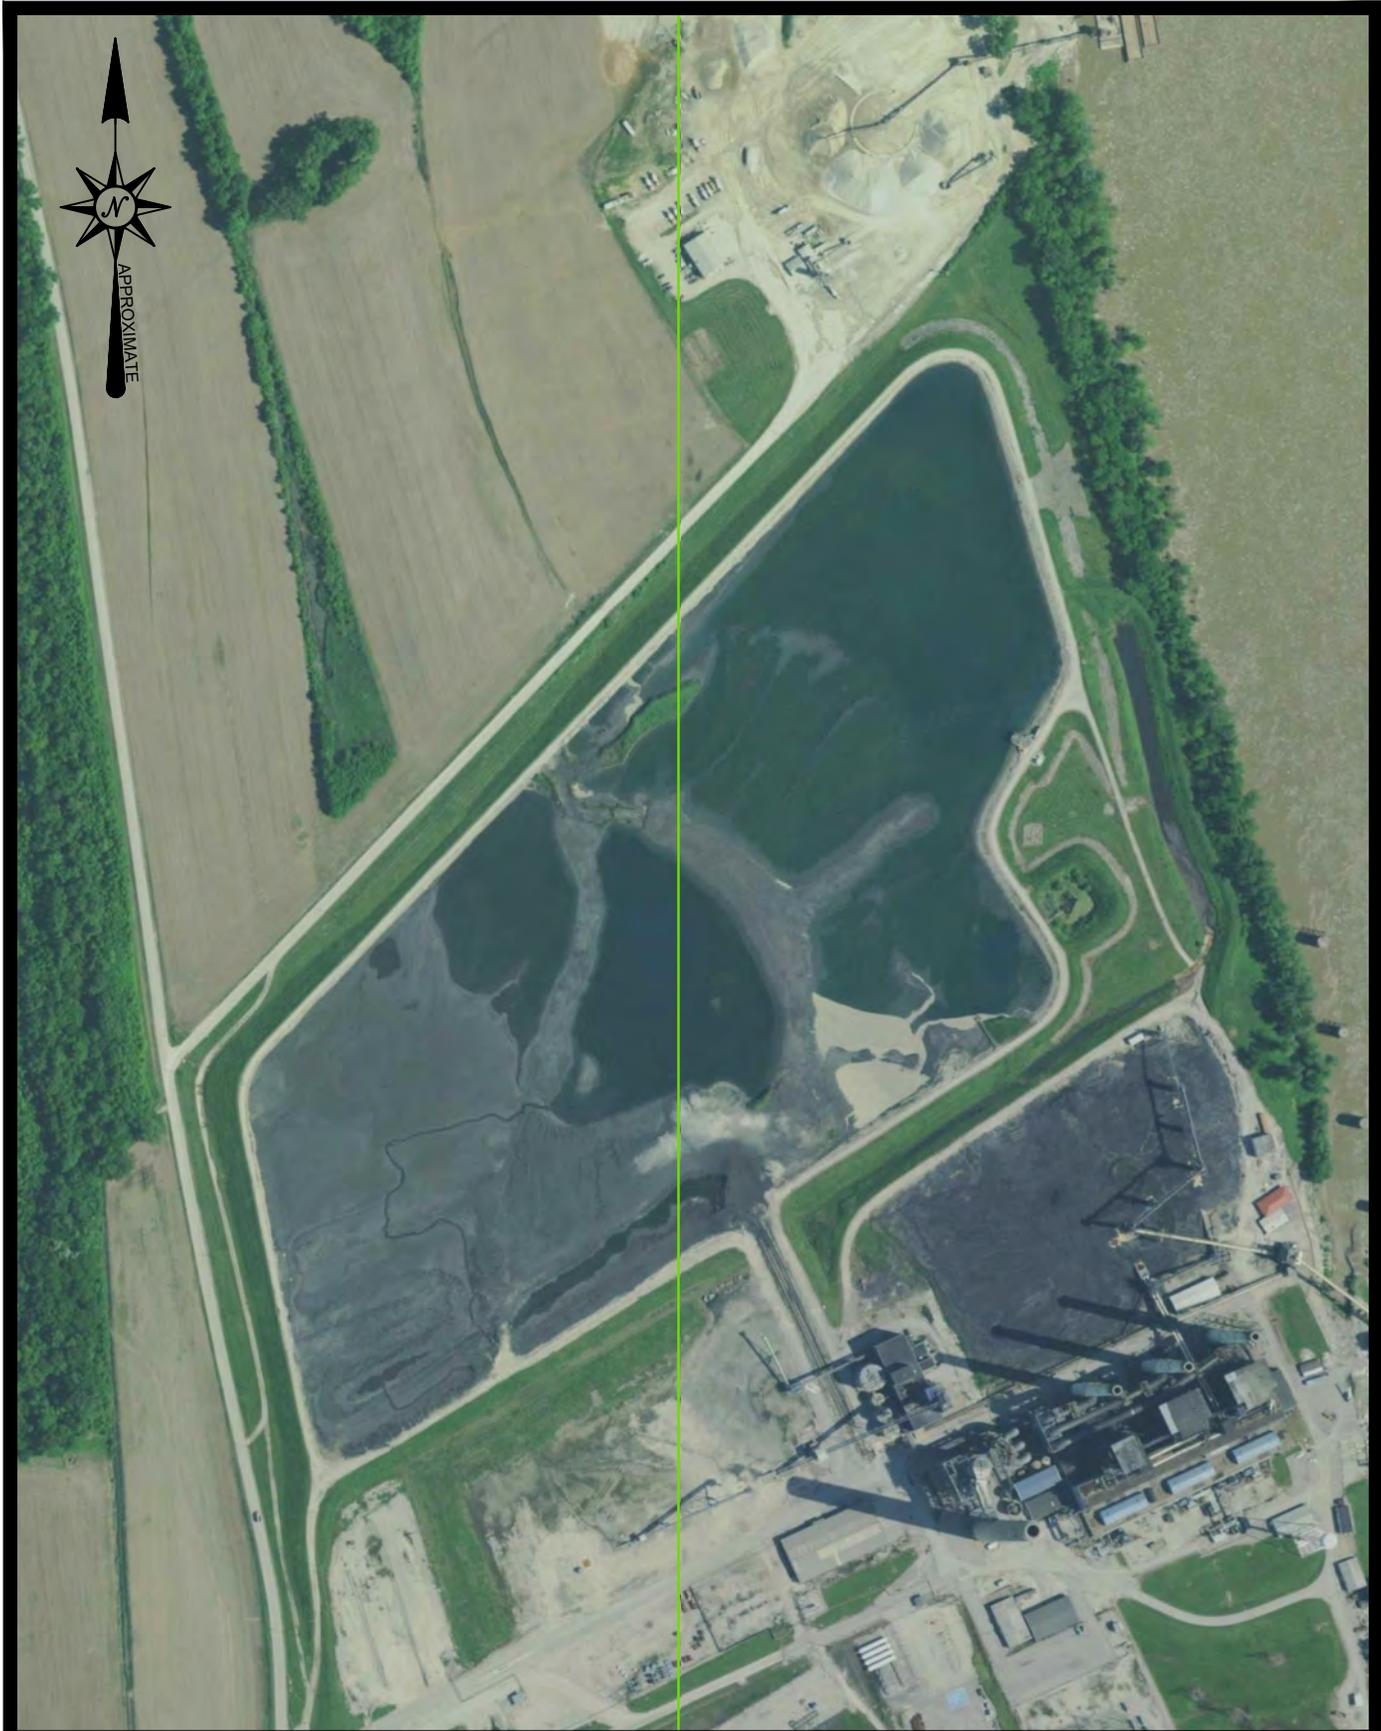
Inspection Map

The pond has been dewatered and excavated to the extent that the dam no longer impounds water or CCR. The inspection consisted of a visual assessment of the surface impoundment, embankments and out of service discharge; and began along the east embankment on the access road. The access road is adequately rocked and maintained. The upstream slope had adequate stone cover. The downstream slope was well vegetated with only minor mower wheel tracking present. The open channel spillway was well rocked and clean of overgrown vegetation.

The north embankment crest was well maintained. The downstream slope was well vegetated and well maintained with only minor mower wheel tracking present. The upstream slope had adequate stone cover.

The west embankment crest was well maintained. The downstream slope was well vegetated and well maintained with a few areas of minor mower wheel tracking present. The upstream slope had adequate stone cover.

The south embankment crest was well maintained. The downstream slope was well vegetated and well maintained. The upstream slope had adequate stone cover.

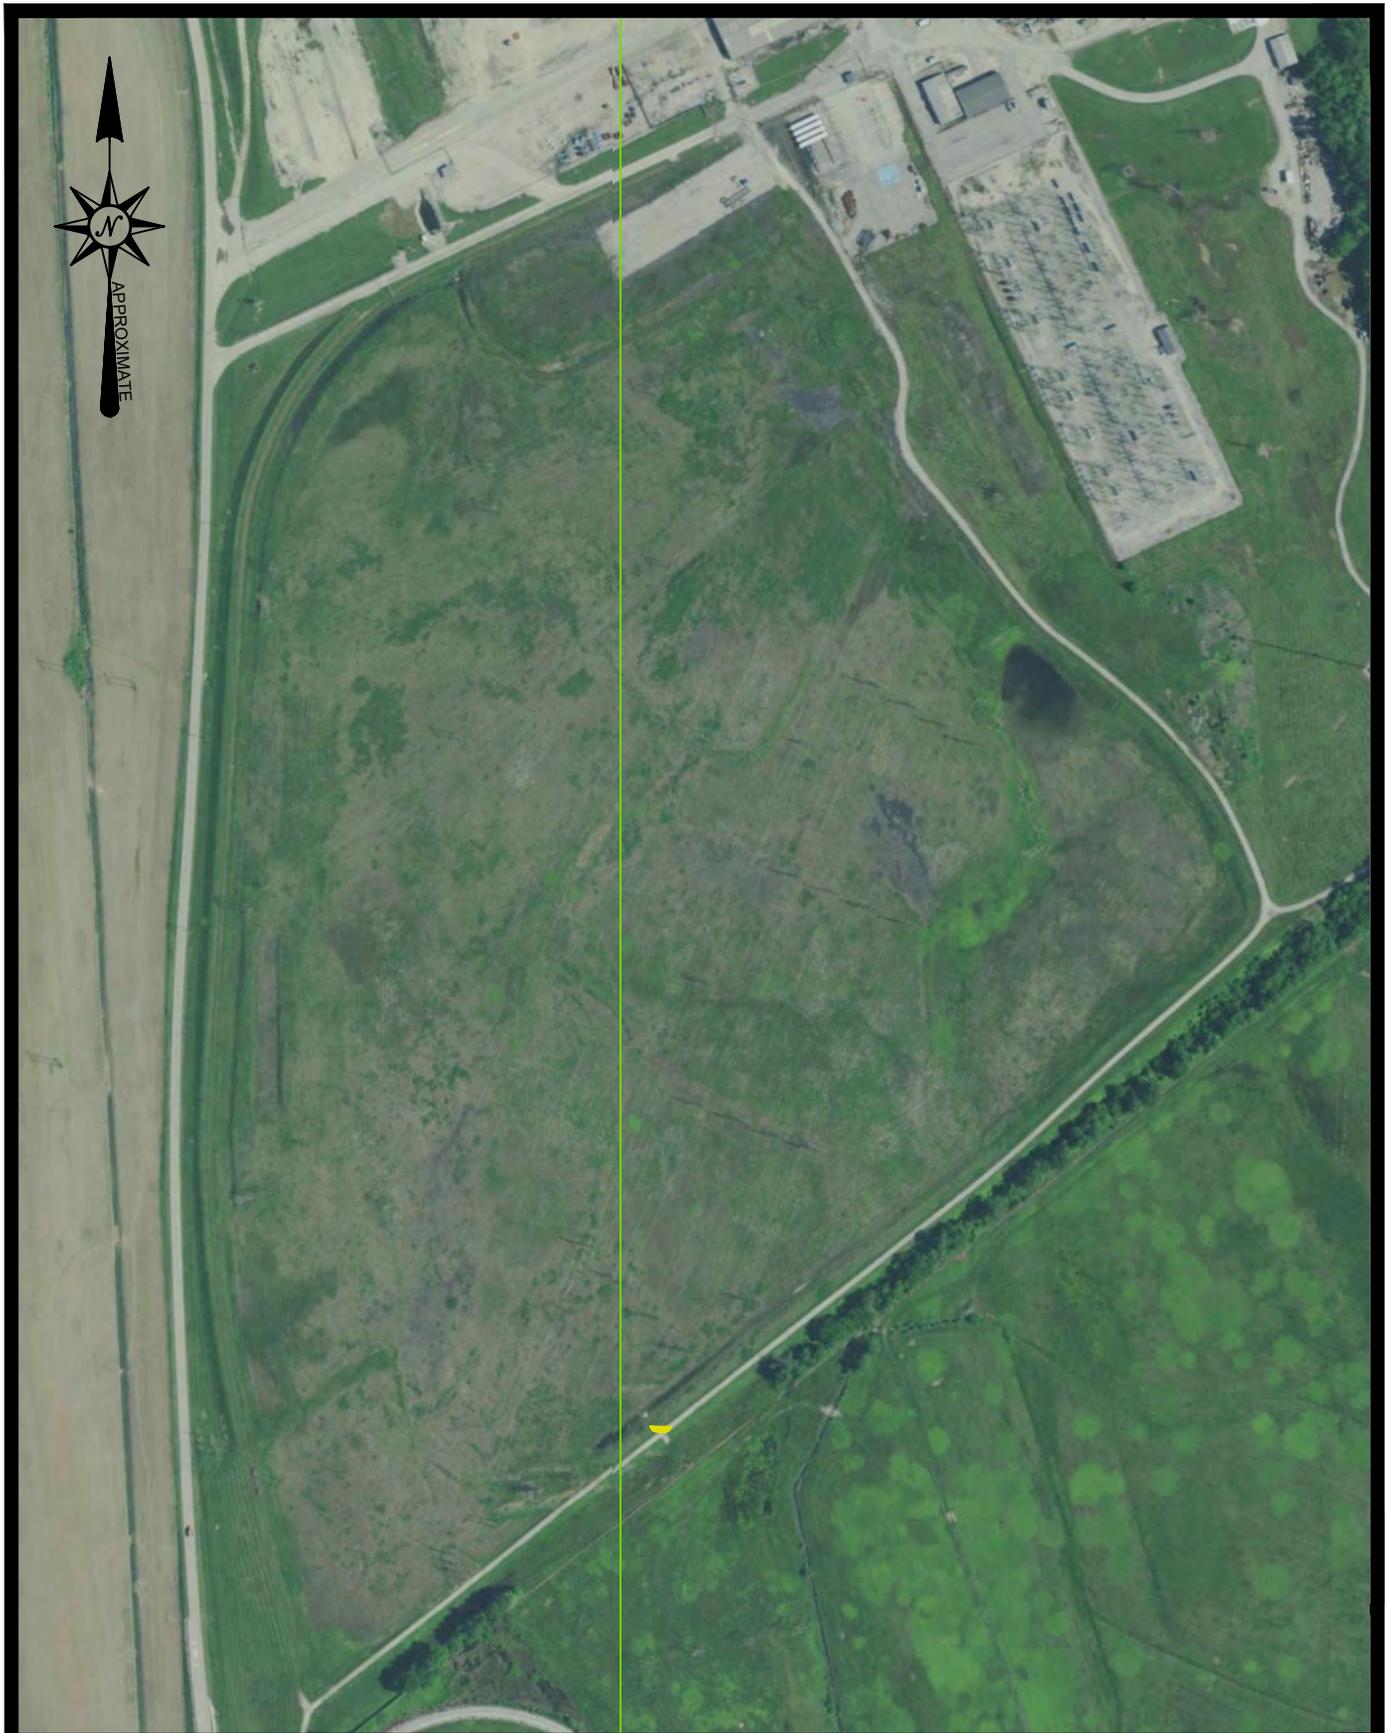
Inspection Map

The pond has been dewatered, excavated, and capped; the dam no longer impounds water or CCR. The inspection consisted of a visual assessment of the surface impoundment, embankments and out of service discharge; and began along the south embankment on the access road. The access road is adequately rocked and maintained. The upstream embankment slope was well vegetated and maintained. The downstream slope was well vegetated and maintained. The decant pipe inlet was clear of vegetation with no observable damage. The decant pipe valve has been closed, the T handle is missing from the valve mechanism. The decant pipe outlet has overgrowth, but not to the extent that a blockage exists.

The west embankment crest was well maintained. The downstream slope was well vegetated and well maintained with only minor mower wheel tracking present. The upstream slope was well vegetated and maintained.

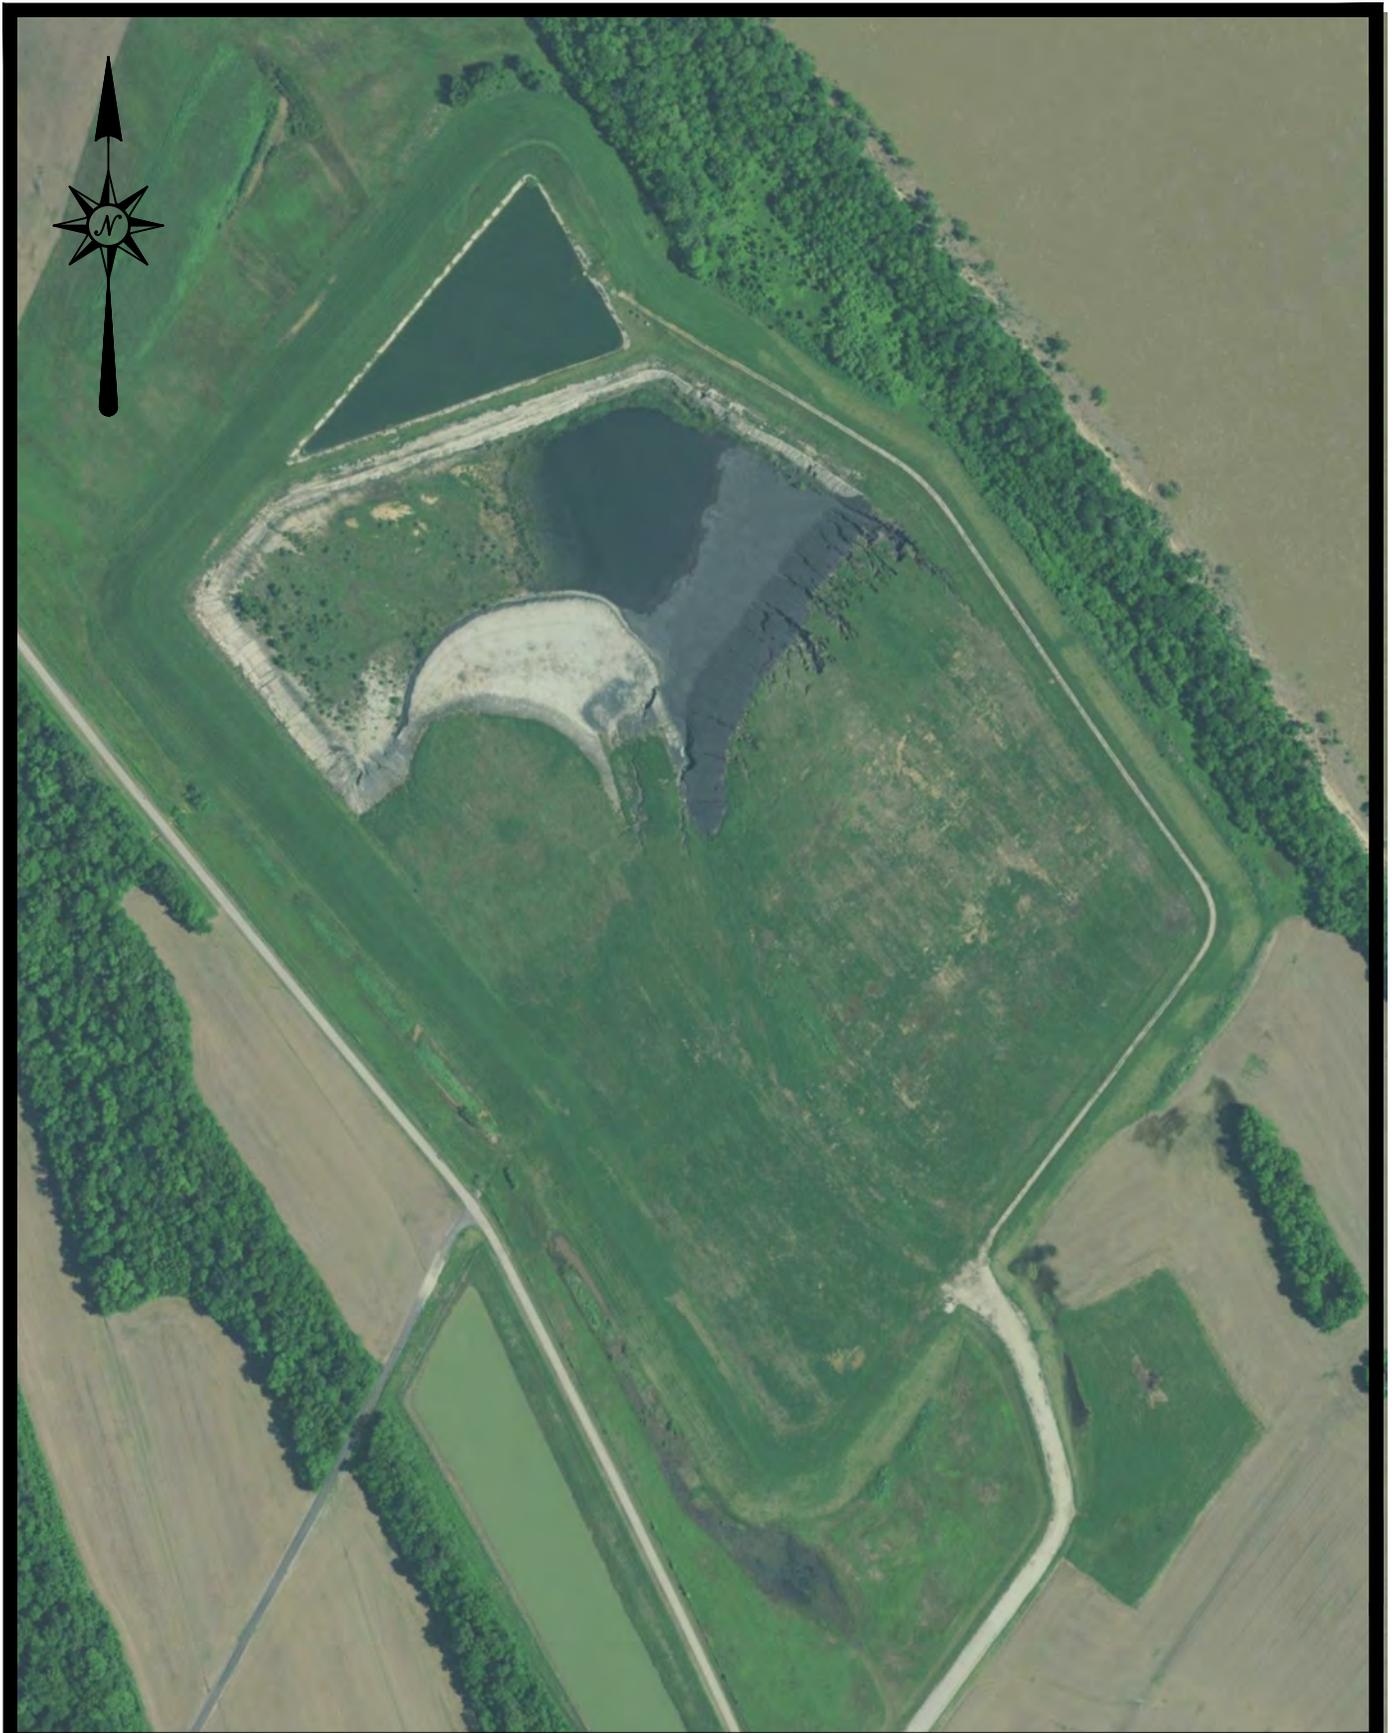
Pond D

The east embankment crest was well maintained. The downstream slope was well vegetated and well maintained with only minor mower wheel tracking present. The upstream slope was vegetated and well maintained. There's some erosion of the CCR housed inside of the pond. The rock along the upstream slope in the freshwater cell of the pond is well maintained. The decant inlet in the freshwater cell of the pond has no visible damage to it. The decant pipe valve has been turned off. The decant outlet is clear of debris and overgrowth and has no visible damage.
