Ash Pond A Legacy CCR Impoundment

Disposal of Coal Combustion Residuals (CCR) from Electric Utilities Final Rule Legacy CCR Impoundment 2025 Annual Inspection Report

February 6, 2025

Big Rivers Electric Corporation
Disposal of Coal Combustion Residuals (CCR) from Electric Utilities Final Rule
Legacy CCR Impoundment 2025 Annual Inspection Report

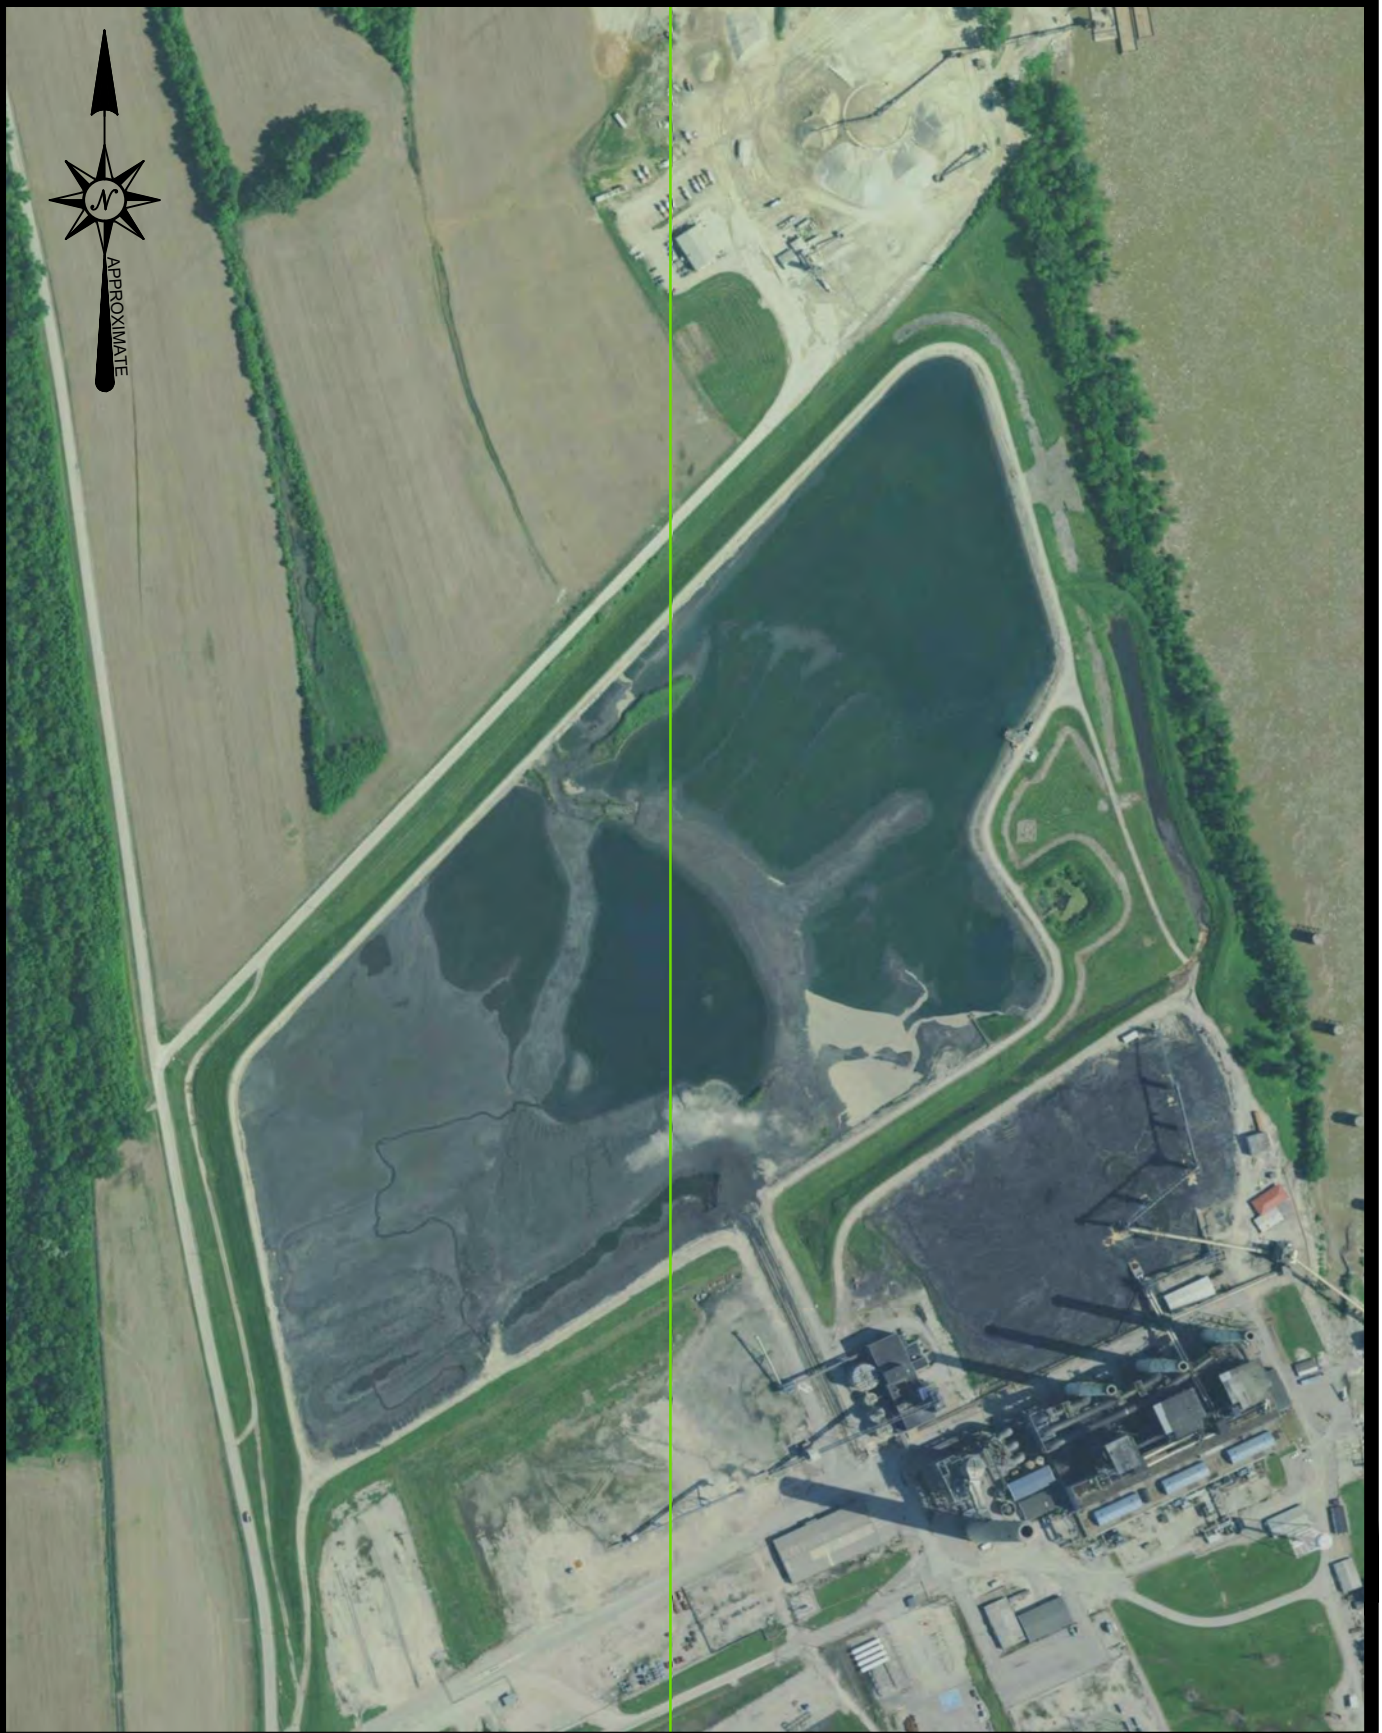
Inspection Map

The pond has been dewatered and excavated to the extent that the dam no longer impounds water or CCR. The inspection consisted of a visual assessment of the surface impoundment, embankments and out of service discharge; and began along the east embankment on the access road. The access road is adequately rocked and maintained. The upstream slope had adequate stone cover. The downstream slope was well vegetated with only minor mower wheel tracking present. The open channel spillway was well rocked and clean of overgrown vegetation.

The north embankment crest was well maintained. The downstream slope was well vegetated and well maintained with only minor mower wheel tracking present. The upstream slope had adequate stone cover.

The west embankment crest was well maintained. The downstream slope was well vegetated and well maintained with a few areas of minor mower wheel tracking present. The upstream slope had adequate stone cover.

The south embankment crest was well maintained. The downstream slope was well vegetated and well maintained. The upstream slope had adequate stone cover.

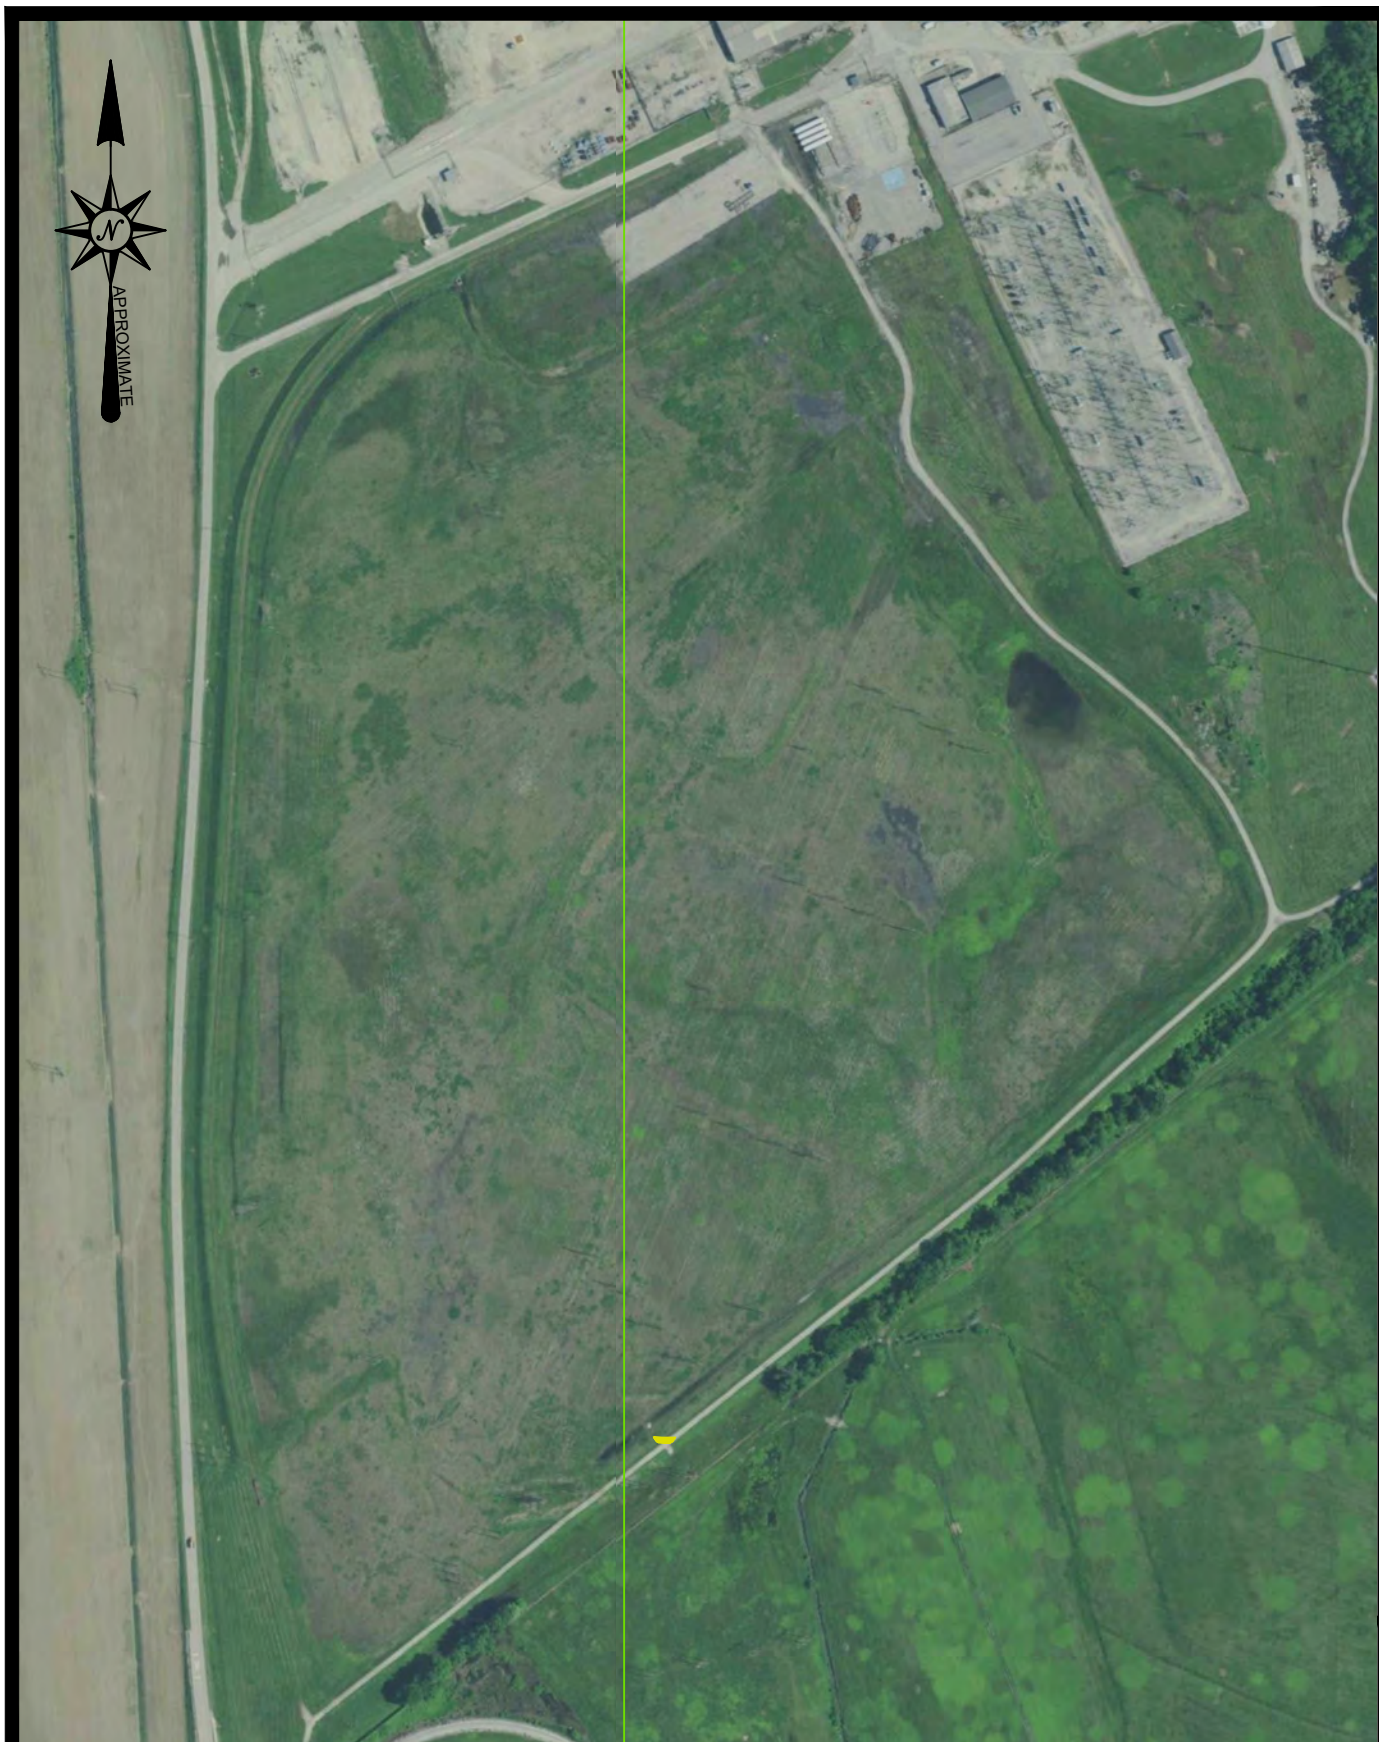
Inspection Map

The pond has been dewatered, excavated, and capped; the dam no longer impounds water or CCR. The inspection consisted of a visual assessment of the surface impoundment, embankments and out of service discharge; and began along the south embankment on the access road. The access road is adequately rocked and maintained. The upstream embankment slope was well vegetated and maintained. The downstream slope was well vegetated and maintained. The decant pipe inlet was clear of vegetation with no observable damage. The decant pipe valve has been closed, the T handle is missing from the valve mechanism. The decant pipe outlet has overgrowth, but not to the extent that a blockage exists.

The west embankment crest was well maintained. The downstream slope was well vegetated and well maintained with only minor mower wheel tracking present. The upstream slope was well vegetated and maintained.

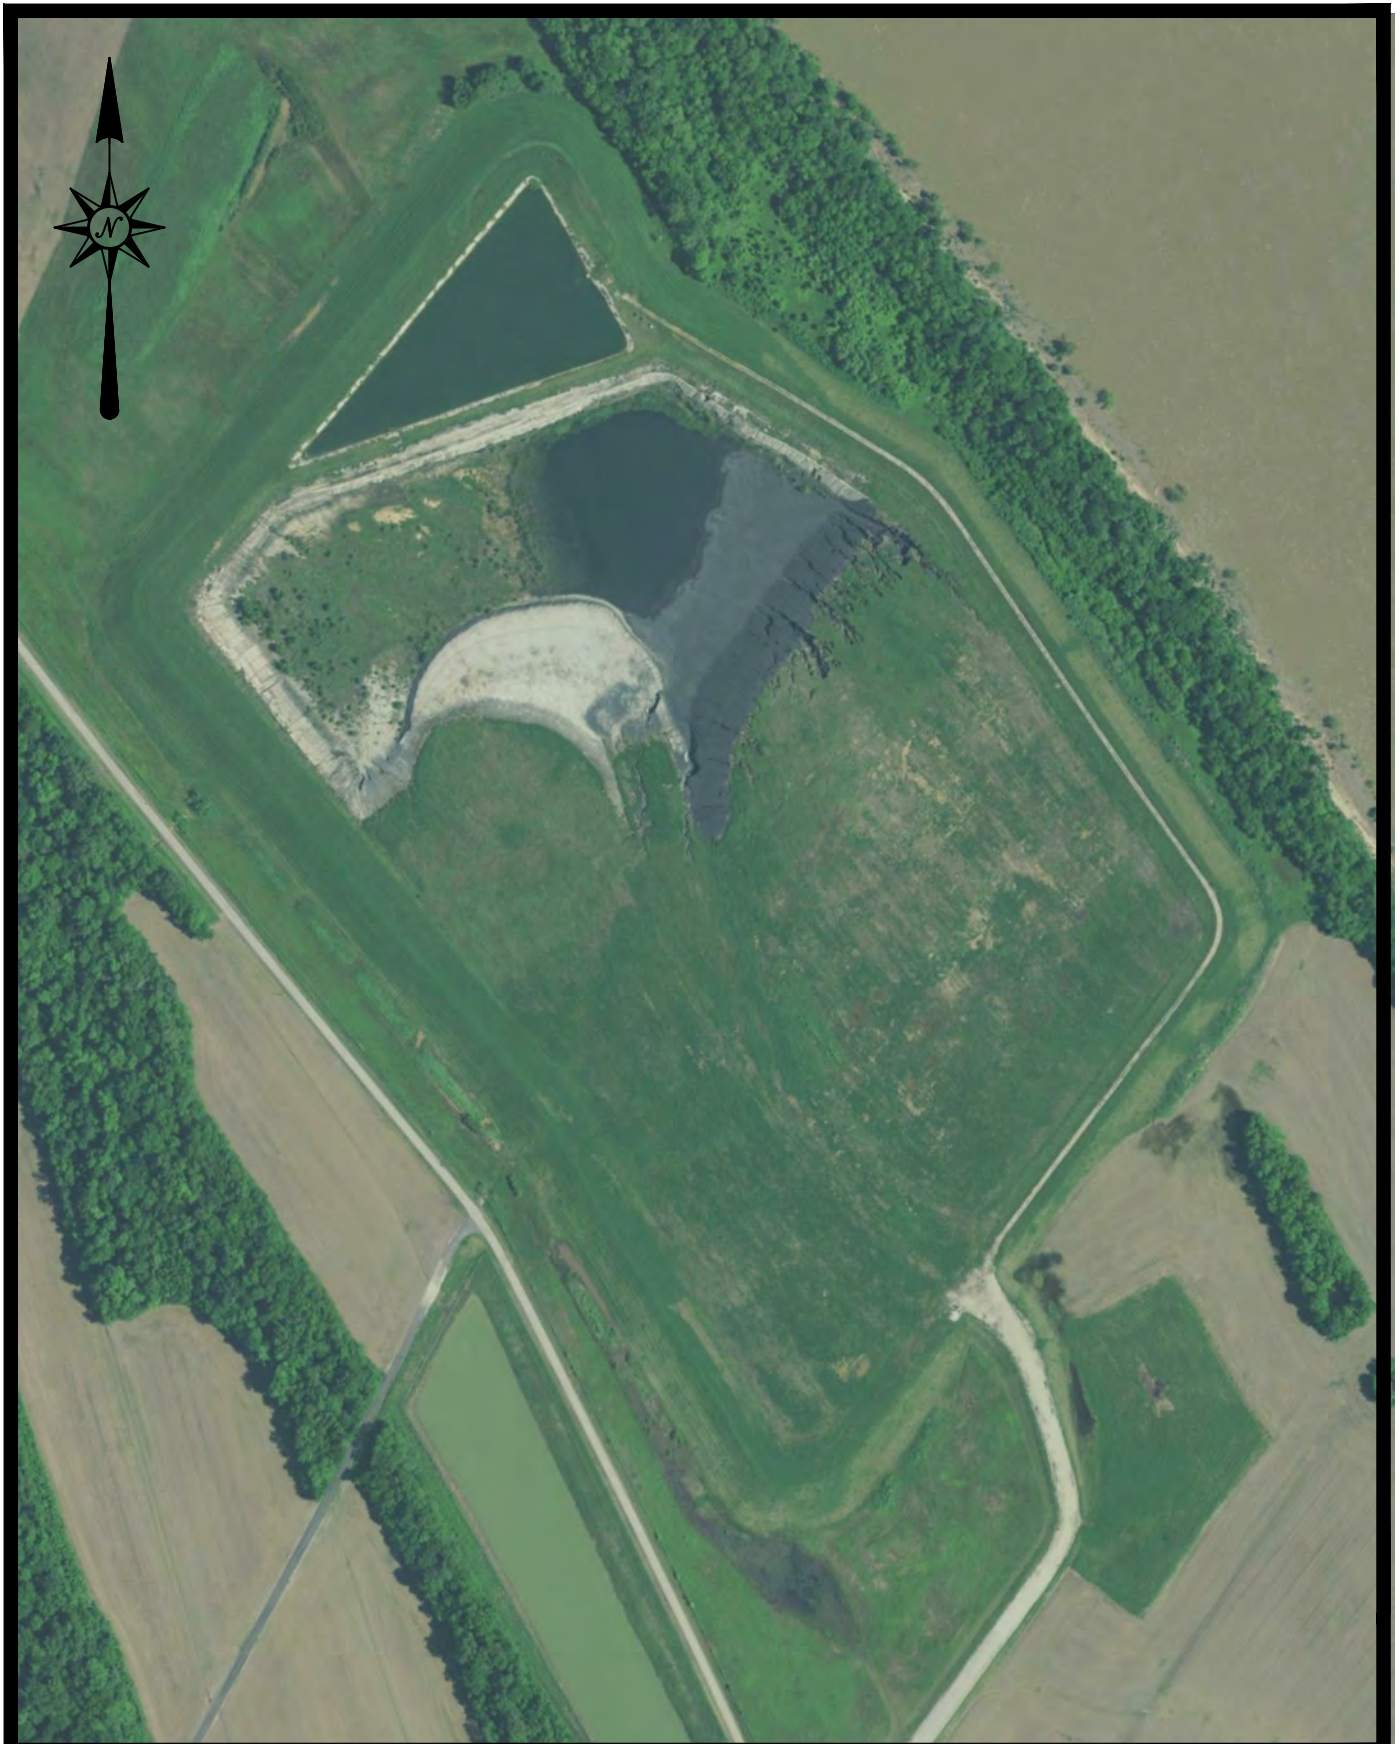
Pond D

The east embankment crest was well maintained. The downstream slope was well vegetated and well maintained with only minor mower wheel tracking present. The upstream slope was vegetated and well maintained. There's some erosion of the CCR housed inside of the pond. The rock along the upstream slope in the freshwater cell of the pond is well maintained. The decant inlet in the freshwater cell of the pond has no visible damage to it. The decant pipe valve has been turned off. The decant outlet is clear of debris and overgrowth and has no visible damage.
