**Big Rivers Electric Corporation  
Disposal of Coal Combustion Residuals (CCR) from Electric Utilities Final Rule  
CCR Impoundment Annual Inspection Report**

Name: Green Station CCR Surface Impoundment  
Operator: Sebree Generating Station  
Address: 9000 Highway 2096  
Robards, Kentucky 42452

SEBREE GENERATING STATION: GREEN STATION  
CCR SURFACE IMPOUNDMENT

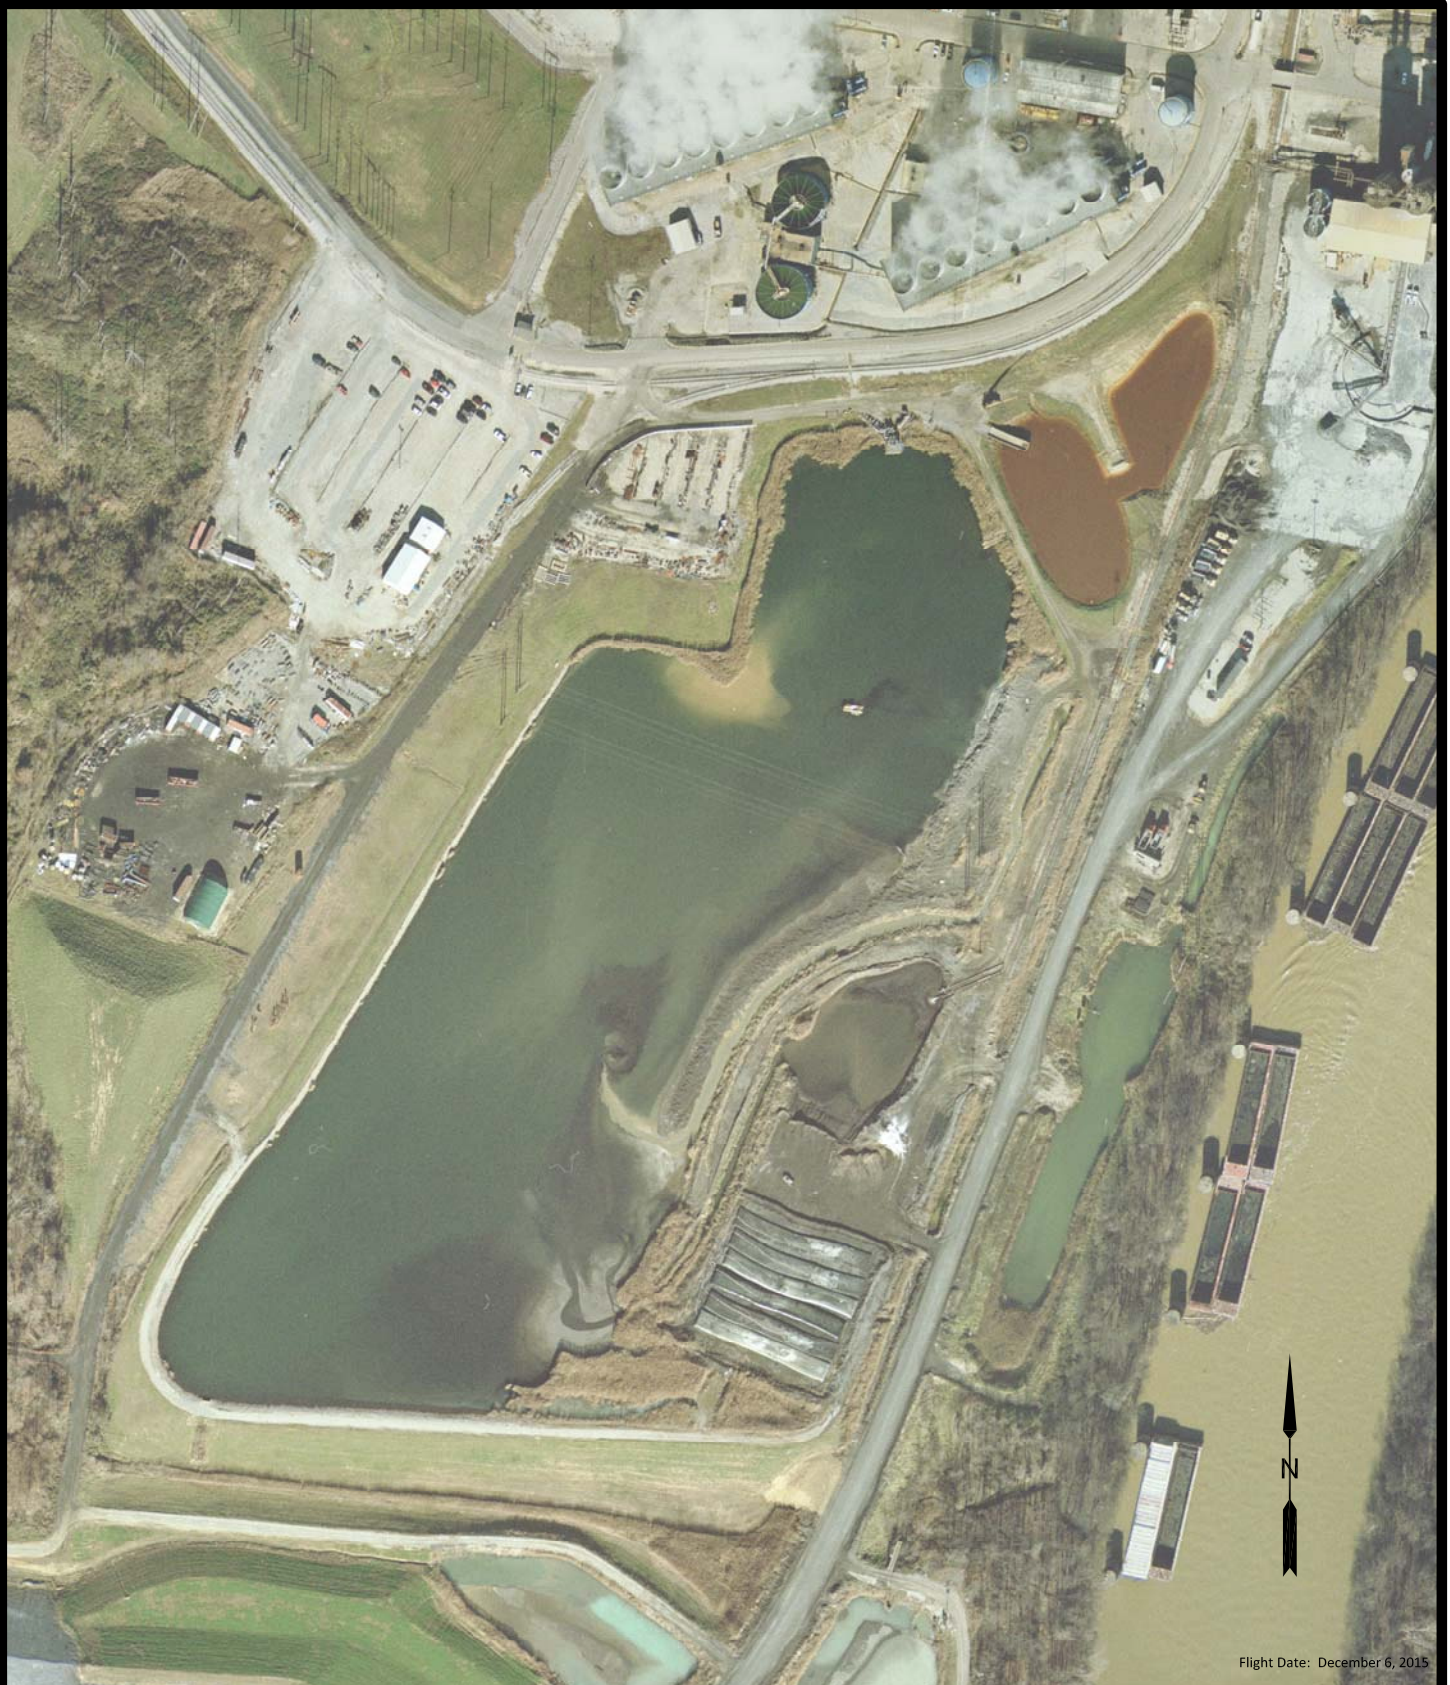
Flight Date: December 6, 2015

The inspection consisted of a visual assessment of the surface impoundment, embankments and discharge (refer to Aerial Photo of the surface impoundment and the Annual Inspection Checklist included with this report); and began on the downstream side of the west embankment. The inspection noted that the embankment crest is comprised of a gravel access road and the slope is vegetated with a flat drainage way formed along the base. The drainage way contained slowly flowing water.
