**Big Rivers Electric Corporation
Disposal of Coal Combustion Residuals (CCR) from Electric Utilities Final Rule
CCR Impoundment Annual Inspection Report**

Name: Reid/HMPL Station CCR Surface Impoundment
Operator: Sebree Generating Station
Address: 9000 Highway 2096
Robards, Kentucky 42452

This is the first annual inspection report for the Reid/HMPL Station CCR surface impoundment pursuant to the Disposal of Coal Combustion Residuals (CCR) from Electric Utilities Final Rule which became effective April 17, 2015.

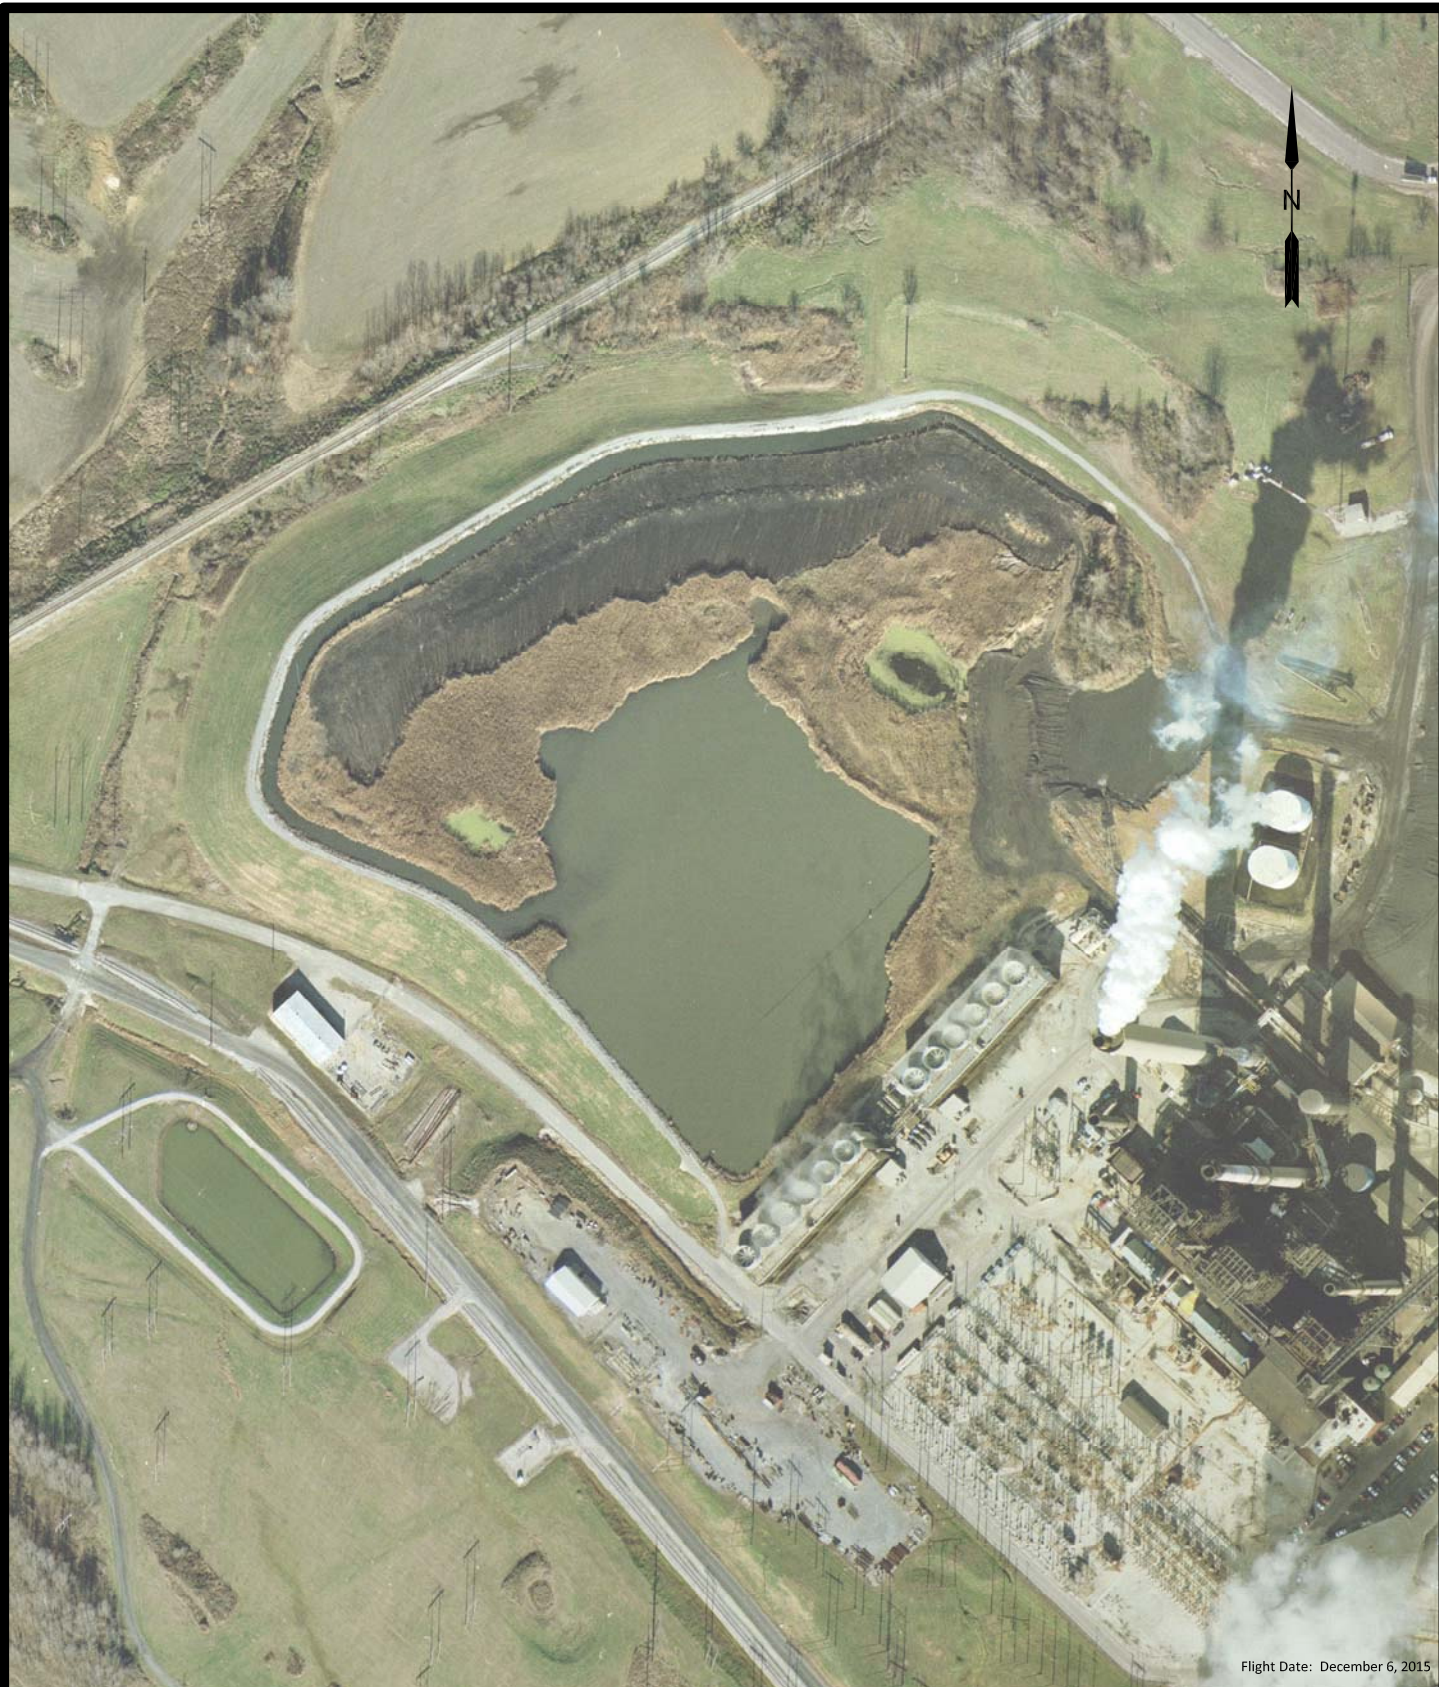
Flight Date: December 6, 2015

The inspection consisted of a visual assessment of the surface impoundment, embankments and discharge (refer to Aerial Photo of the surface impoundment and the Annual Inspection Checklist included with this report); and began on the downstream side of the south end of the west embankment. The inspection noted sporadic loose topsoil and animal burrowing. Thick grass thatch from mowing is choking vegetation and retaining moisture, and longitudinal ruts from tractor and mower wheels are retaining water. Some small depressions, wet areas and rills are present primarily from mid-slope to the embankment toe. As the inspection progressed to the north end of the west embankment it was noted that the toe became very wet with standing water along the embankment toe where it transitions to the north embankment at the west end of the impoundment. Lower areas of the embankment at this location were very wet with standing water supporting thick phragmites stands. The ground is very soft in this area as a result of seepage believed to be from the designed embankment blanket toe drain.

The inspection continued on the downstream side of the north embankment where the ground continued to be very wet downstream of the toe. As with the west embankment, loose topsoil and animal burrowing were evident, thick grass thatch from mowing is choking vegetation and retaining moisture, and longitudinal ruts from tractor and mower wheels are retaining water. Some small depressions, wet areas and rills are present primarily from mid-slope to the embankment toe. Standing water near the toe supports thick stands of phragmites. The wettest conditions occur on the northwest embankment and the toe is very poorly drained. Generally, the north embankment exhibits an irregular ground surface below the crest in several areas; soft/wet soil; heavy grass thatch; animal disturbance, trails and burrows; and loose soil material. The facility has retained a varmint control contractor to eradicate burrowing rodents and other small mammals.

The south embankment which parallels the cooling towers is the smallest embankment and was inspected next. The embankment is steep-sided and heavily vegetated except where erosion

and rip rap occur on the downstream side and where erosion and woody vegetation (phragmites and willows) occur on the upstream side of the embankment. The facility has sprayed invasive species to control and eradicate undesirable vegetation. Other areas of the embankment are poorly vegetated and dirt is exposed on steep slopes. The cooling tower blowdown pipe runs along the crest (south end) and exits at the discharge structure located in the southwest corner of the impoundment. The embankment crest supports a gravel access road around the southwest, west, north and northeast perimeter of the impoundment.

Associated Engineers, Inc. will be retained to assist in developing measures to address maintenance items (e.g. erosion, bare spots, drainage and seepage issues, invasive vegetation, animal burrows, etc.) identified in this inspection description.
