Green CCR Landfill

Disposal of Coal Combustion Residuals (CCR) from Electric Utilities Final Rule CCR Landfill 2021 Annual Inspection Report

February 4, 2022

**Big Rivers Electric Corporation
Disposal of Coal Combustion Residuals (CCR) from Electric Utilities Final Rule
CCR Landfill 2021 Annual Inspection Report**

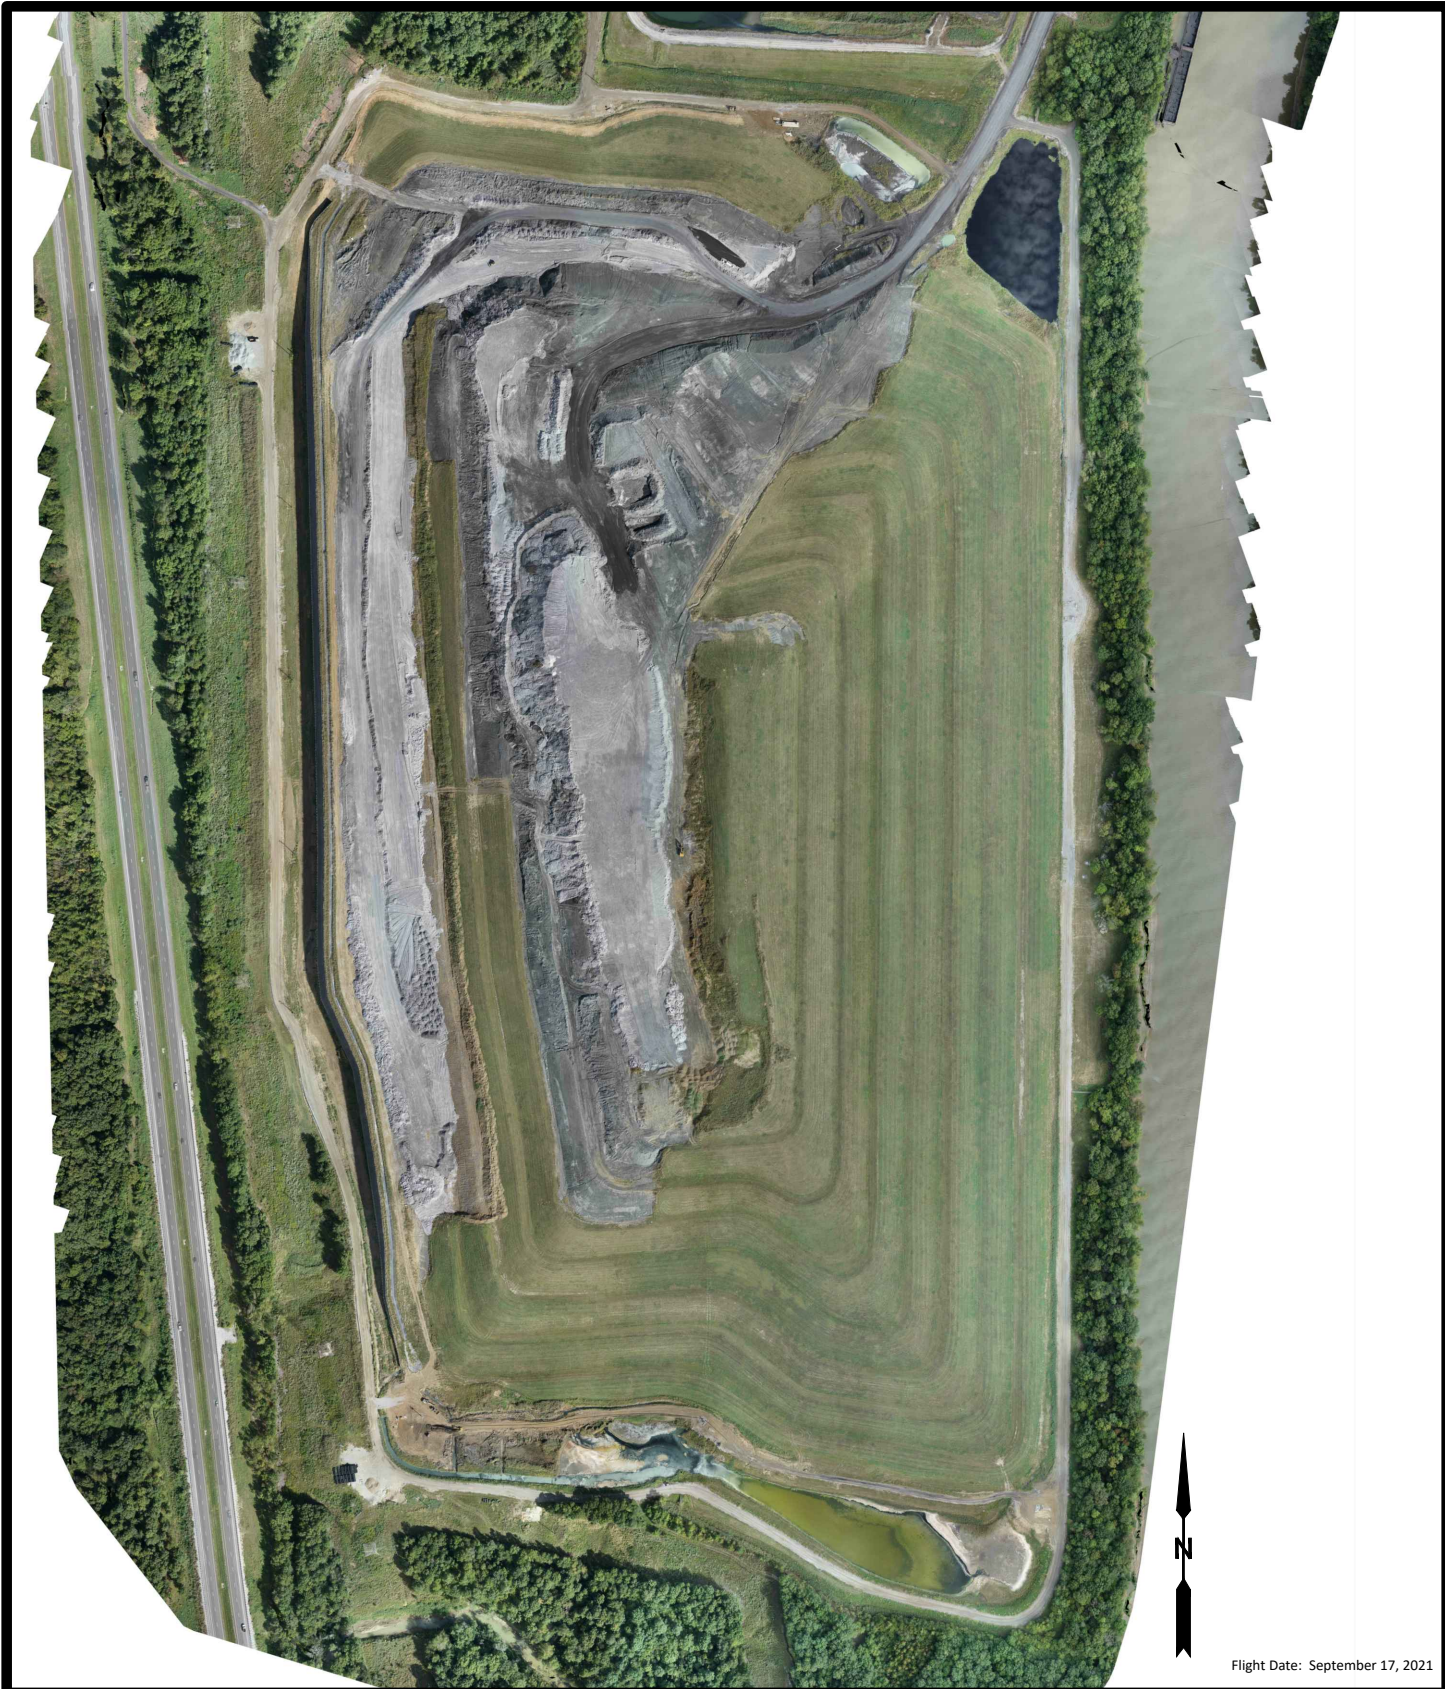
Green CCR Landfill
2021 Annual Inspection Aerial Photo

The total volume of CCR material contained in the Green CCR Landfill was estimated to be 23.2 million cubic yards. This volume was calculated from available baseline topography compared to October 2021 flight derived topographic contours.
