## **Reid/HMP&L CCR Surface Impoundment**

### **Disposal of Coal Combustion Residuals (CCR) from Electric Utilities Final Rule CCR Impoundment 2021 Annual Inspection Report**

**January 7, 2022**

**Project ID: 21-0216**

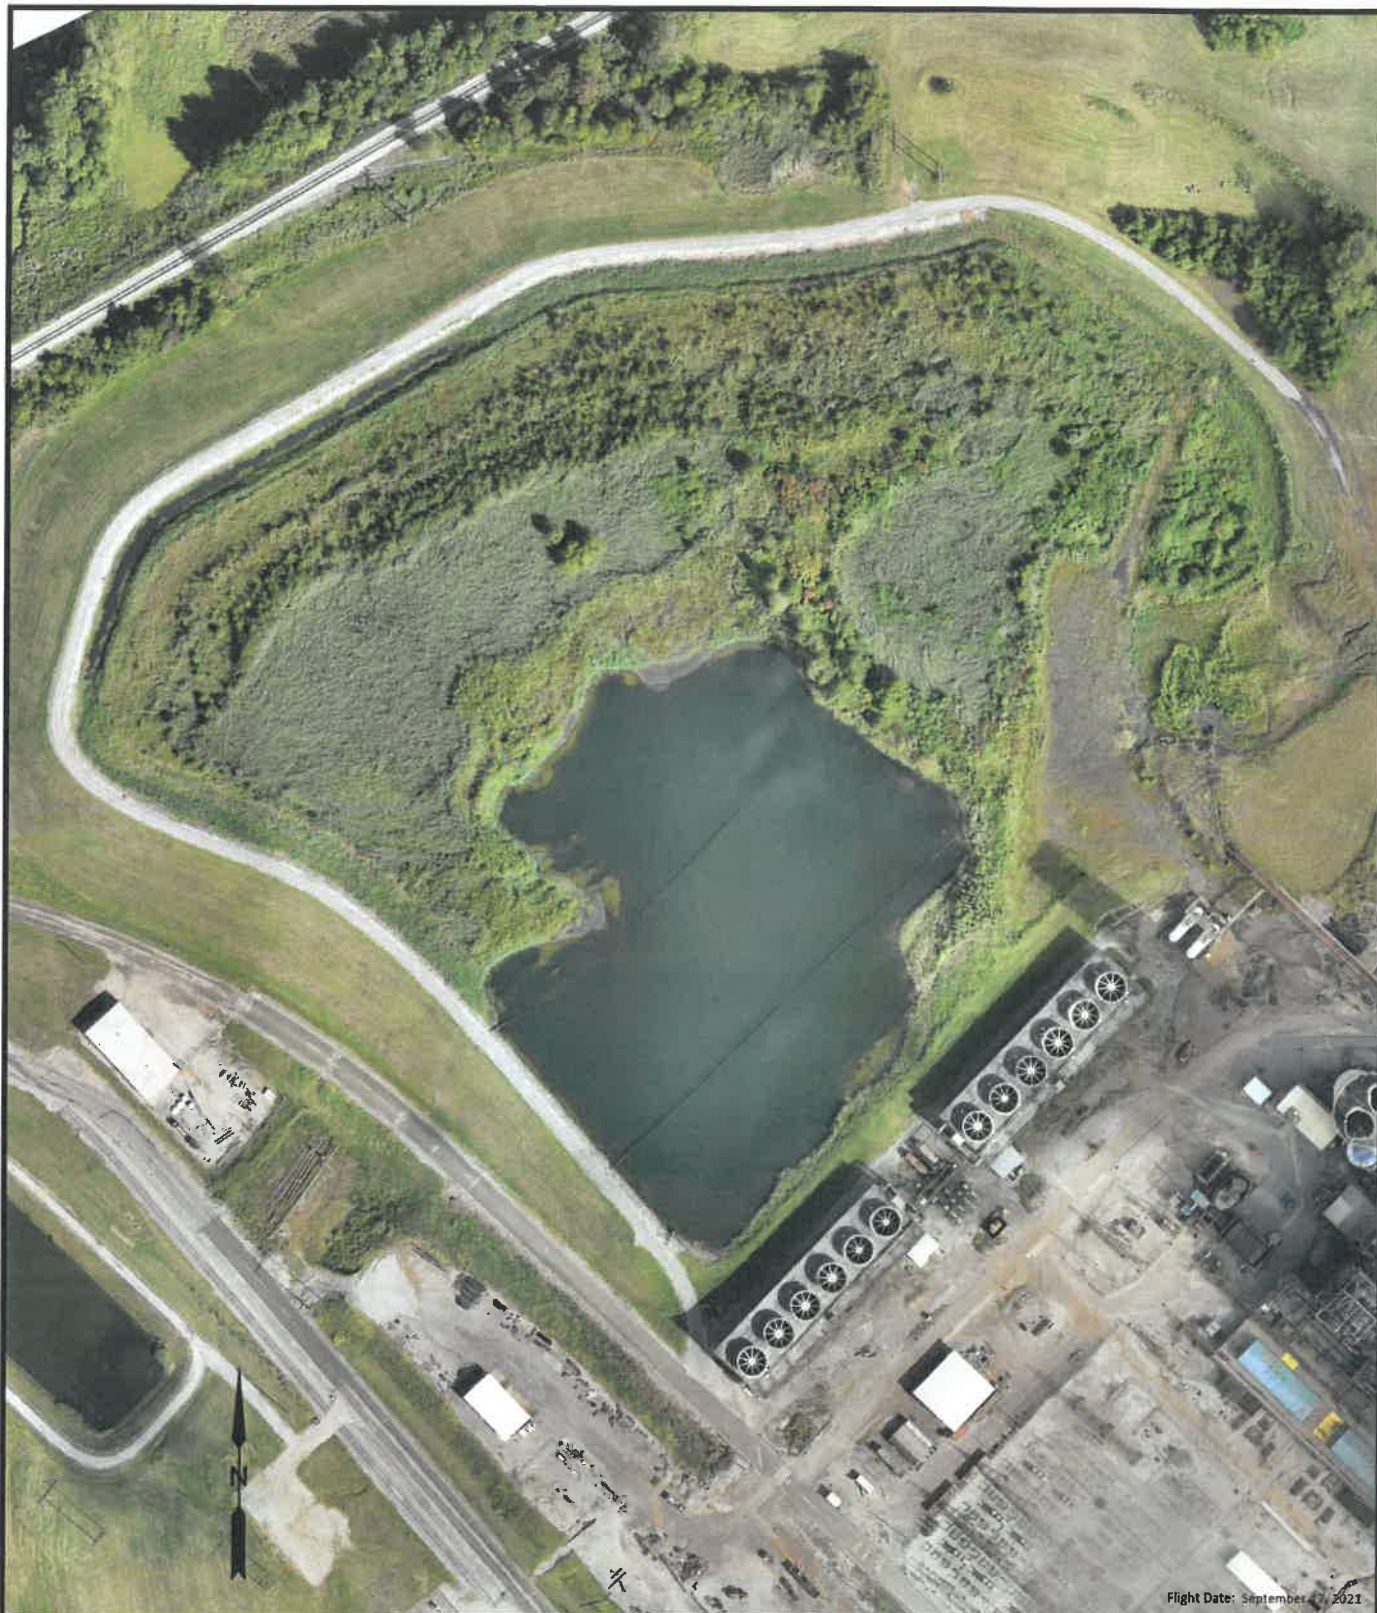
Reid/HMP&L CCR Surface Impoundment  
2021 Annual Inspection Aerial Photo

The inspection continued to the downstream slope of the south embankment where damage to vegetation from mowing equipment was noted at the southeast corner across from the discharge structure. The south downstream slope was vegetated and generally in good condition. It should be noted that a repair area was observed at the southwestern toe of the impoundment. This area is a low-lying area of saturated soil where a piece of mobile equipment became lodged. The area had been regraded and revegetated at the time of the inspection. As the inspection progressed west, areas along the slope were very wet and supported thick vegetation. Areas of saturated ground were observed on the lower slope adjacent to the toe were observed. Signs requiring hand mowing of these area were noted and few if any mower ruts were present in these areas. Minor mower damage was observed along the upper downstream slope at the north end of the west embankment as well as the north end of the north embankment. It appeared that other areas along the downstream embankment on the north and west side had been recently repaired and re-seeded. The crest of the west embankment was well maintained.

The inspection of the downstream slope of the north embankment noted an area of approximately one-quarter acre of standing water and very thick vegetation at the east end of the embankment. The crest of the north embankment was in good condition. The surface

impoundment no longer receives coal combustion residual (CCR) flow as of February 1, 2019. Much of the northern area of the impoundment interior was observed to be thickly vegetated with stands of phragmites.

Repair activities of the areas of mower rutting appear to be underway and the current program of inspection and subsequent repair upon discovery is adequate.

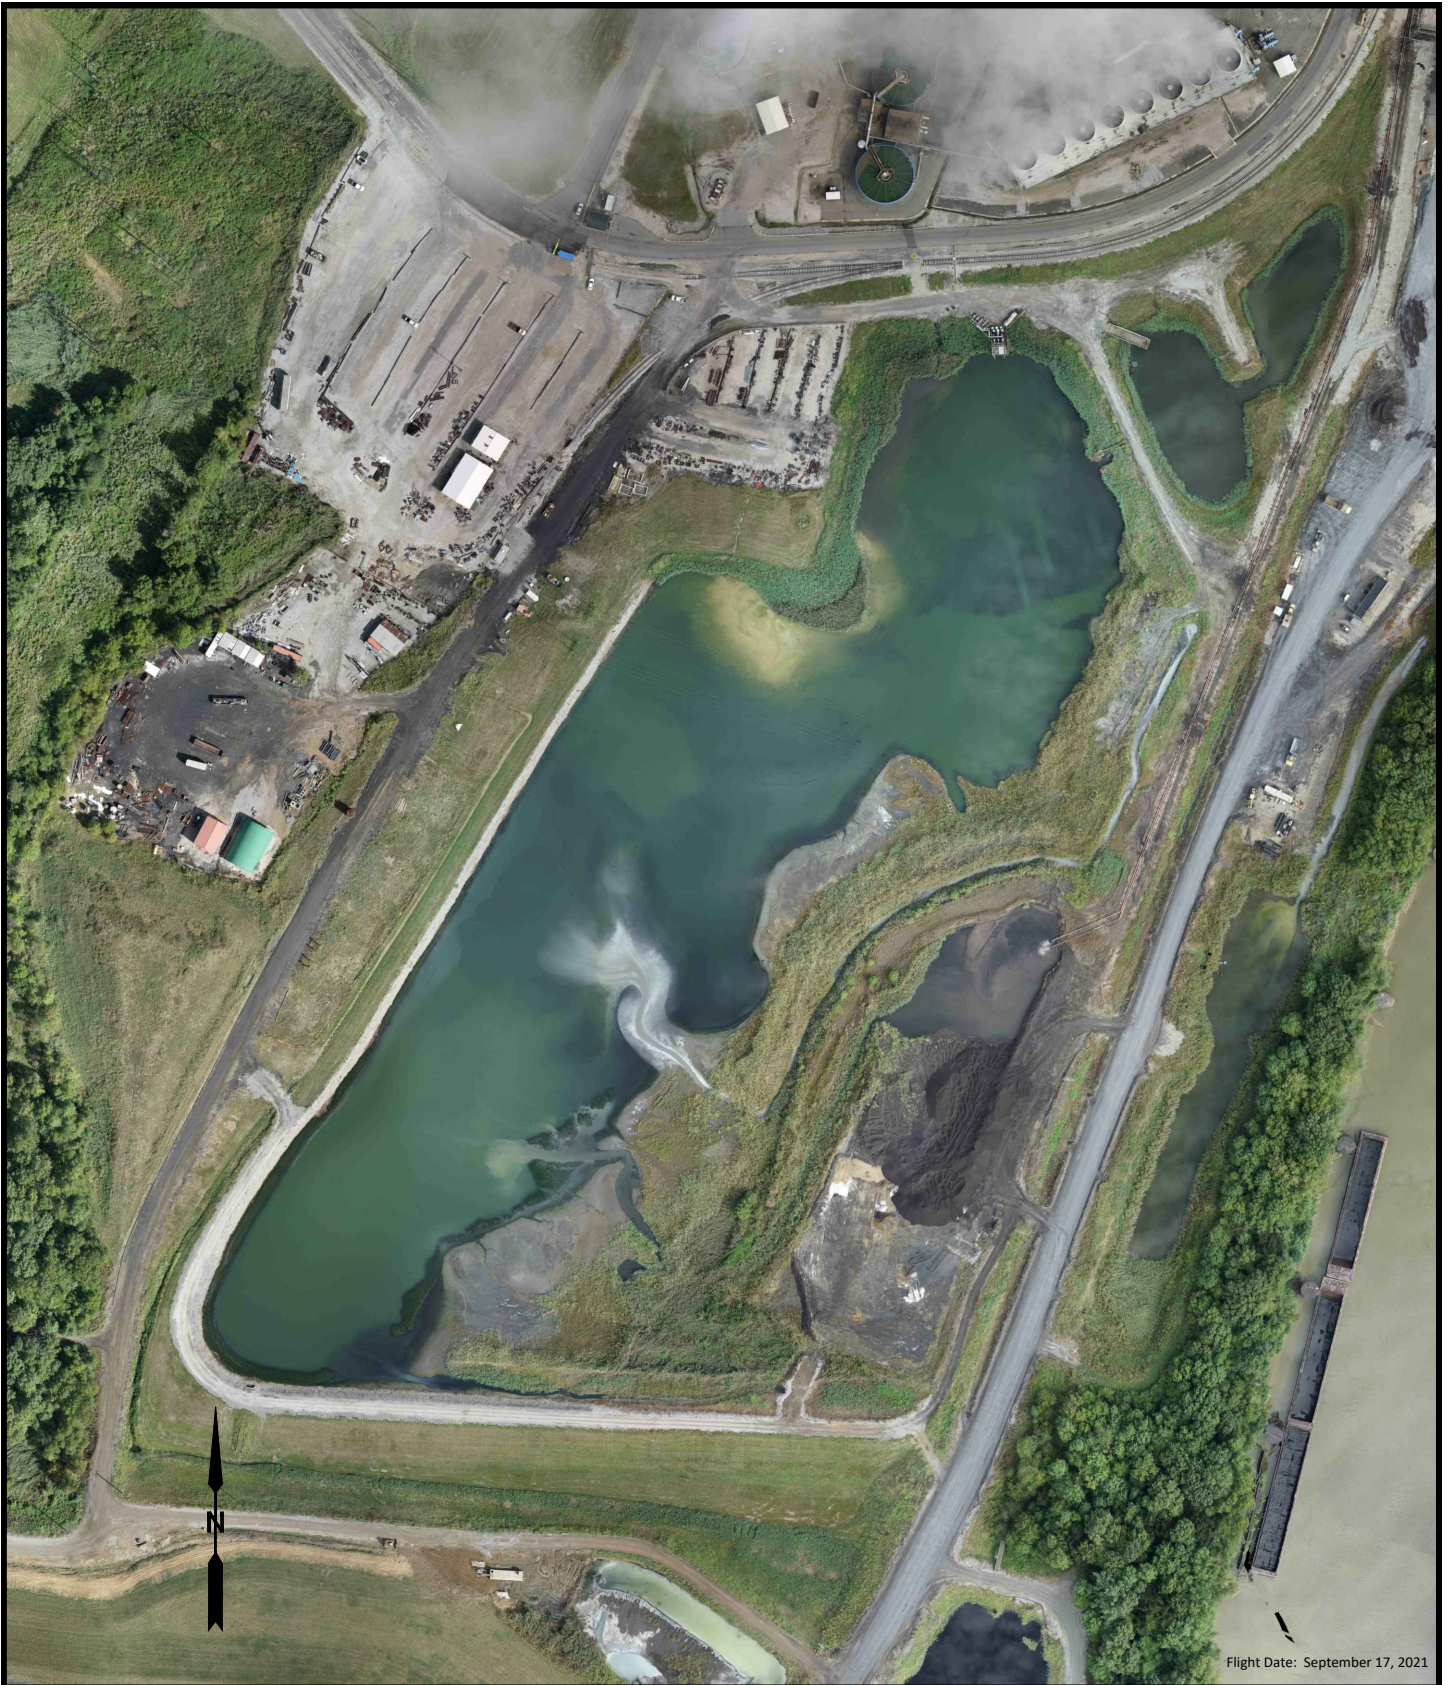
Flight Date: September 17, 2021

The east side of the impoundment interior contains CCR material at or above the current pool elevation. Active management of CCR material was observed where stored above the pool elevation. The east crest access road is not well separated from interior CCR storage areas. Areas of exposed CCR material and minor erosion were observed on the east embankment downstream slope and the southeast corner contains thick vegetation primarily consisting of phragmites obstructing the view of the interior slope.

The northeast, north and northwest portions of the impoundment are incised, and the upstream slopes were observed to be thickly vegetated with stands of phragmites that extend approximately 30 feet into the impoundment, which obstructs viewing of this area.

The northern portion of the west embankment crest and upstream slope was generally observed to be adequately rocked and the downstream slope adequately vegetated. Minor small animal burrows and areas of sparse vegetation were observed on the embankment crest adjacent to the rocked upstream slope and vegetated downstream slope. Moderate erosion and substantial vegetation were observed at the northwest corner of the impoundment directly south of the graveled lot.
