**Engineer's Certification of Unstable Areas Demonstration
Existing Green CCR Landfill
EPA Final CCR Rule
Sebree Station
Robards, Kentucky**

Existing Green CCR Landfill

Disposal of Coal Combustion Residuals (CCR) from Electric Utilities Final Rule Unstable Areas Demonstration for CCR

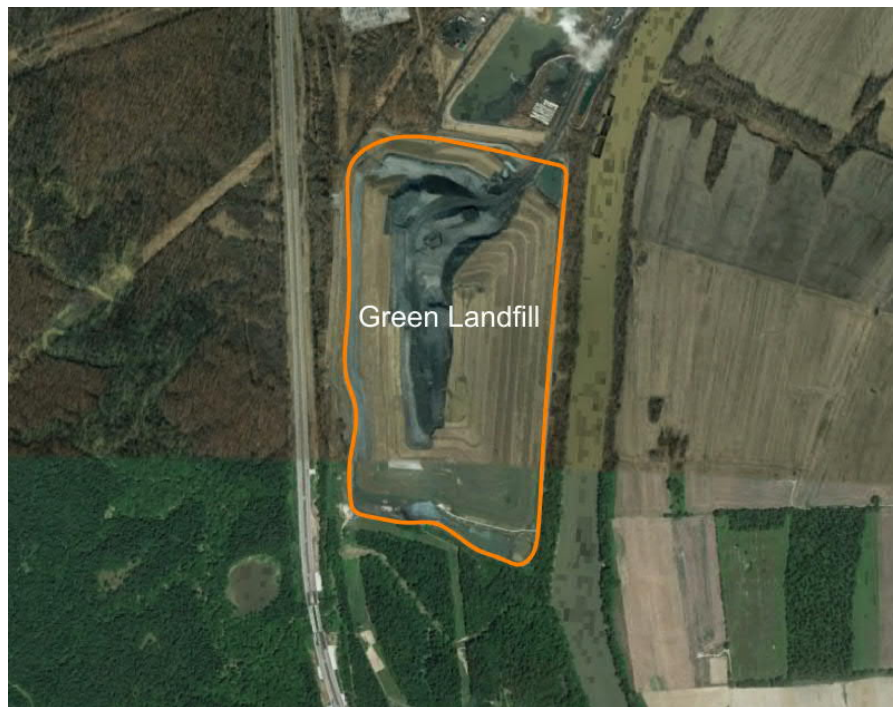
Figure 2: Site Overview

A site location plan of the Sebree Station is supplied as **Figure 1**. An aerial photograph of Green CCR Landfill is shown on the next page in **Figure 2**.

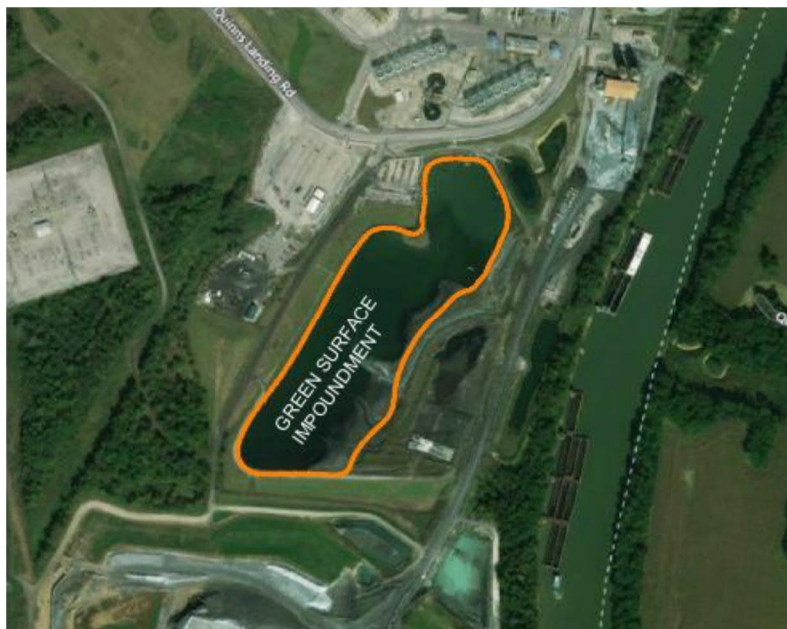
Figure 2: Site Overview

The CCR unit has been in existence for more than 40 years. The CCR unit operator has general maintenance and repair procedures in place as they determine necessity. There are no known occurrences of structural instability of the CCR unit. A site location plan of the Sebree Station is supplied as **Figure 1**. The current Green CCR Surface Impoundment footprint is approximately 21 acres. An aerial photograph of Green CCR Surface Impoundment is shown on the next page in **Figure 2**.

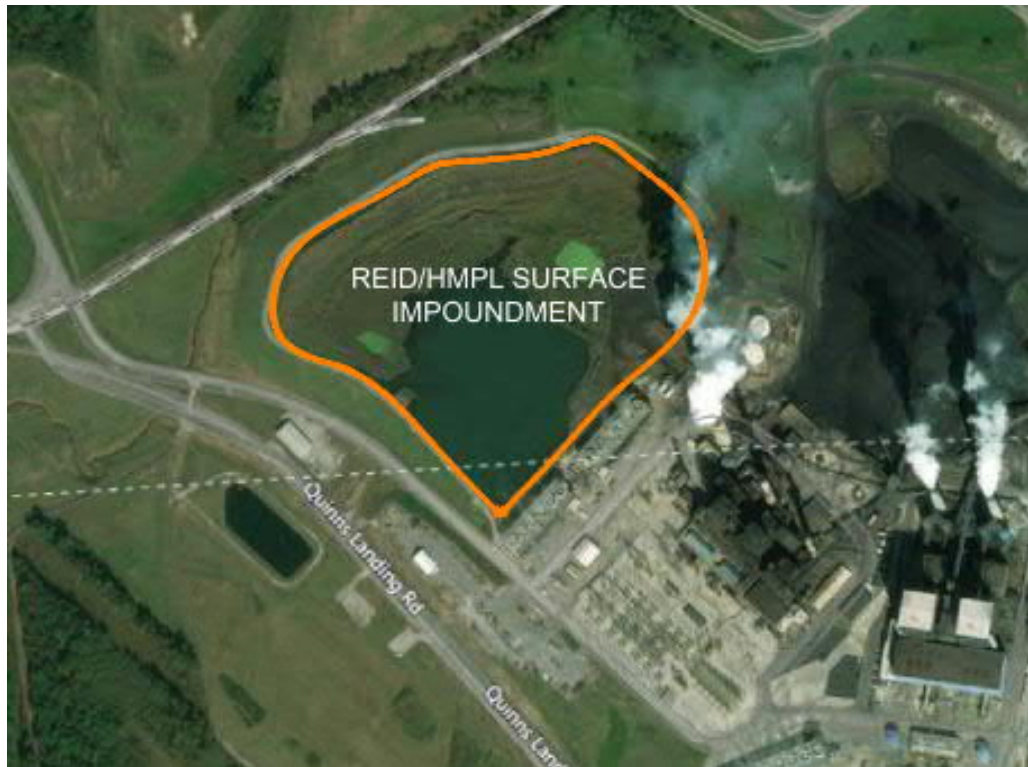
Figure 2: Site Overview

The impoundment discharges through two 30-inch diameter corrugated metal pipes located on the south end of the facility. An aerial photograph of Reid/HMPL CCR Surface Impoundment is shown below in **Figure 2**.
