**Big Rivers Electric Corporation
Disposal of Coal Combustion Residuals (CCR) from Electric Utilities Final Rule
CCR Landfill Annual Inspection Report**

Name: Green Station CCR Landfill
Operator: Sebree Generating Station
Address: 9000 Highway 2096
Robards, KY 42452

**SEBREE GENERATING STATION: GREEN STATION
CCR LANDFILL**

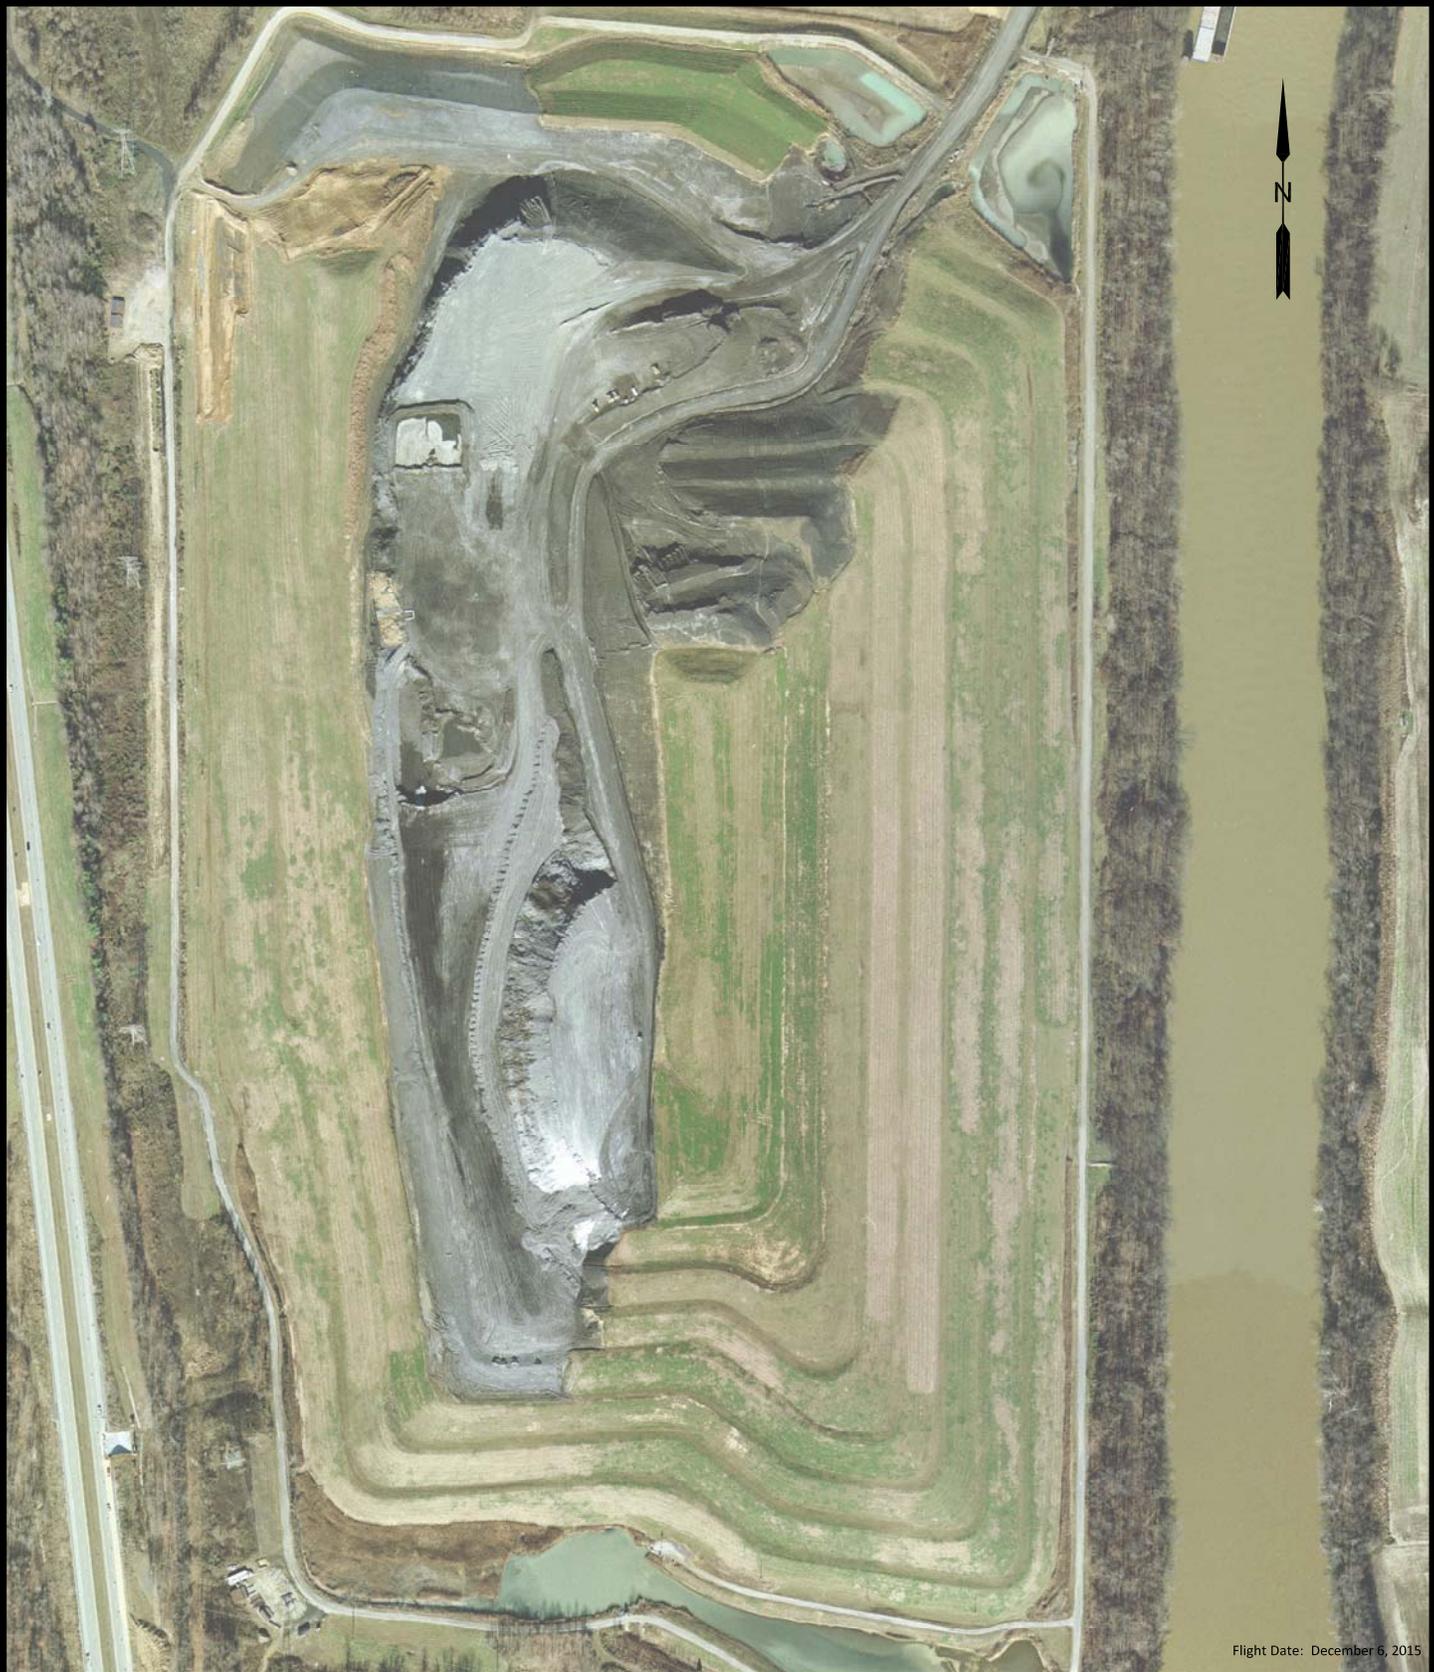
Flight Date: December 6, 2015

Job Number:	15-0140E
Date:	1/15/2016
Scale:	NOT TO SCALE
Drawn By:	E.J.A.
