Green CCR Surface Impoundment

Disposal of Coal Combustion Residuals (CCR) from Electric Utilities
Final Rule
CCR Surface Impoundment 2018 Annual Inspection Report - Revision B
Big Rivers Electric Corporation

Reid/HMPL CCR Surface Impoundment

Disposal of Coal Combustion Residuals (CCR) from Electric
Utilities Final Rule
CCR Surface Impoundment 2018 Annual Inspection Report

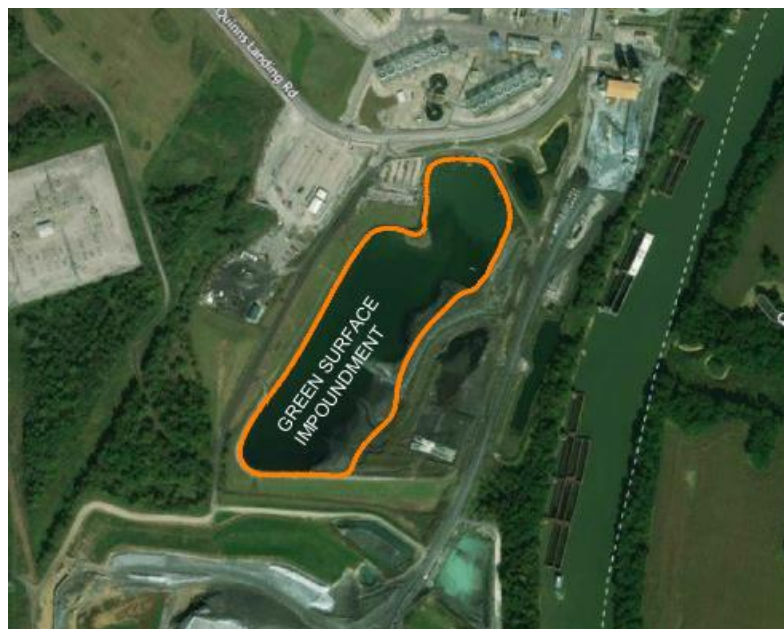
Figure 1: Green CCR Surface Impoundment Aerial Photograph

The CCR unit has been in existence for more than 40 years. The CCR unit operator has general maintenance and repair procedures in place as they determine necessity. There are no known occurrences of structural instability of the CCR unit. The current Green CCR Surface Impoundment footprint is approximately 21 acres. An aerial photograph of Green CCR Surface Impoundment is shown below in **Figure 1**.

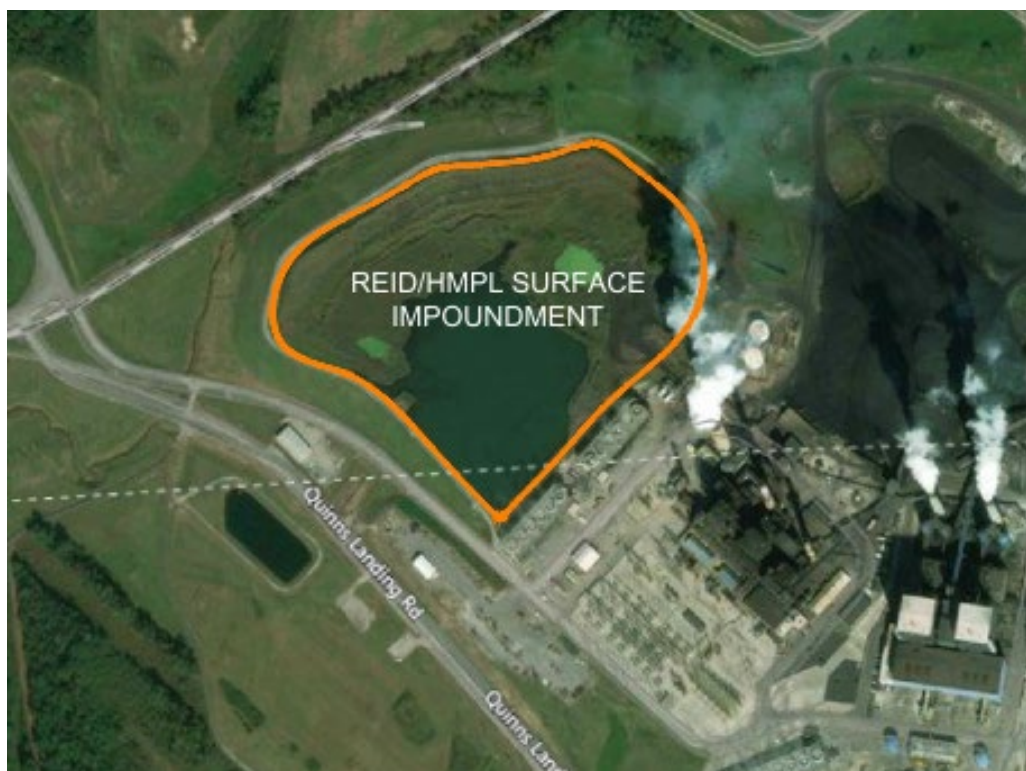
Figure 1: Big Rivers Reid/HMPL CCR Surface Impoundment Overview

The CCR unit has been in existence for more than 40 years. The CCR unit operator has general maintenance and repair procedures in place as they determine necessity. There are no known occurrences of structural instability of the CCR unit. The current Reid/HMPL CCR Surface Impoundment footprint is approximately 25.4 acres. An aerial photograph of Reid/HMPL CCR Surface Impoundment is shown below in Figure 1.

The Reid/HMPL CCR Surface Impoundment consists of an earthen embankment on the south, west and north sides and incised to the east as shown in Figure 1. The impoundment is approximately 2,500 feet to the east of the Green River and the maximum height of the embankment is 42 feet on the west dike. The impoundment currently receives only sluiced bottom ash however, previously received both sluiced fly ash and bottom ash until 1985 when the Boothe system was put into operation.

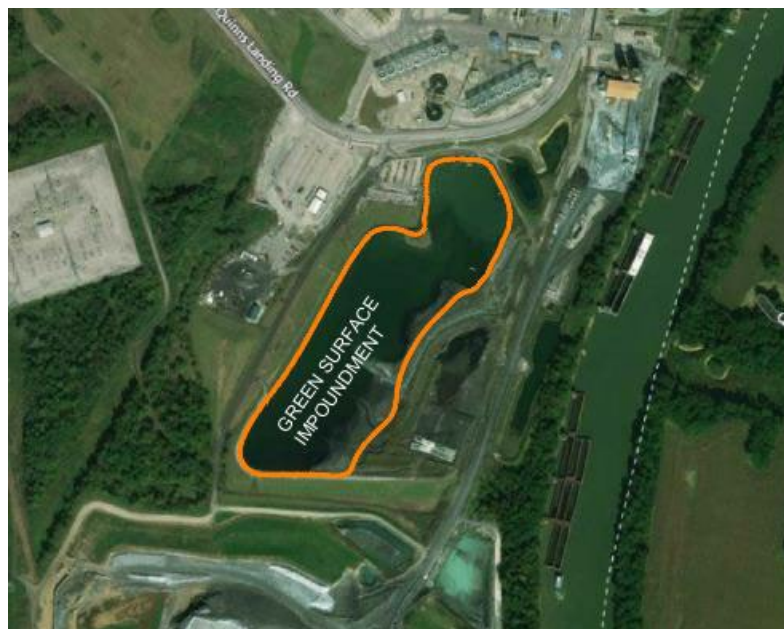
Figure 1: Green CCR Surface Impoundment Aerial Photograph

The CCR unit has been in existence for more than 40 years. The CCR unit operator has general maintenance and repair procedures in place as they determine necessity. There are no known occurrences of structural instability of the CCR unit. The current Green CCR Surface Impoundment footprint is approximately 21 acres. An aerial photograph of Green CCR Surface Impoundment is shown below in **Figure 1**.
