# Reid/HMP&L CCR Surface Impoundment

Disposal of Coal Combustion Residuals (CCR) from Electric  
Utilities Final Rule  
CCR Surface Impoundment 2019 Annual Inspection Report

Big Rivers Electric Corporation

Project number: 60613511

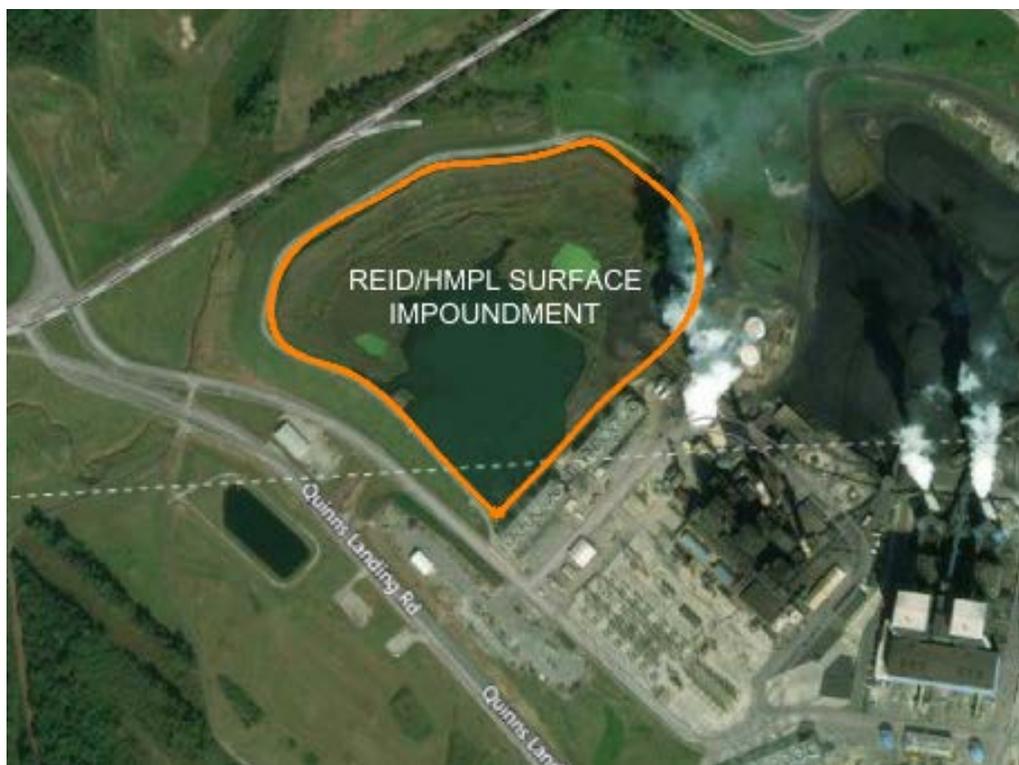
**Figure 1:** Big Rivers Reid/HMP&LCCR Surface Impoundment Overview

The CCR unit has been in existence for more than 40 years. The CCR unit operator has general maintenance and repair procedures in place as they determine necessity. There are no known occurrences of structural instability of the CCR unit. The current Reid/HMP&LCCR Surface Impoundment footprint is approximately 25.4 acres. An aerial photograph of Reid/HMP&LCCR Surface Impoundment is shown below in Figure 1.

The Reid/HMP&LCCR Surface Impoundment consists of an earthen embankment on the south, west and north sides and incised to the east as shown in Figure 1. The impoundment is approximately 2,500 feet to the east of the Green River and the maximum height of the embankment is 42 feet on the west dike. As discussed previously in Section 4, the ash pond no longer receives CCR flow as of February 1, 2019.

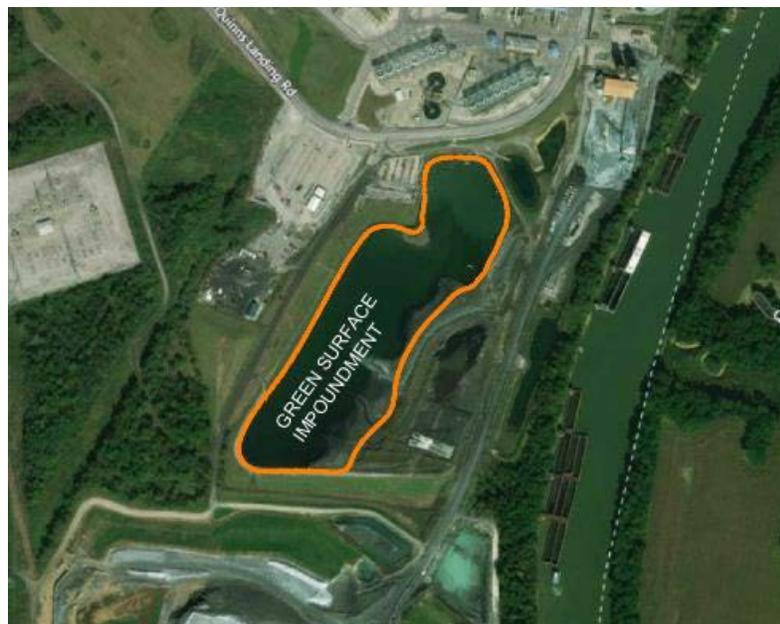
**Figure 1: Green CCR Surface Impoundment Aerial Photograph**

The CCR unit has been in existence for more than 40 years. The CCR unit operator has general maintenance and repair procedures in place as they determine necessity. There are no known occurrences of structural instability of the CCR unit. The current Green CCR Surface Impoundment footprint is approximately 21 acres. An aerial photograph of Green CCR Surface Impoundment is shown below in **Figure 1**.
