Reid/HMP&L CCR Surface Impoundment

Disposal of Coal Combustion Residuals (CCR) from Electric
Utilities Final Rule
CCR Surface Impoundment 2020 Annual Inspection Report

Big Rivers Electric Corporation

January 8, 2021

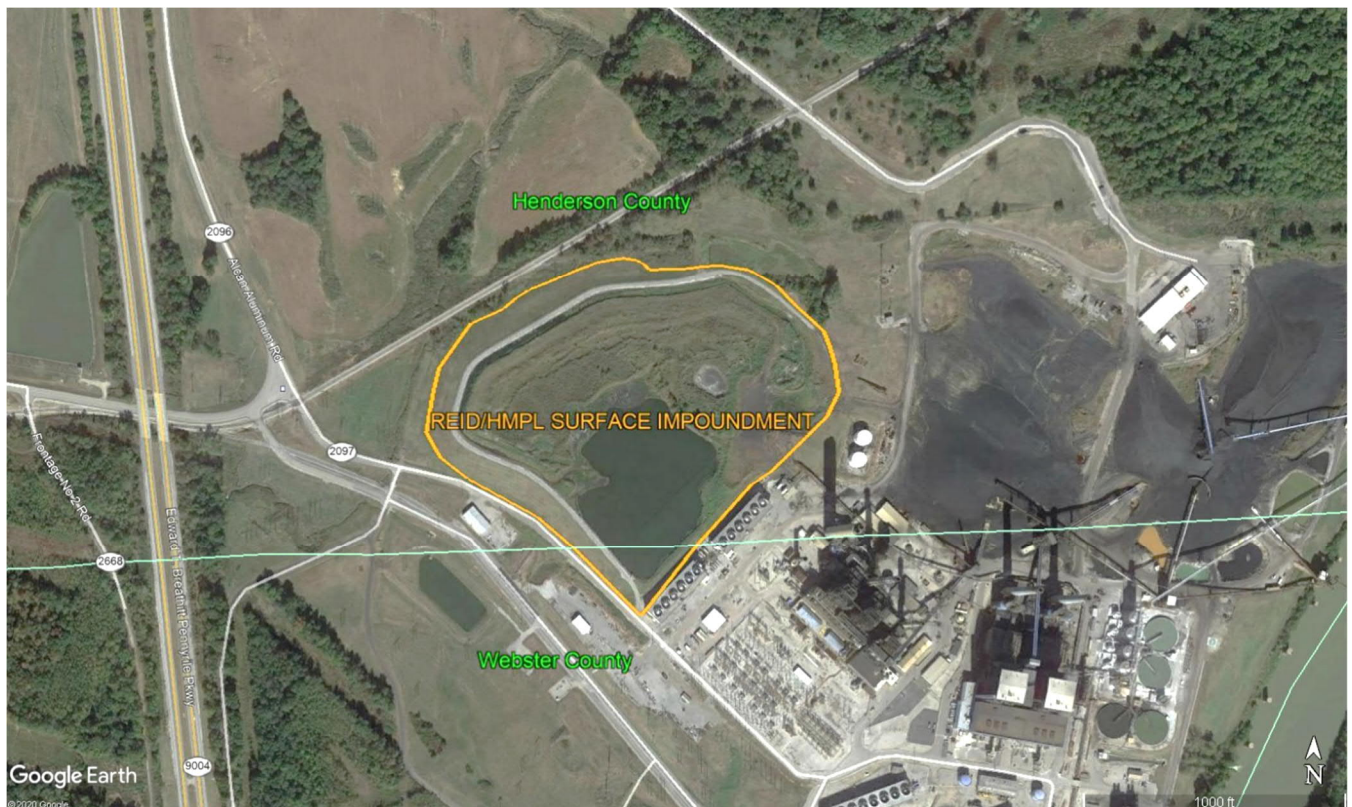
The CCR unit has been in existence for more than 40 years. The CCR unit operator has general maintenance and repair procedures in place as they determine necessity. There are no known occurrences of structural instability of the CCR unit. The current Reid/HMP&L CCR Surface Impoundment footprint is approximately 25.4 acres and 29.4 acres corresponds to entire area along toe of dikes. An aerial photograph of Reid/HMP&LCCR Surface Impoundment is shown below in Figure 1.

Figure 1: Big Rivers Reid/HMP&L CCR Surface Impoundment Overview (Google Earth, 2020)

The Reid/HMP&L CCR Surface Impoundment consists of an earthen embankment on the south, west and north sides and incised to the east as shown in Figure 1. The impoundment is approximately 2,500 feet to the west of the Green River and the maximum height of the embankment is approximately 42 feet along the west dike. As discussed previously in Section 4, the ash pond no longer receives CCR flow as of February 1, 2019.

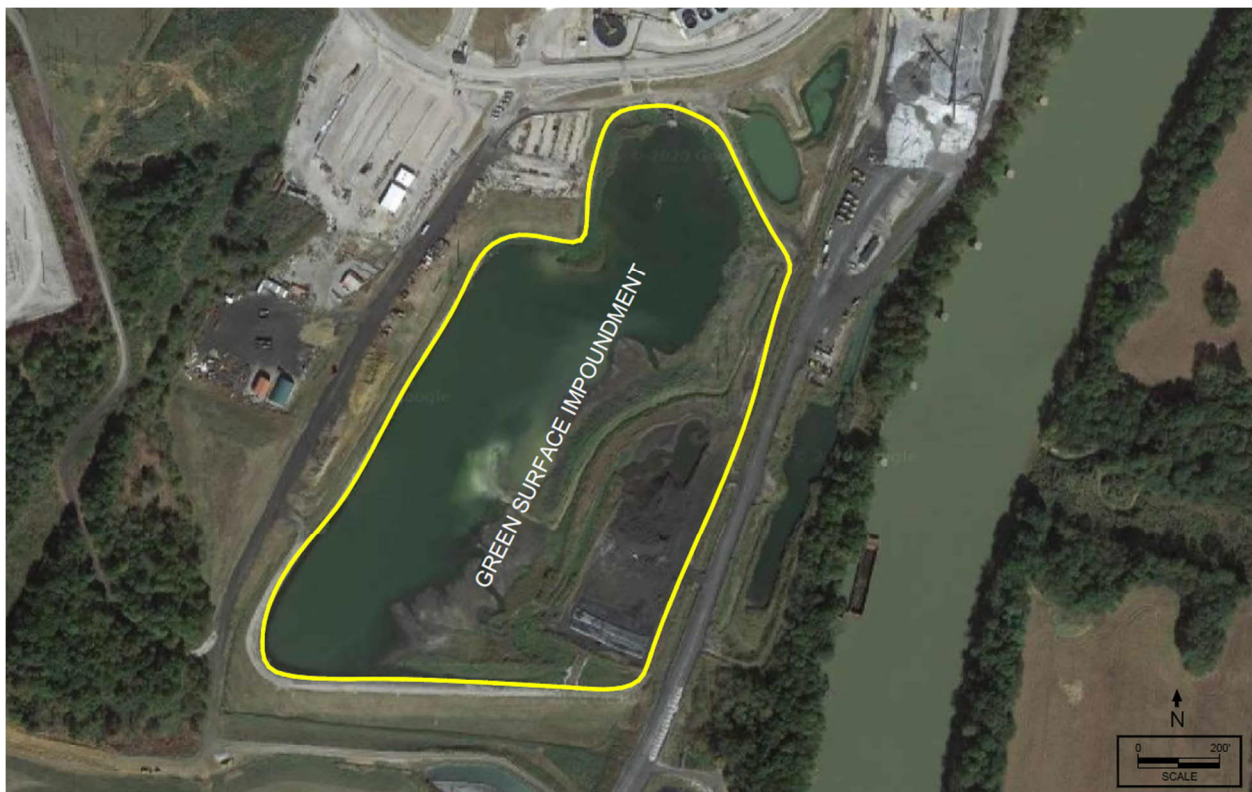
The CCR unit has been in existence for more than 40 years. The CCR unit operator has general maintenance and repair procedures in place as they determine necessary. There are no known occurrences of structural instability of the CCR unit. The current Green CCR Surface Impoundment footprint is approximately 23 acres. An aerial photograph showing the approximate limits of the Green CCR Surface Impoundment is shown below in **Figure 1**.

Figure 1: Green CCR Surface Impoundment Aerial Photograph (Google Earth, 2020)
