Green CCR Landfill

Disposal of Coal Combustion Residuals (CCR) from Electric
Utilities Final Rule
CCR Landfill 2020 Annual Inspection Report

Big Rivers Electric Corporation

Project number: 60636158

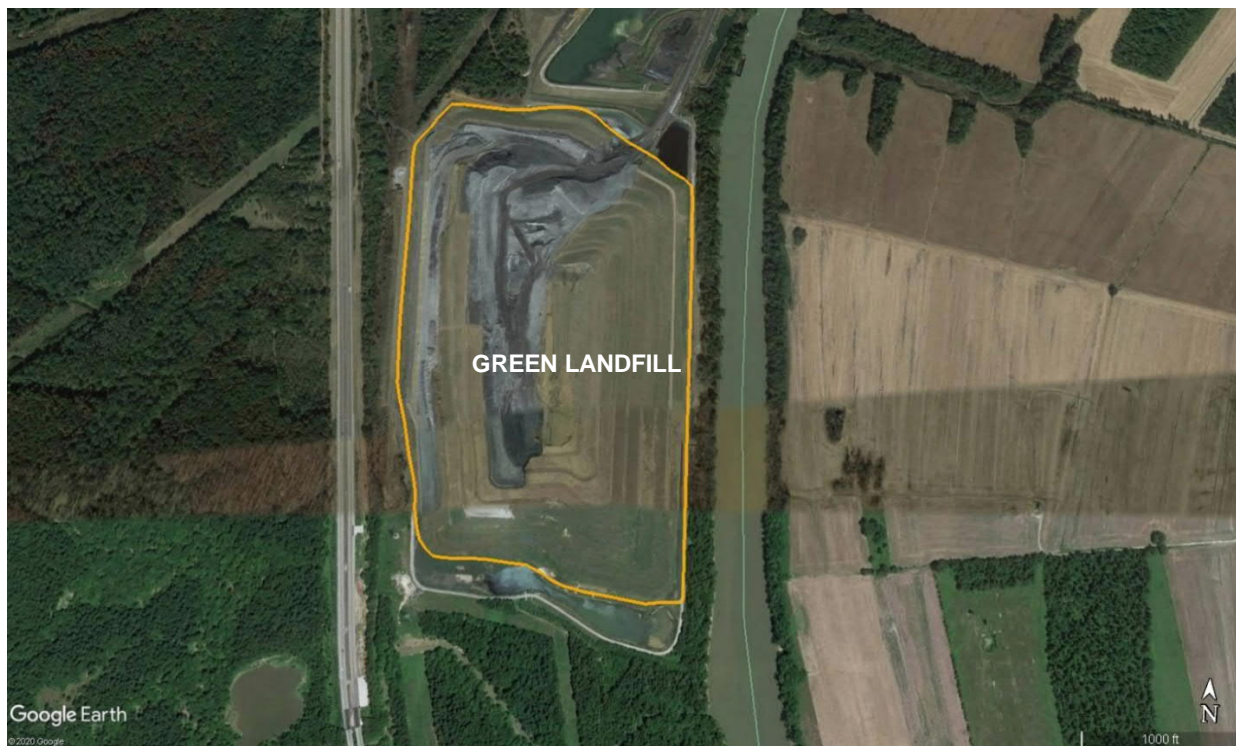
Figure 1: Big Rivers Green Landfill Overview (Google Earth, 2020)

The Green CCR Landfill is used for the placement of coal combustion residual (CCR) material including primarily Poz-O-Tec and related materials. The landfill has a maximum elevation of approximately 608 feet above mean sea level (ft. AMSL), based on aerial photogrammetry conducted by Associated Engineers in September 2020. The Green River lies to the east and Groves Creek lies to the south of the landfill. The landfill has approximately 7 continuous benches on the south and east side, each higher in elevation until the top of landfill is reached. The north side and top and bottom portions of the west side of the landfill are receiving CCR placement as part of BREC operations. An aerial photograph of the Green CCR Landfill is presented in Figure 1.
