Green CCR Landfill

**Disposal of Coal Combustion Residuals (CCR) from Electric Utilities Final Rule
CCR Landfill 2022 Annual Inspection Report**

**Big Rivers Electric Corporation
Disposal of Coal Combustion Residuals (CCR) from Electric Utilities Final Rule
CCR Landfill 2022 Annual Inspection Report**

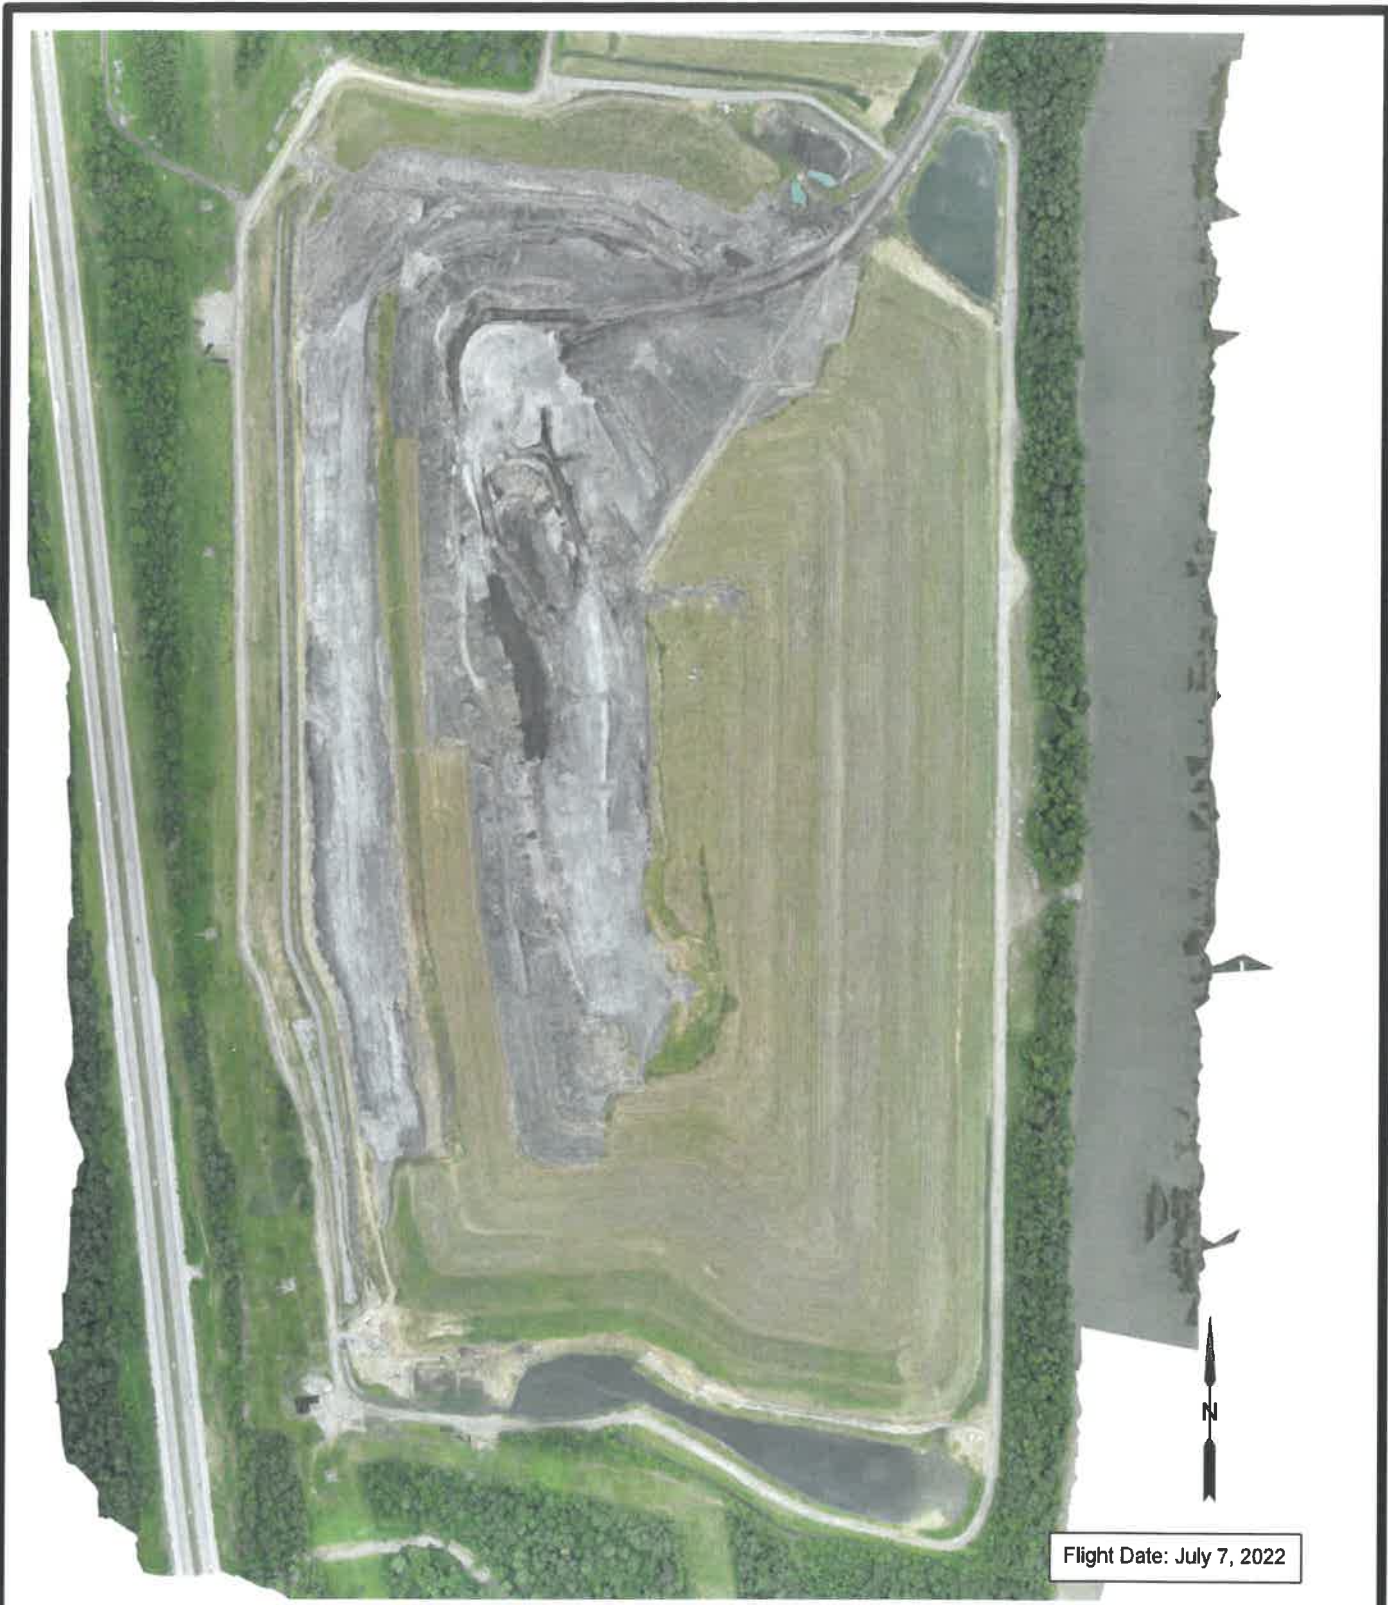
ASSOCIATED ENGINEERS, INC. ENGINEERS • GEOLOGISTS • SURVEYORS	BIG RIVERS ELECTRIC CORPORATION		Job Number: 22-0215	Revisions:
	Green CCR Landfill		Date: 01/05/2023	
	2022 Annual Inspection Aerial Photo		Scale: 1" = 250'	
			Drawn By: A.E.I.	
2740 North Main St. • Madisonville, KY 42431 Phone: (270) 821-7732 • Fax: (270) 821-7789 www.associatedengineers.com

The inspection consisted of a visual assessment of the landfill and associated drainage control features; and began on the west side of the landfill adjacent to the vertical expansion combination wall (expansion wall). Evidence of minor seepage and slight ponding in a few isolated places along the toe of the wall approximately 1,450' north of the southwest end of the wall was observed. It appears this seepage was being managed by the subsurface drainage improvement along the toe of the wall. These improvements included the installation of a perforated subsurface pipe and trench filled with drainage medium to route the seepage underground to strategically placed pump stations surrounding the landfill. These subsurface drainage improvements were not only completed on the west side of the landfill but were installed throughout the entire perimeter except for a small section on the north end of the pile. In the areas where higher concentrations of moisture were previously present laterals and/or parallel subsurface draining structures were added to further reduce the presence and effects of seepage at the surface. At the time of the inspection virtually all the seepage from the landfill had been routed underground to the subsurface drainage system which flows to a series of pump stations. These pump stations are then pumped to the target manhole which is then pumped into the Green Ash Pond where it is treated and discharged with the remainder of the contact water. There was an area along the south toe which the subsurface drainage system was having maintenance activity performed. This area lacked vegetative cover due to the construction activities, but seeding and final grading of the surface is scheduled for the spring per BREC. The drainage ditch adjacent to the west access road that parallels the expansion wall and reports to Pond 012 at the south end of the landfill has been regraded and repurposed to primarily convey non-contact surface run off. As previously mentioned, this ditch is unvegetated in places due to prolonged periods of water in areas. It will be addressed as part of regular maintenance.

The inspection proceeded from the west side landfill to the inactive east side along the access road adjacent to the embankment toe. Proceeding north, the completion of the subsurface seepage collection system appears to have re-routed most if not all the seepage previously noted underground. The ditch along the east side of the landfill had recently been mowed and there was an area of minor settlement and erosion related to the underdrain system. This will be addressed as a part of routine maintenance now that it is visible. Along the lower bench at approximately the midpoint a small surficial slope failure of the cover material due to mower activity was noted. The inspection of the lower slope continued to the north side of the inactive landfill where there was an area of stressed vegetation along the northeast toe which appears to be caused by recent mowing and removal of phragmite. This vegetation is anticipated to recover in the next growing season.
